January 29, 2020

Project B1909819

Re: Slope Evaluation Letter
Crown Plaza Site
3601 American Blvd E
Bloomington, Minnesota

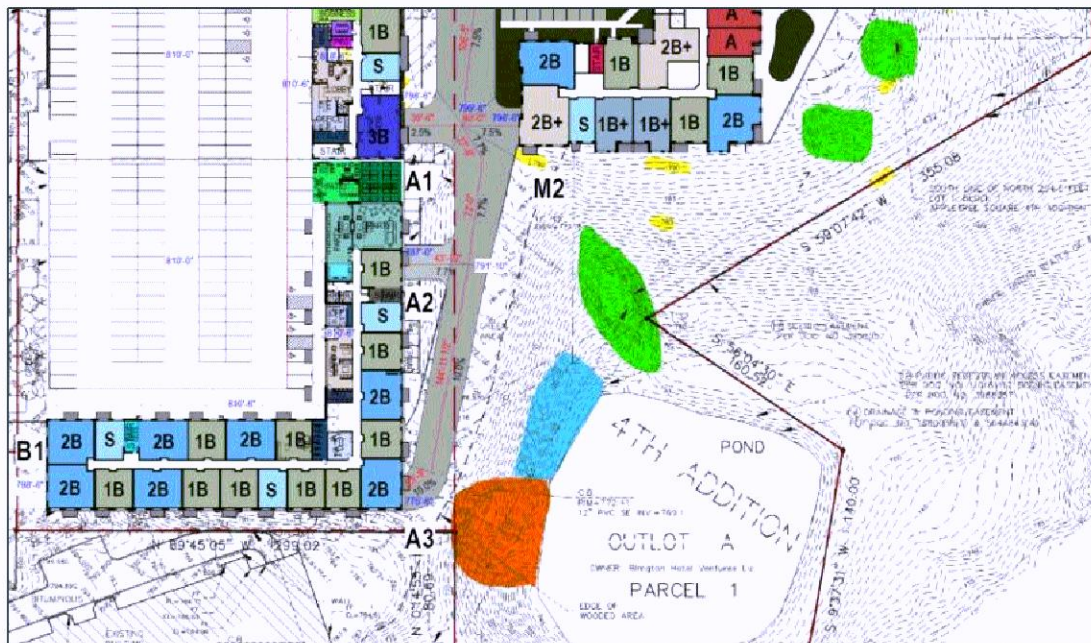
Figure 1. Slope Conditions

On the slopes uphill from the pond to the north and west, we noted slope instability in various locations. In Figure 1, the three areas shaded in green approximate the location of erosional cuts downhill from areas where stormwater drainage is concentrated. The area shaded in blue represents a section of the slope where some minor surface erosion has steepened the base of a slope. The area shaded in red represents a location where erosion from concentrated water flow has occurred and has led to movement of the slope. The slope movement generally appears to be shallow and within a few feet of the surface. Within the red area there are three pipes, two near the top of the slope and one at the base of the slope. All three have had a constant flow of water during our visits to the site in October and November, with flow ranging from a trickle of water to a flow of about 1/4-inch deep. Photograph 1 further illustrates this location. Note the exposed fabric to the left of the pipe, presumably placed either as a base for slope protection (rip rap) or to aid in growth of vegetation.

For the slopes directly adjacent the proposed development, uphill to the north and west of the pond, we recommend that we be engaged to review the stability of the slope if structures will be placed within a horizontal distance from the top edge of the slope equal to the height of the slope. Depending on the location and depth of proposed structures, a review of the slope stability may reveal that some modifications may be needed to the existing slopes. Potential modifications could include flattening the slopes, incorporating some form of slope reinforcement, or providing surface protection to the slope face. Furthermore, we recommend that no structures (including pavements) be planned for location within the current slopes, unless a detailed slope stability assessment is conducted as part of the design.
