January 29, 2020

Project B1909819

Re: Slope Evaluation Letter  
Crown Plaza Site  
3601 American Blvd E  
Bloomington, Minnesota

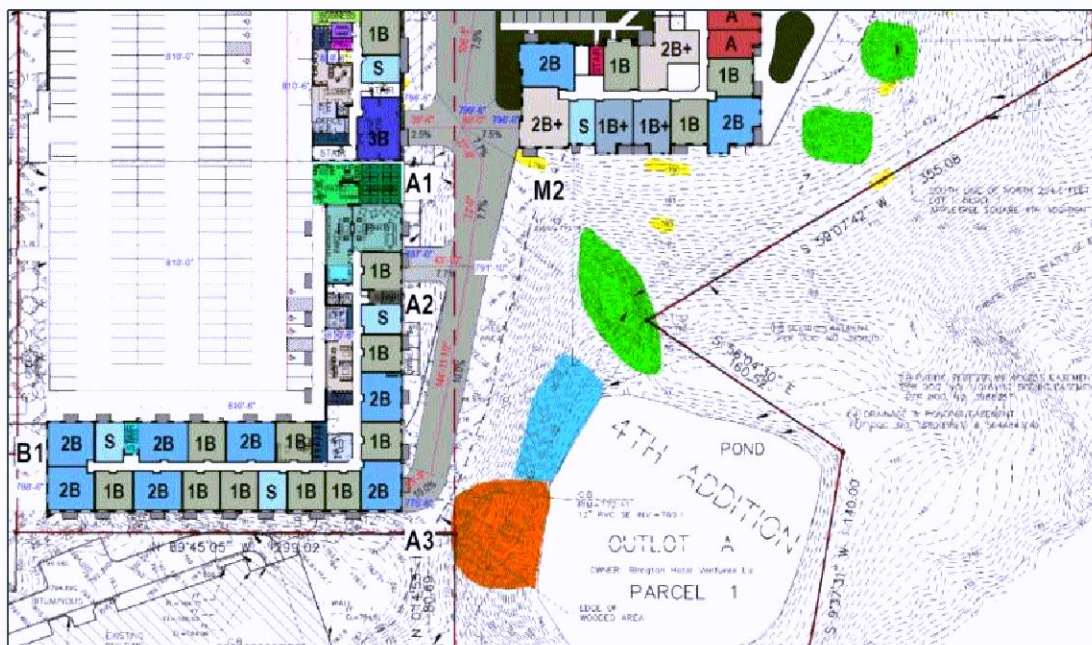
**Figure 1. Slope Conditions**

On the slopes uphill from the pond to the north and west, we noted slope instability in various locations. In Figure 1, the three areas shaded in green approximate the location of erosional cuts downhill from areas where stormwater drainage is concentrated. The area shaded in blue represents a section of the slope where some minor surface erosion has steepened the base of a slope. The area shaded in red represents a location where erosion from concentrated water flow has occurred and has led to movement of the slope. The slope movement generally appears to be shallow and within a few feet of the surface. Within the red area there are three pipes, two near the top of the slope and one at the base of the slope. All three have had a constant flow of water during our visits to the site in October and November, with flow ranging from a trickle of water to a flow of about 1/4-inch deep. Photograph 1 further illustrates this location. Note the exposed fabric to the left of the pipe, presumably placed either as a base for slope protection (rip rap) or to aid in growth of vegetation.

For the slopes directly adjacent the proposed development, uphill to the north and west of the pond, we recommend that we be engaged to review the stability of the slope if structures will be placed within a horizontal distance from the top edge of the slope equal to the height of the slope. Depending on the location and depth of proposed structures, a review of the slope stability may reveal that some modifications may be needed to the existing slopes. Potential modifications could include flattening the slopes, incorporating some form of slope reinforcement, or providing surface protection to the slope face. Furthermore, we recommend that no structures (including pavements) be planned for location within the current slopes, unless a detailed slope stability assessment is conducted as part of the design.
