December 15, 2020

Project B2010536

Re: Slope Evaluation Letter  
Proposed Bloomington Apartments  
8131 34th Avenue  
Bloomington, Minnesota

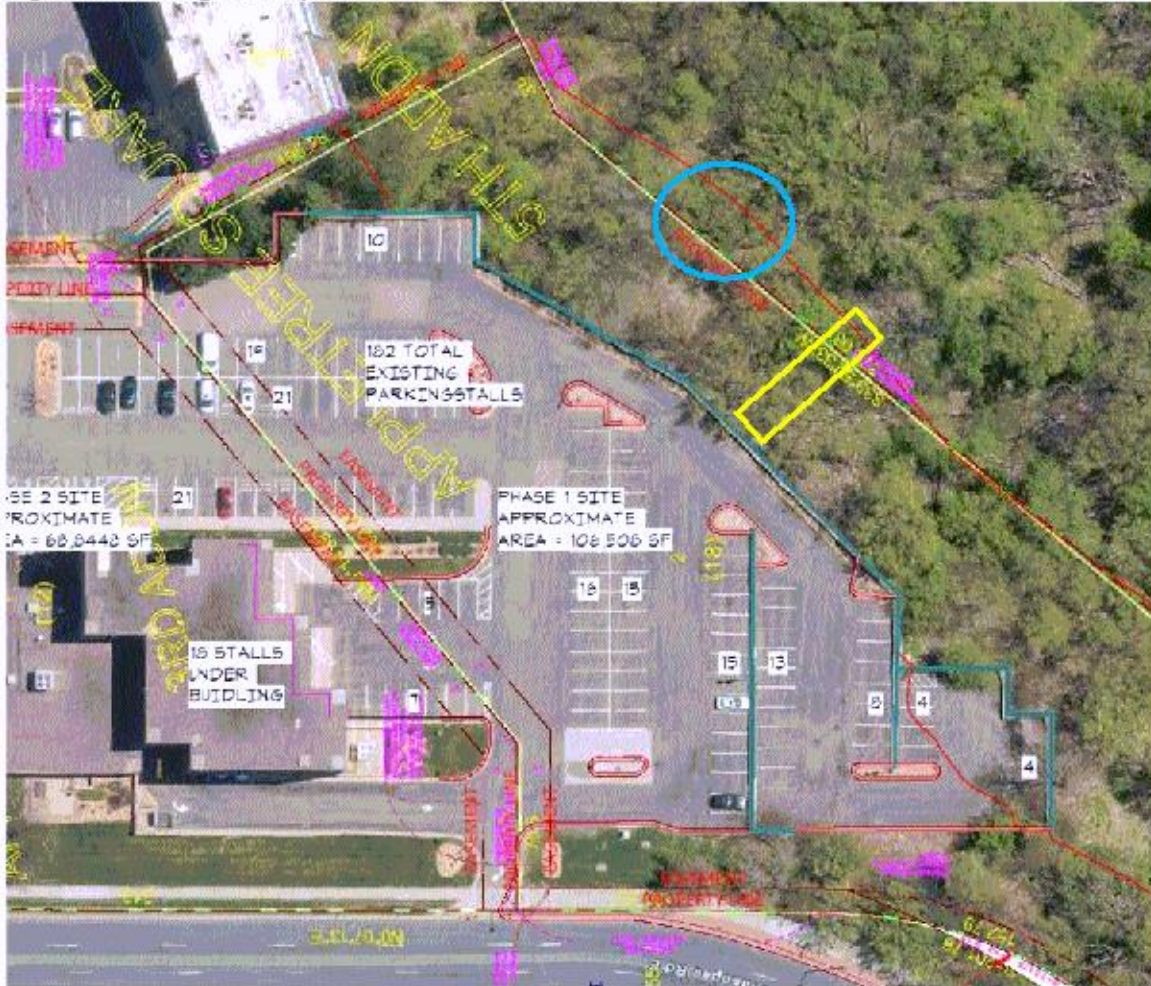
Figure 1. Existing Site Layout and Development Area

Figure 1 provides the existing site layout with the planned Phase I site development area. The green line in the figure represents the retaining wall and the yellow line to the east represents the property line and border with the Minnesota Valley National Wildlife Refuge.

We observed an area of seepage from the slope approximately 100 feet downslope of the retaining wall. The approximate area of seepage is highlighted by the blue circle shown in Figure 1 above. We did not observe signs of slope instability near the slope seepage.

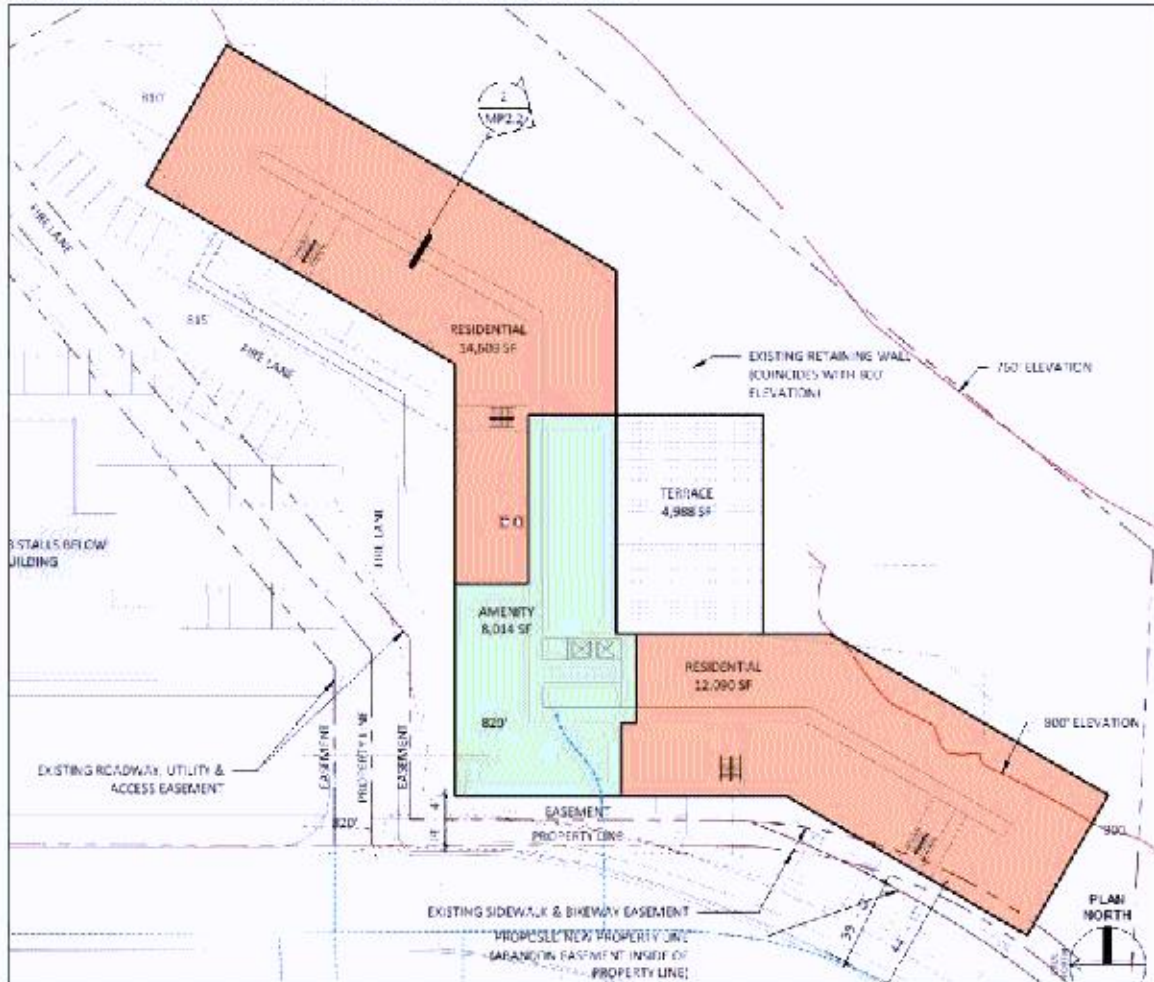
**Figure 2. Existing Site Layout and Development Area**

Figure 2 displays the conceptual building layout for the site. The existing retaining wall is shown by the small-dashed line and the property line is shown by the large-dashed line. Based on the provided conceptual plans, the planned development will remove the retaining wall and excavate down to an elevation 786 feet. The conceptual plan states that the base of the retaining wall is at approximate elevation 790 feet. As shown in Figure 2, the proposed building extends to the east to the location of the retaining wall with small areas extending past the retaining wall.

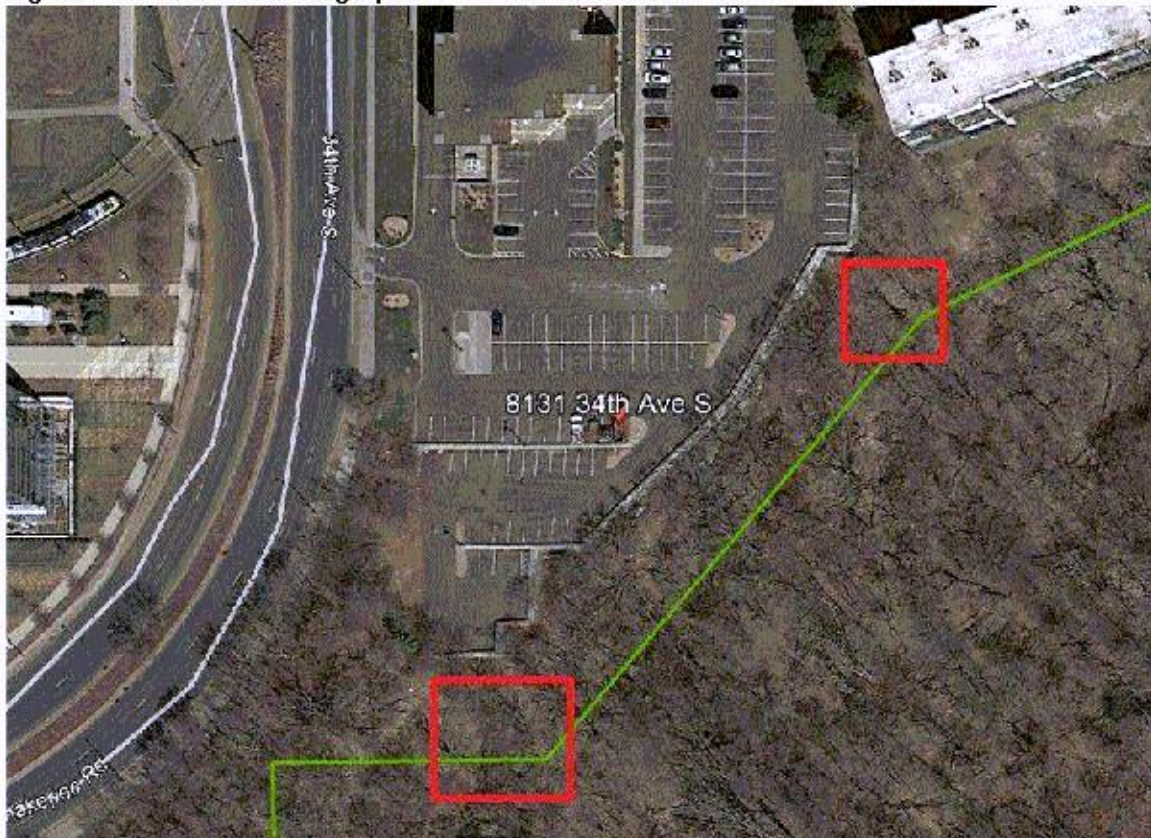
Figure 3. 2018 Aerial Photograph

In our review of historic aerial images from Google Earth and Minnesota Historical Aerial Photographs Online (MHAPO), we noted that the parking lot and retaining wall was in place in 1991. The tree cover of the slope limits the use of the available aerial photographs to evaluate the general slope condition. Figure 3 shows an aerial photograph from 2018. In the photograph, existing drainage chutes can be seen extending downslope from each end of the wall, as highlighted by the red boxes. These existing chutes were observed during our limited site reconnaissance discussed below.

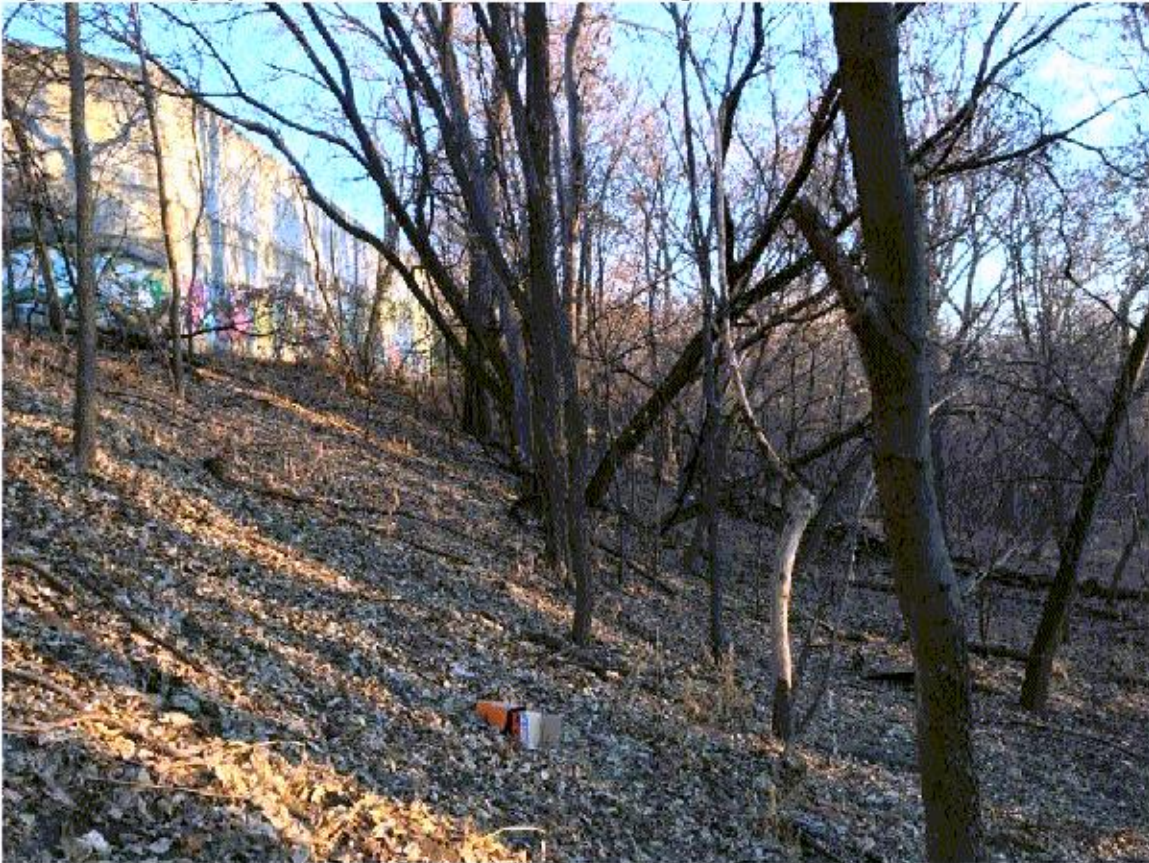
**Figure 4. Photograph of General Slope Condition Looking North from South End**

We completed our limited site reconnaissance on December 9, 2020. In general, the slope is partially tree and brush covered, approximately 20 to 40 feet in height, with a slope inclination that ranges from less than 2H:1V to approximately 1.5H:1V in limited areas. At approximately the boundary with the Minnesota Valley National Wildlife Refuge, the slope flattens to near horizontal and extends to the east for 100+ feet before steepening down towards the river. Figures 4 and 5 provides photographs of the general slope conditions on the south and north ends, respectively, taken during our site reconnaissance.

As shown in the photographs, mature trees are present on the slope and show limited to no apparent signs of slope movement (bending, pistol-butted trunk form, toppling).

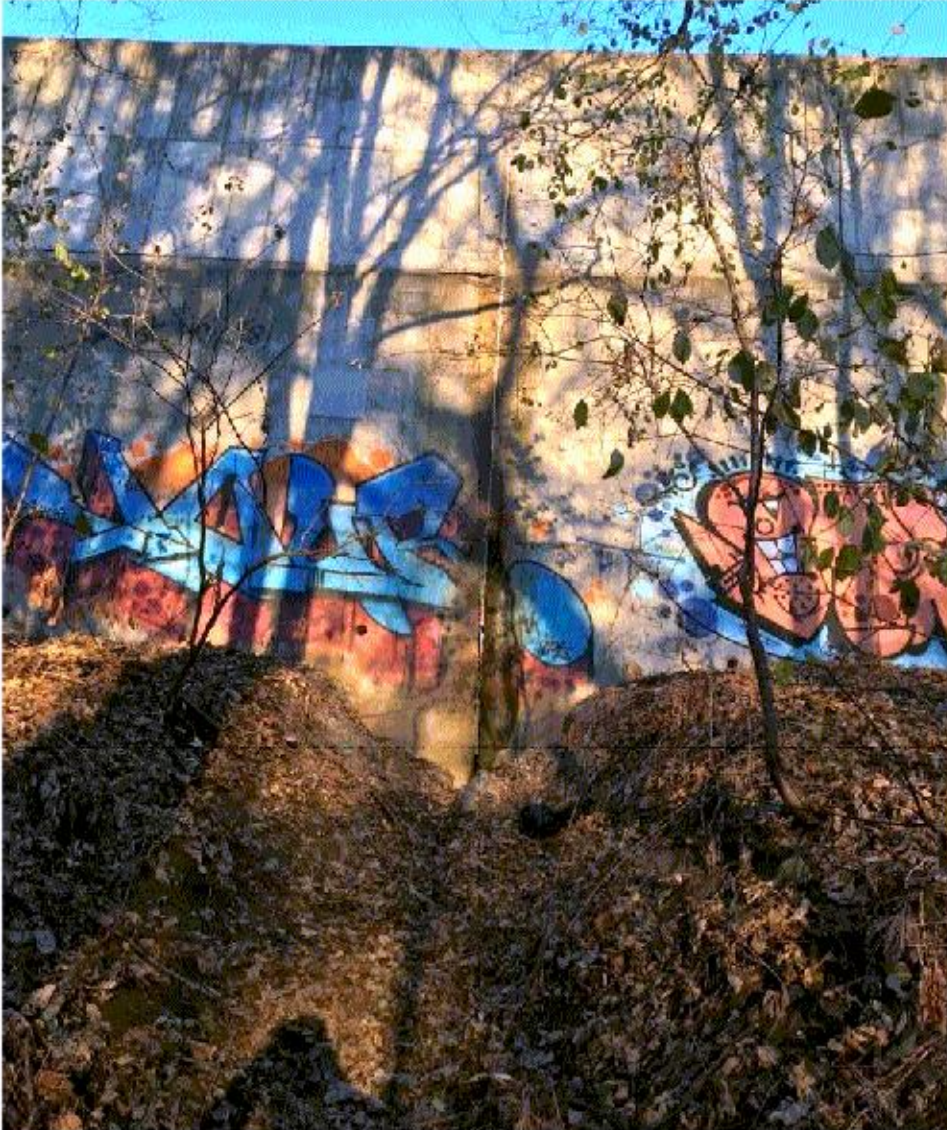
**Figure 6. Drainage/Erosion Gully Located near the Center of the Retaining Wall on the Slope**

We observed drainage gullies at each end of the retaining walls created by surface water runoff. The gullies are approximately 1 to 3 feet deep. Additionally, we observed a drainage/erosion gully in the central section of the wall. The wall panels are slightly separated, and it appears that water has flown through the crack and down the slope. The location of this drainage gully is outlined by the yellow rectangle shown in Figure 1 above. Figure 6 shows a photograph of this drainage gully that extends from the base of the wall down the slope.

Based on the information noted in our site visit and historical document review, it is our professional opinion there is little risk to instability of the slopes downhill from the existing retaining wall and the planned development. We recommend that site drainage be addressed during construction of the planned development to reduce the potential for surficial water runoff down the slope. Additionally, we recommend that the existing drainage/erosion gullies on the slope be properly filled during site construction to reduce the potential for future erosion near the proposed development.
