Response Action Plan and Construction Contingency Plan

Proposed American Square Apartments
3701 American Boulevard East
Bloomington, Minnesota

March 20, 2020

Project B1909819.00

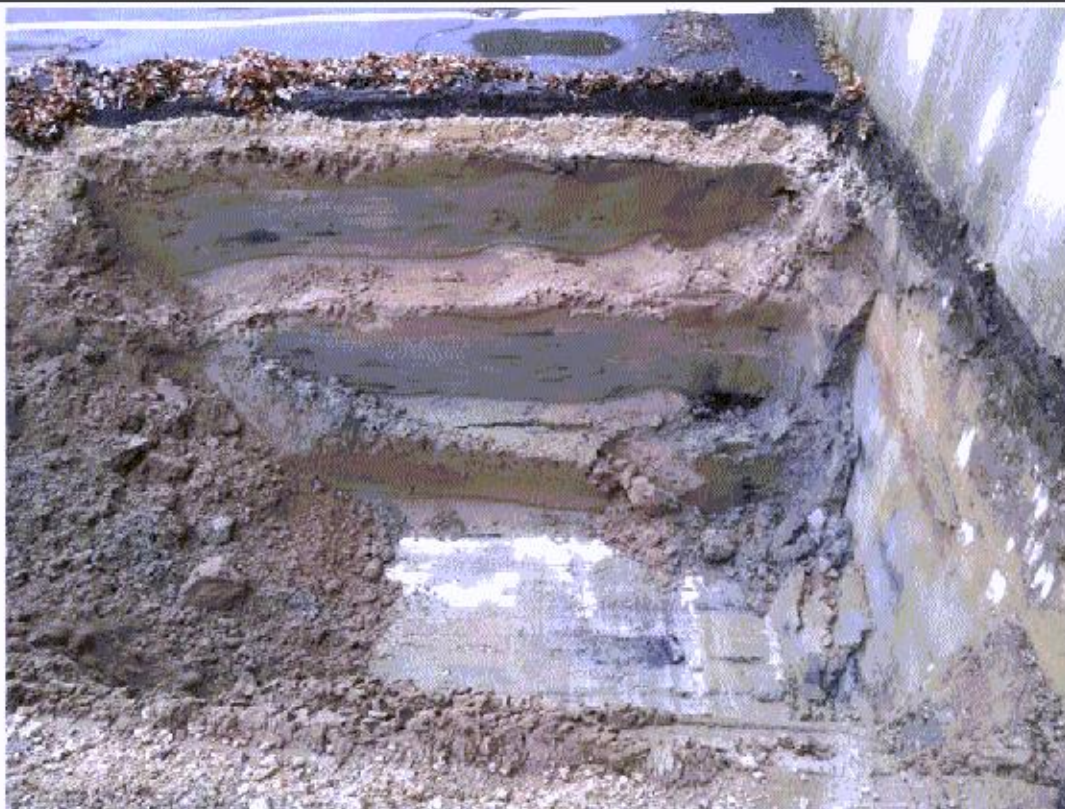
Photograph #1	Crown Plaza Site	B1909819
Date:	November 21, 2019	BRAUN INTERTEC
Direction:	Facing West	
Subject:	Soils in TP-1 excavated to 6 feet bgs to expose existing parking structure footing.

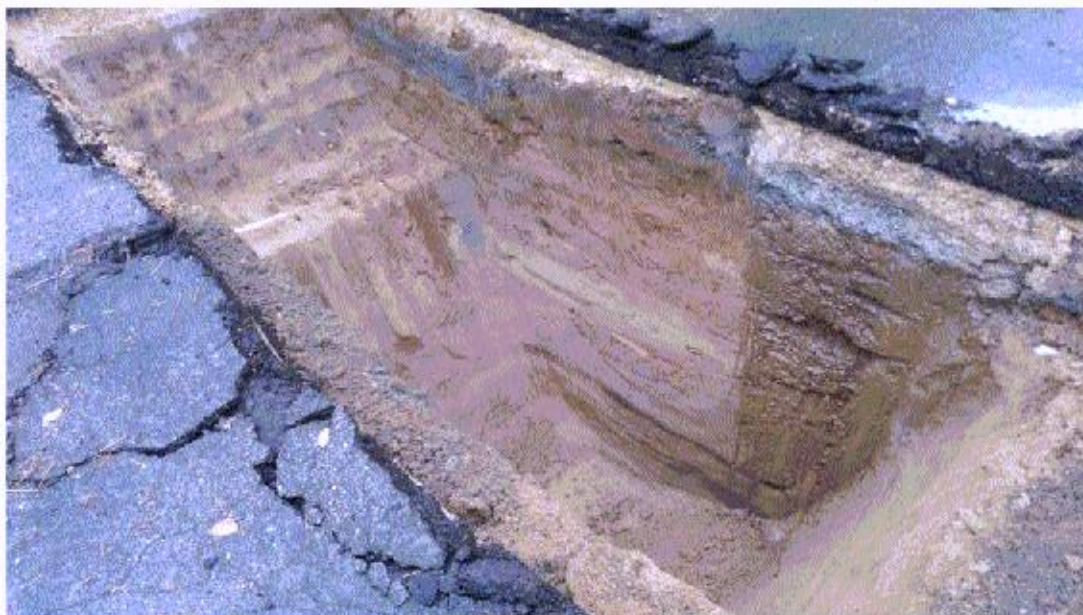
Photograph #2	Crown Plaza Site	B1909819
Date:	November 21, 2019	BRAUN INTERTEC
Direction:	NA	
Subject:	Native soil exposed below fill materials in TP-2.

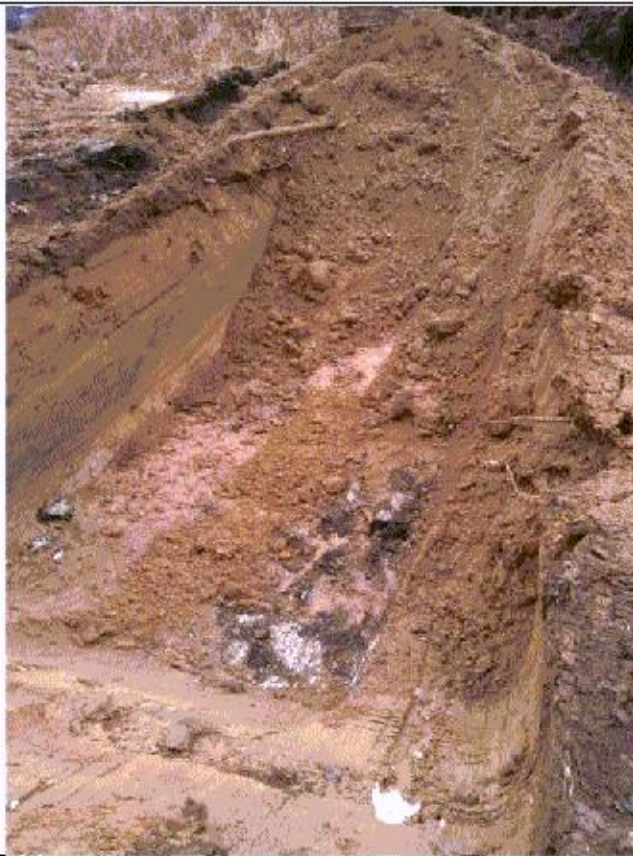
Photograph #3	Crown Plaza Site	B1909819
Date:	November 21, 2019	BRAUN INTERTEC
Direction:	Facing East	
Subject:	Buried layer of bituminous material at approximately 5 feet bgs in TP-3.

6.0		Bituminous layer from 5-7 feet	5		0.0		Soil sample TP-3 (5-7') @ 10:50 collected for VOCs, GRO, DRO, PAHs and 8 RCRA metals
		FILL: CLAYEY SAND (SC), trace Gravel, reddish brown, moist			0.0		
			10		0.0

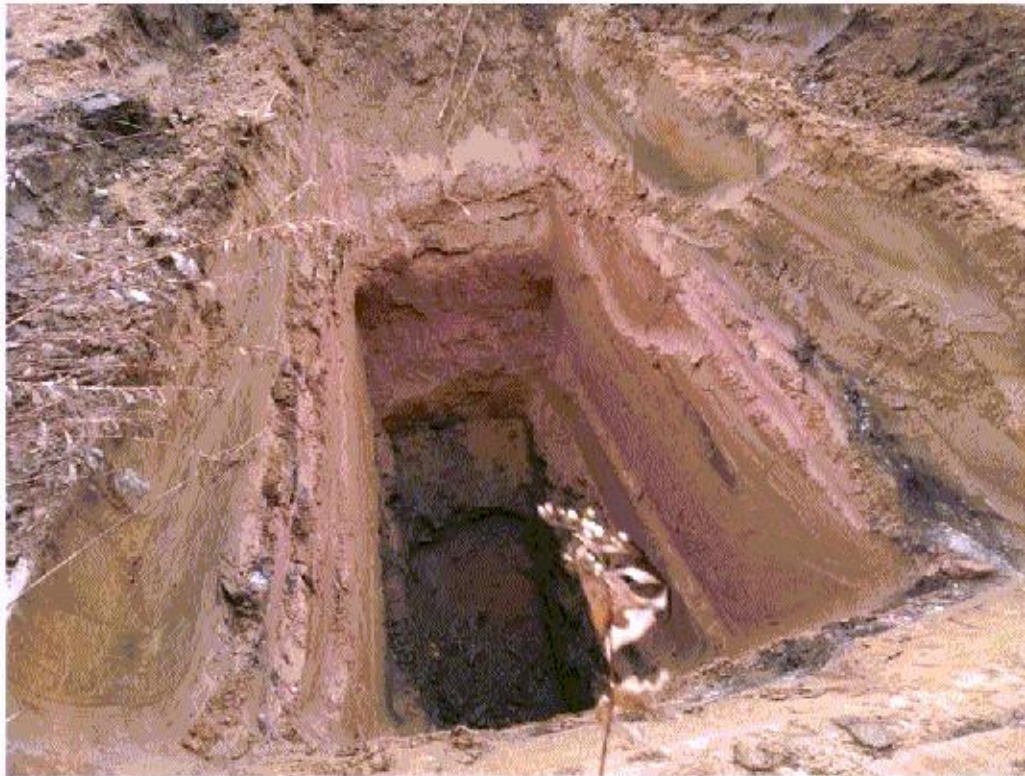
Photograph #4	Crown Plaza Site	B1909819
Date:	November 21, 2019	BRAUN INTERTEC
Direction:	Facing Southeast	
Subject:	Dark colored fill soils with bituminous material visible at 17 feet to the end of TP-3 at 26 feet bgs.

15.0			15		0.0		
17.0		FILL: SILTY SAND (SM), fine to medium-grained Sand, trace Gravel, brown, moist			0.0		
		FILL: POORLY GRADED SAND with SILT (SP-SM), fine to medium-grained Sand, trace Gravel, gray, moist With bituminous debris	20		0.0		Soil sample TP-3 (17-26') @ 11:10 collected for VOCs, GRO, DRO, PAHs and 8 RCRA metals
			25

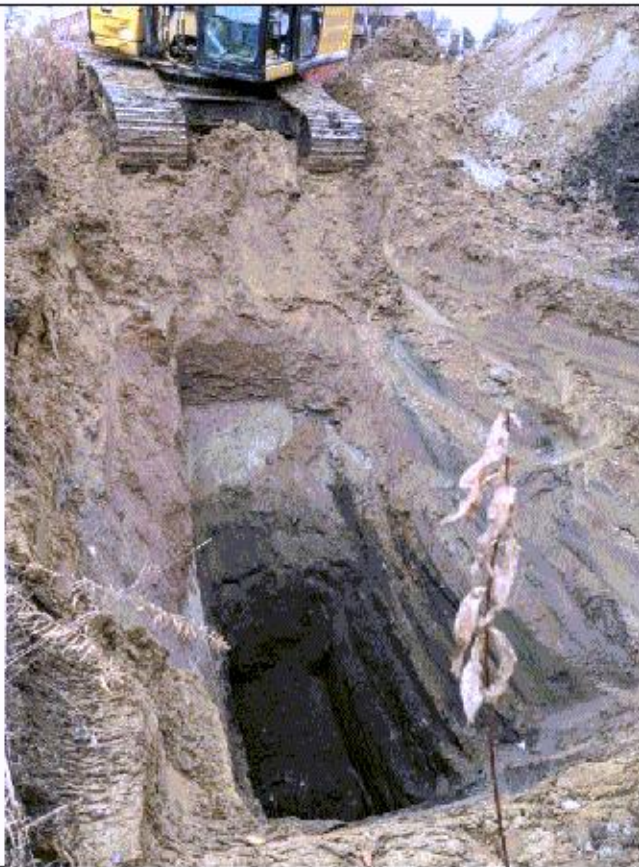
Photograph #5	Crown Plaza Site	B1909819
Date:	November 21, 2019	BRAUN INTERTEC
Direction:	Facing Northwest	
Subject:	TP-4 excavated to 26 feet bgs.

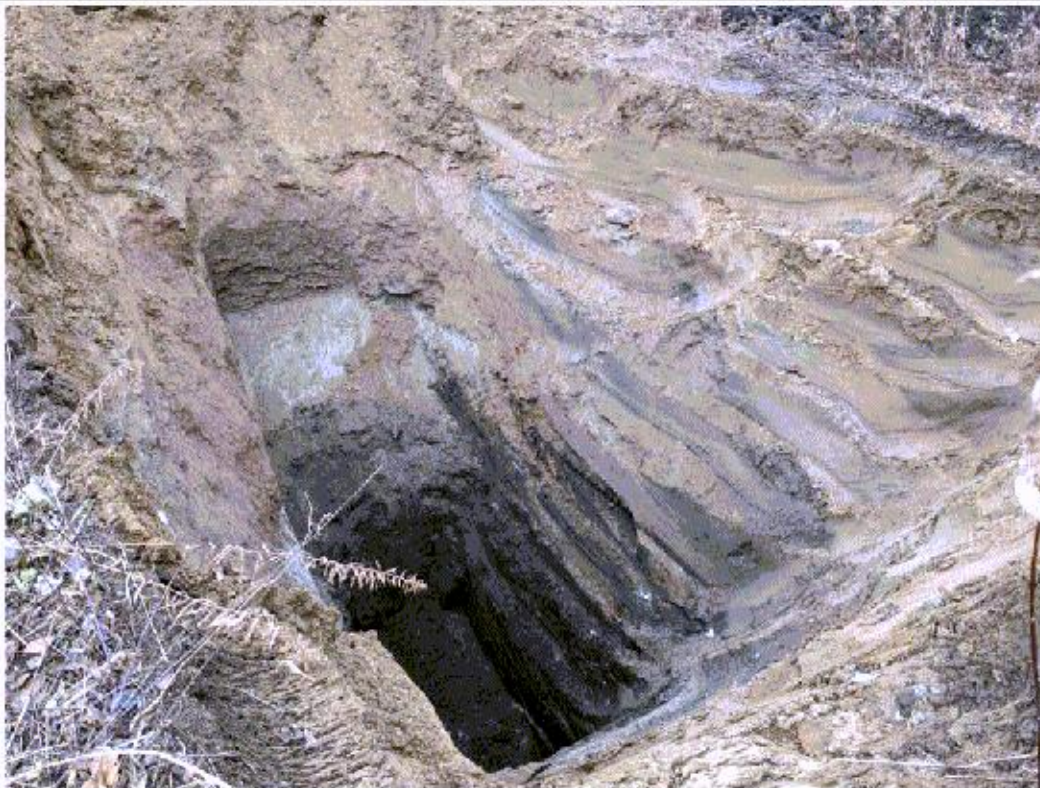
Photograph #6	Crown Plaza Site	B1909819
Date:	November 21, 2019	BRAUN INTERTEC
Direction:	Facing North	
Subject:	Fill soils with bituminous materials present at 16 feet to the end of TP-4 at 26 feet bgs.

16.0							
		FILL: POORLY GRADED SAND with SILT (SP-SM), fine to medium-grained Sand, trace Gravel, black to dark brown, moist <i>With bituminous debris</i>	20
