TCWS Muffler Report

Sound Level Testing – Hudsonville 5/18/21

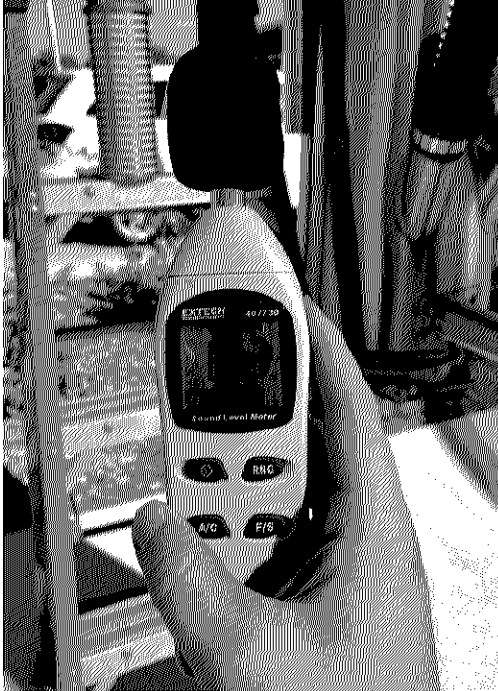
FIGURE 1.1

1. BASELINE RESULTS (No mufflers attached)
 - a. Noise
 - i. Ambient (no vacs running): 65.7 dB (See figure 1.1)
 - ii. Running Vac with no muffler: 88.1 dB (See Figure 1.2)
 - b. Additional Maintenance necessary / clogging: NO
 - c. Suction: 50 kPa/ 0%
 - d. Aesthetics: Great

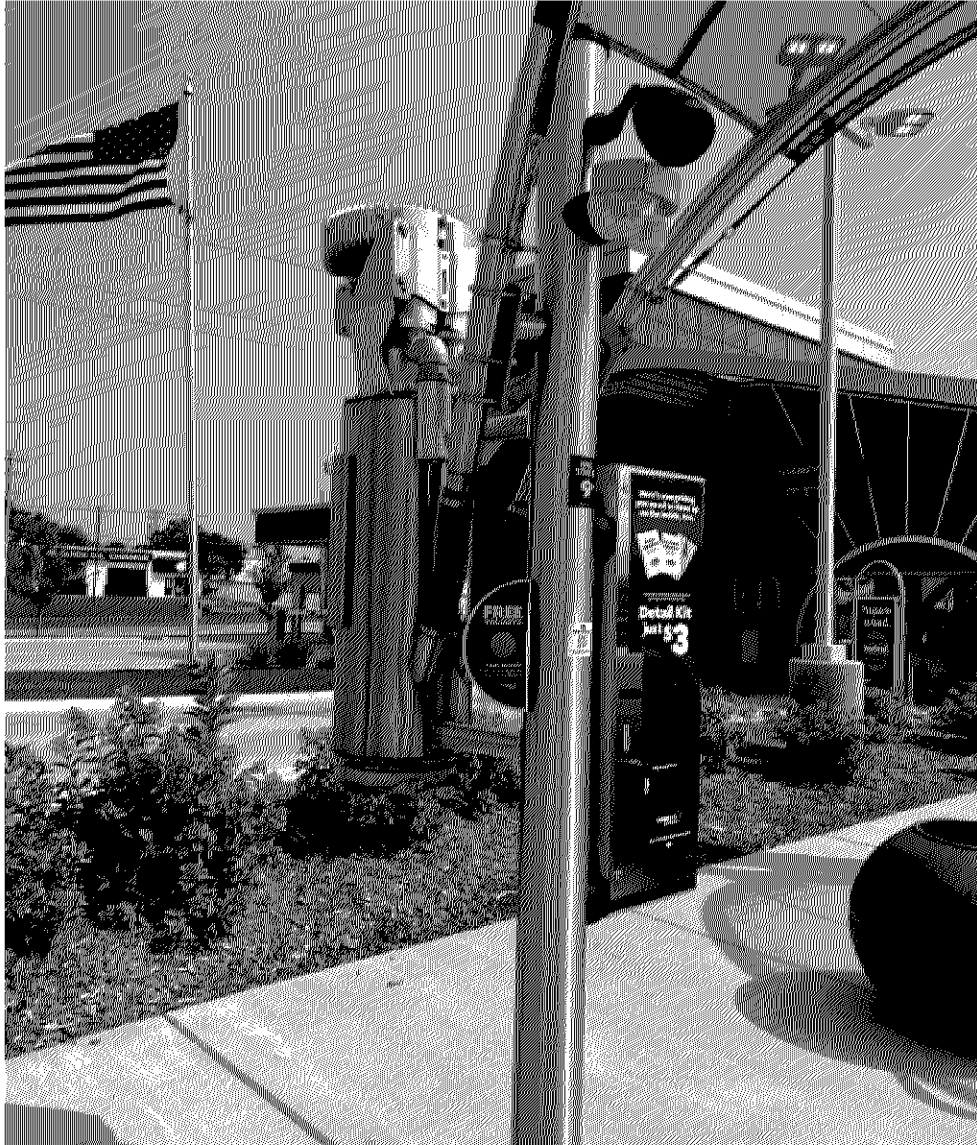
- a. Noise reduction (dB):
 - i. Reading: 77.6 dB (See Figure 2.1)
 - ii. Reduction: 10.5 dB
- b. Additional Maintenance necessary / clogging
 - i. Yes: Minor (additional maintenance and clogging)
 - 1. Reverse pulse vacs to help with this
 - 2. Wash Mufflers to help with this
- c. Suction loss (KPa and %)
 - i. Reading: 40kPa (see Figure 2.2)
 - ii. Loss: 10kPa – 20% loss in suction
- d. Aesthetics
 - i. Good (See Figure 2.3)

Figure 2.3: P-VAC-334

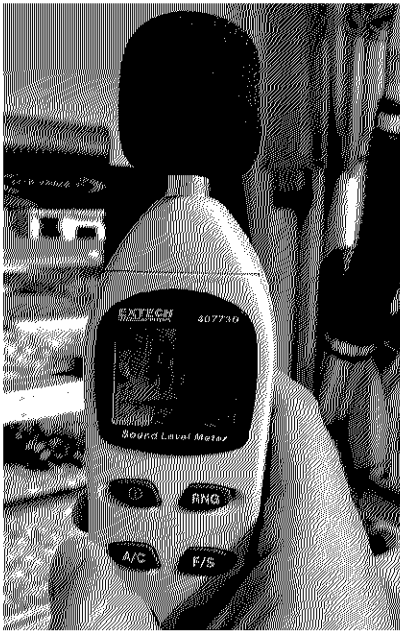
3.1

- a. Noise reduction (dB):
 - i. Reading: 79.1 dB (See Figure 3.1)
 - ii. Reduction: 9 dB
- b. Additional Maintenance necessary / clogging
 - 1. Yes: Minimal (additional maintenance, no clogging)
 - a. Eventually replace filter of muffler.
- c. Suction loss (KPa and %)
 - i. Reading: 50kPa (see Figure 3.2)
 - ii. Loss: 0kPa – 0% loss in suction
- d. Aesthetics
 - i. Fair (See Figure 3.3)

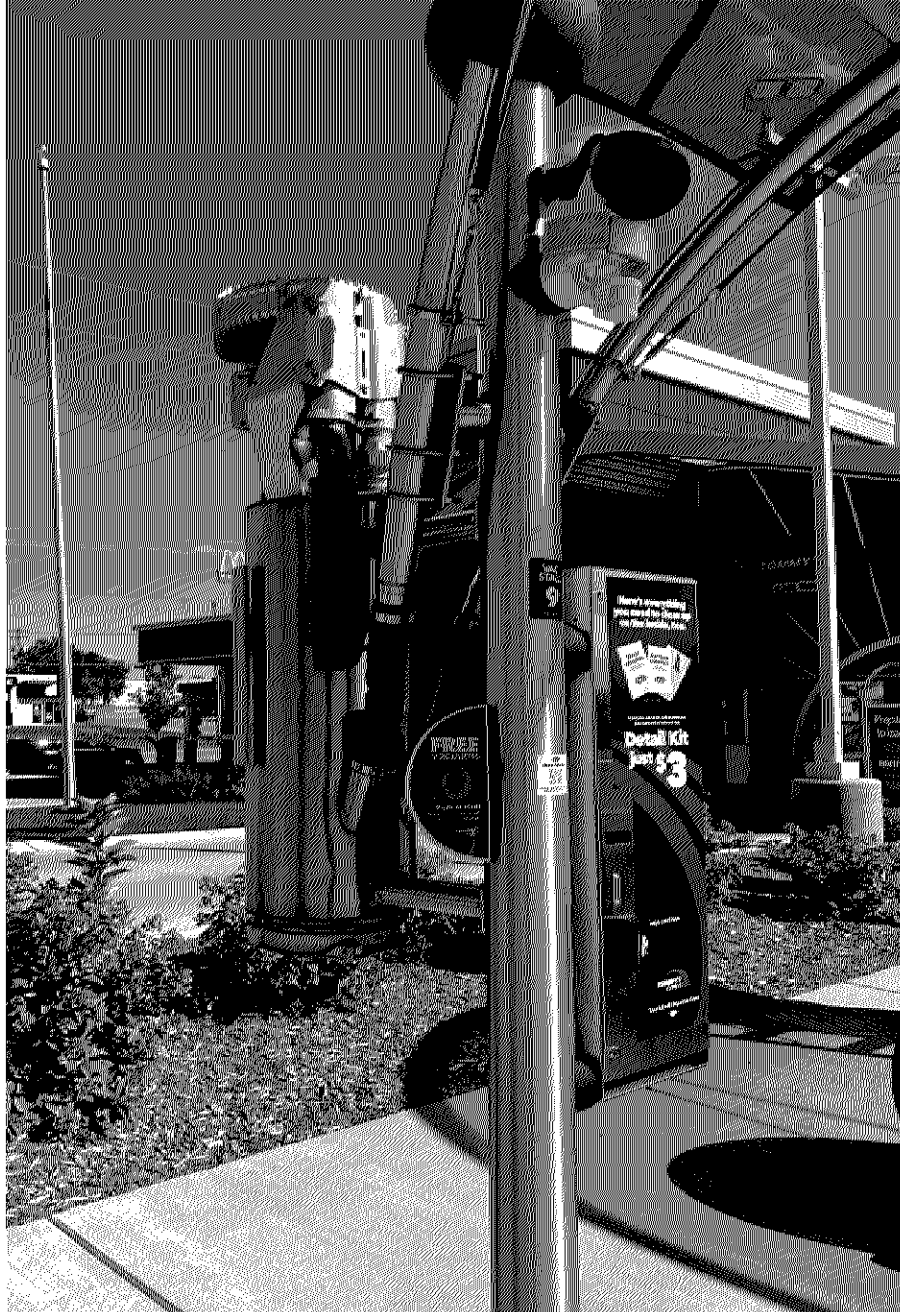
FIGURE 3.3 (P-VAC-335)

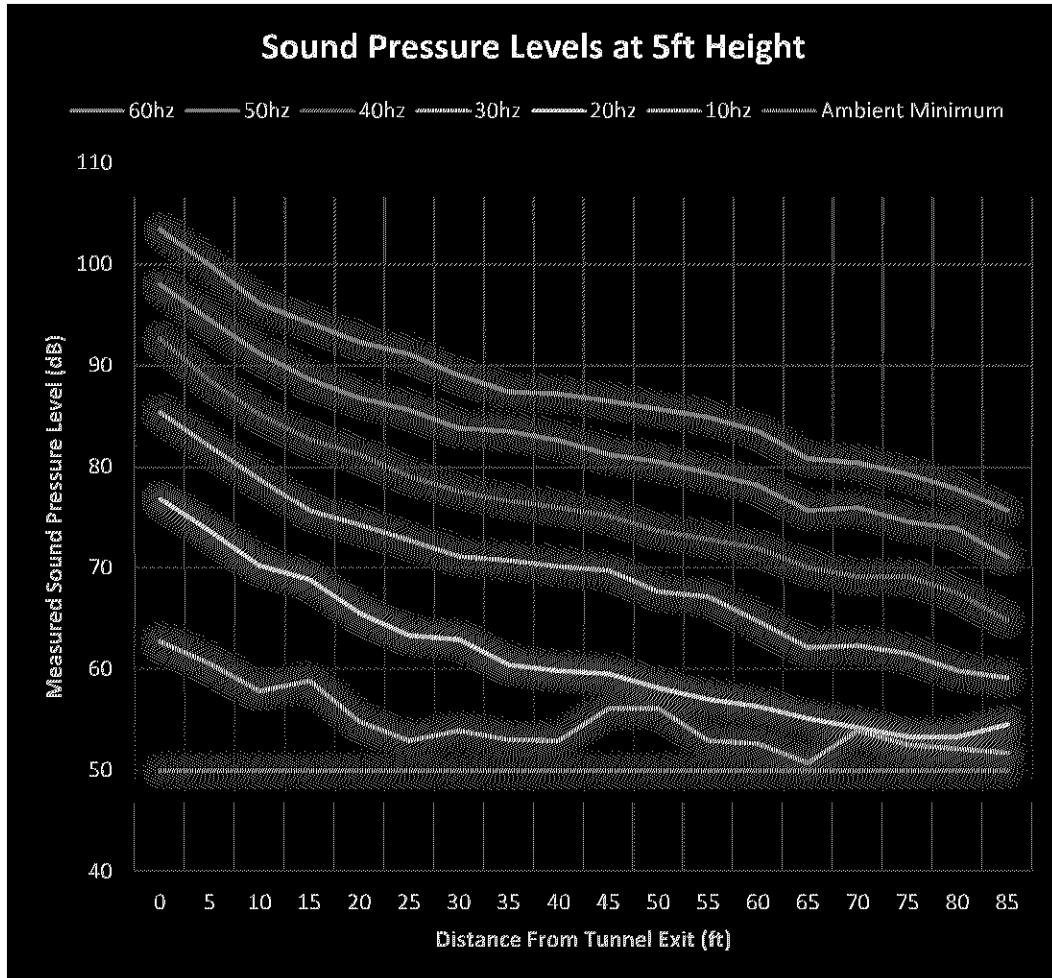
Recorded data for each position at ground level is shown below in Table 2. This data is displayed in Figure 1. Recorded data for each position at 5ft height is shown below in Table 3. This data is displayed in Figure 2.

Figure 2: Measured Sound Pressure Levels at 5ft Height

Distance (ft)	60hz	50hz	40hz	30hz	20hz	10hz
0	103.4	98	92.7	85.4	76.8	62.7
5	99.9	94.5	88.5	82	73.6	60.5
10	96.1	91.2	85.2	78.8	70.2	57.8
15	94.2	88.6	82.7	75.6	68.8	58.8
20	92.3	86.8	81.2	74.2	65.5	54.8
25	91.1	85.6	79.1	72.7	63.3	52.9
30	89	83.8	77.6	71.1	62.9	53.9
35	87.4	83.5	76.6	70.7	60.4	53
40	87.2	82.6	75.9	70.1	59.8	52.9
45	86.5	81.2	75.1	69.7	59.5	56.1
50	85.7	80.5	73.6	67.6	58.1	56.1
55	84.9	79.4	72.8	67.1	57	52.9
60	83.5	78.2	71.9	64.7	56.3	52.6
65	80.8	75.6	70	62.1	55.1	50.7
70	80.4	75.9	69.1	62.3	54.2	53.9
75	79.3	74.5	69.1	61.5	53.3	52.5
80	77.8	73.8	67.5	59.8	53.3	52.1
85	75.6	71	64.8	59.1	54.5	51.7

By varying the frequency of the blower motor, it was possible to achieve sound pressure levels which did not exceed the ambient conditions at the maximum recorded distance. It was not possible to record the true sound level at these positions due to ambient sound conditions.
