# **Response Action Plan and Construction Contingency Plan**

Proposed American Square Apartments  
3701 American Boulevard East  
Bloomington, Minnesota

Project B1909819.00

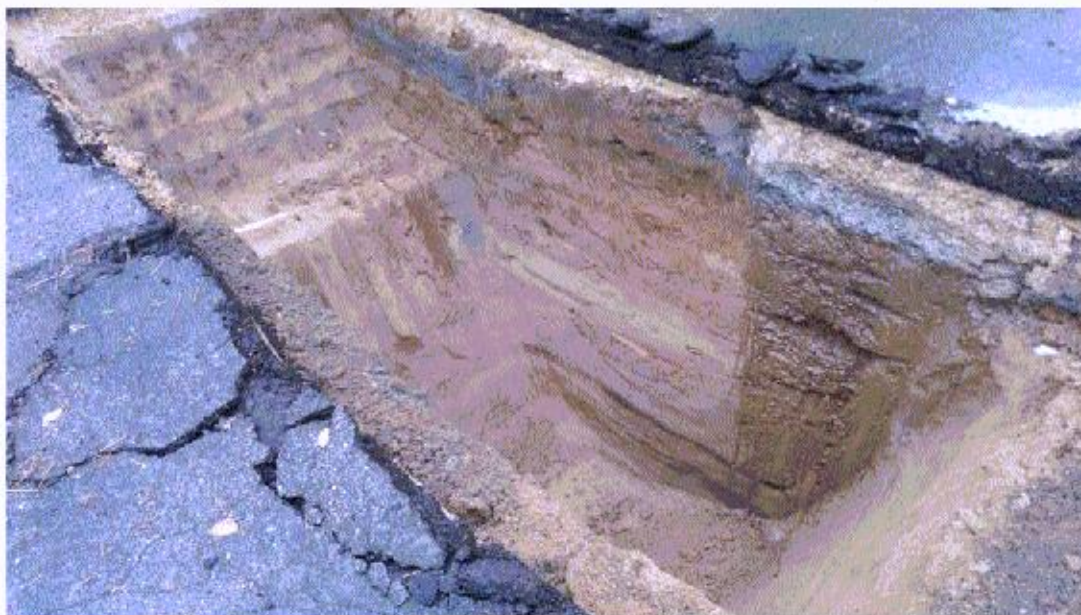
| Photograph #2 | Crown Plaza Site | B1909819 |

| Subject: | Native soil exposed below fill materials in TP-2. | |

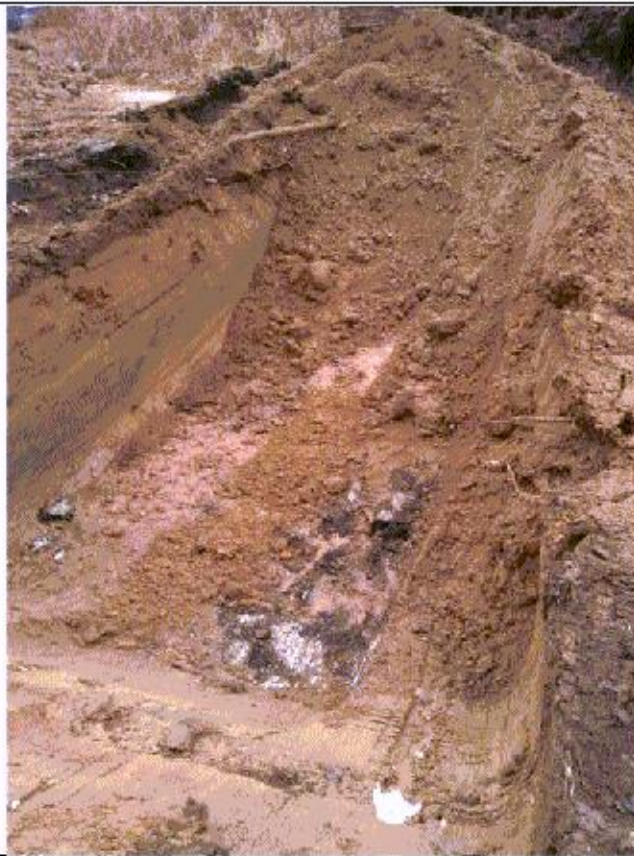
| Photograph #3 | Crown Plaza Site | B1909819 |

| Subject: | Buried layer of bituminous material at approximately 5 feet bgs in TP-3. | |

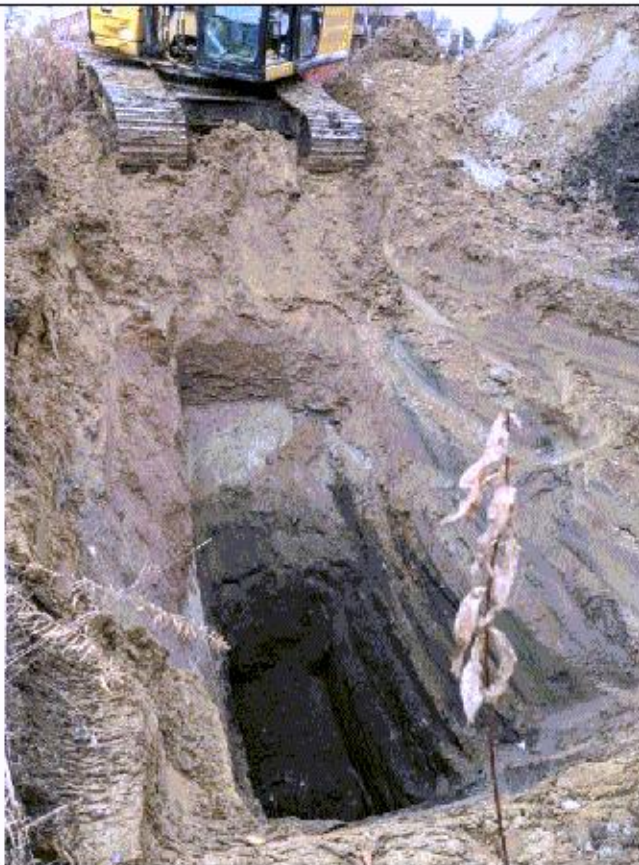
| Photograph #5 | Crown Plaza Site | B1909819 |

| Subject: | TP-4 excavated to 26 feet bgs. | |
