# Geotechnical Evaluation Report

Crown Plaza Site  
3601 American Blvd E  
Bloomington, Minnesota

Project B1909819

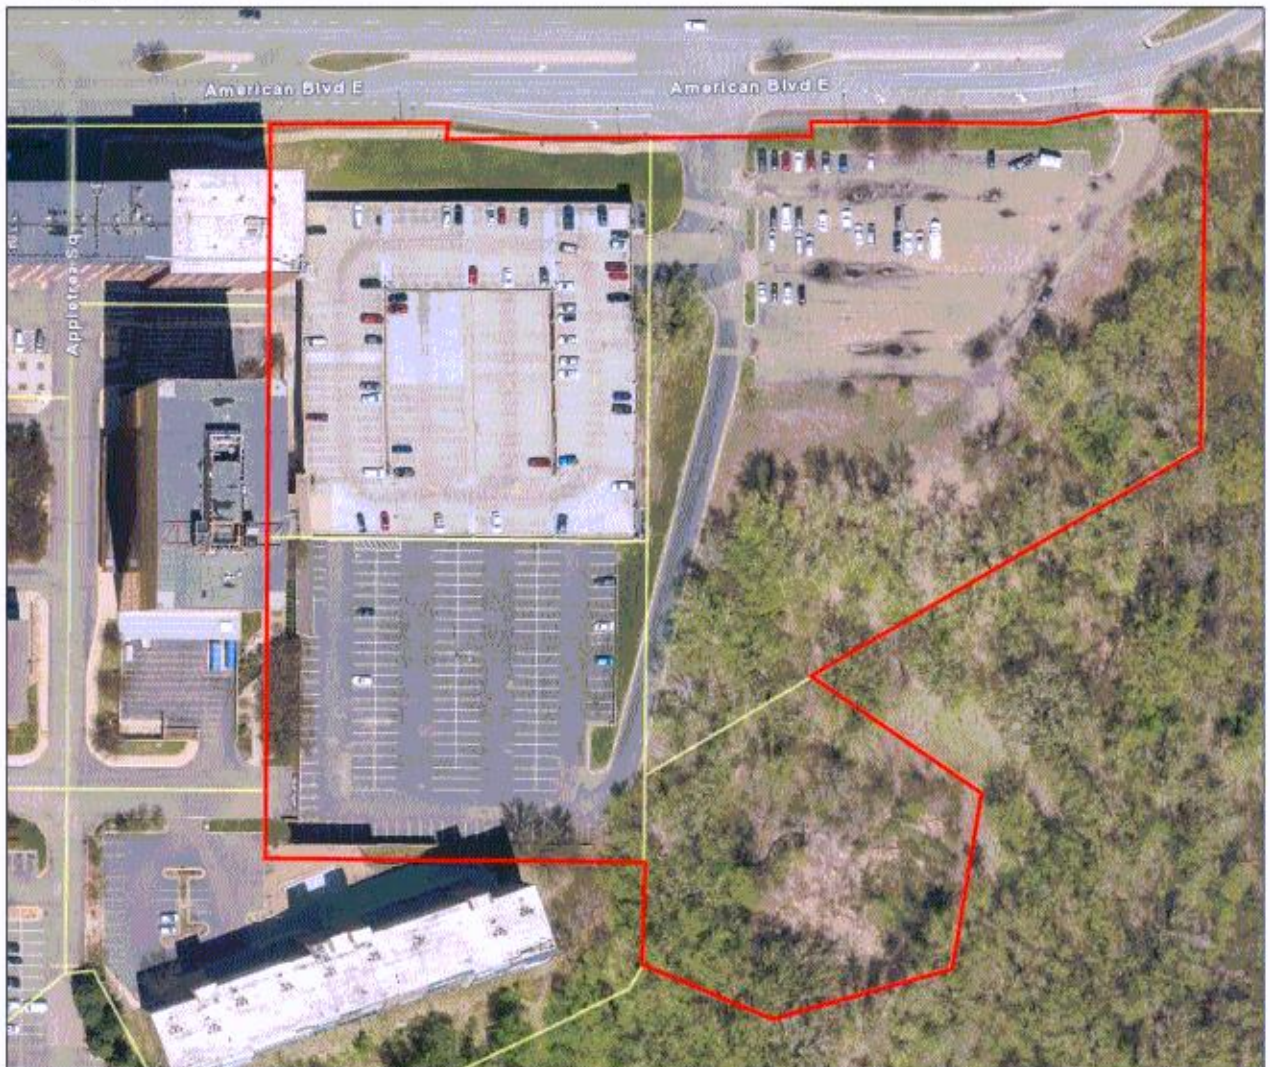
**Photograph 1. Site Extents**

Currently, the site exists as four separate parcels as shown in Photograph 1 below. The parcels on the west half of the site currently contains a six-story parking garage with a surface parking lot to the south of the ramp. The east parcel exists as a surface parking lot. The site has a notable topography with current grades ranging from 774 to 811 feet Mean Sea Level (MSL). Generally, the site is sloping, from the northwest corner of the site to the southeast corner of the site, with the low area of the site being in the southeast corner around the existing pond.

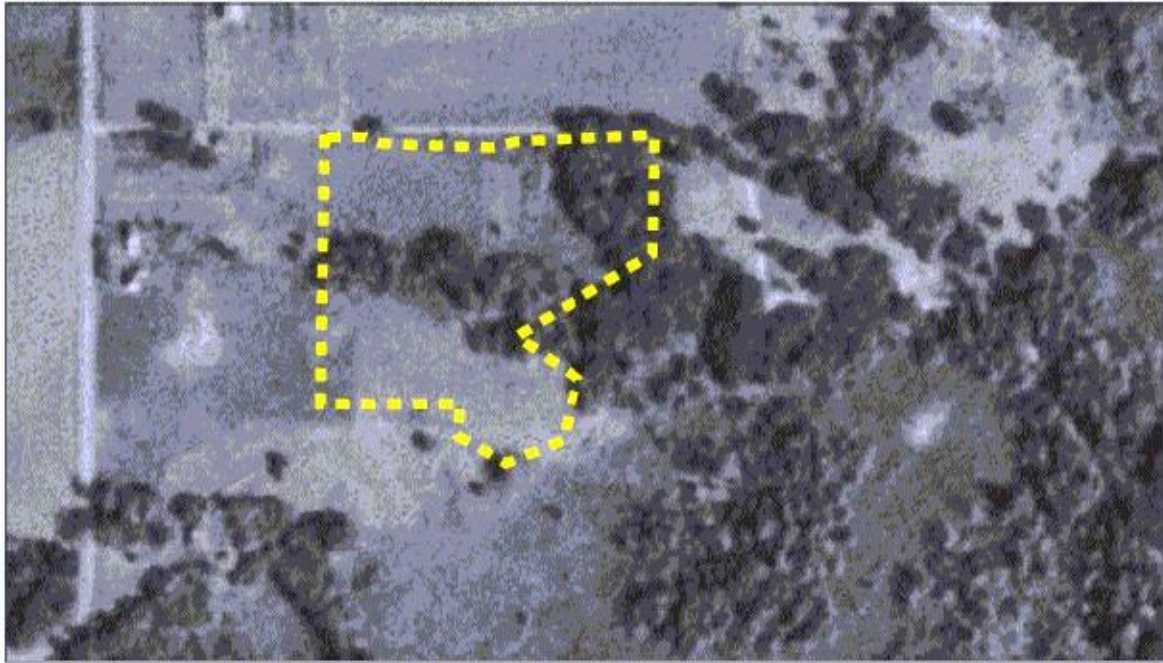
**Photograph 2. Aerial Photograph of the Site in 1953**

Historically, it appears the site was used for agricultural purposes until the 1950s. As shown in Photograph 2 below, you will note the site has a row of trees down the middle. Based on the photograph and topographic map in Figure 2, it appears to be a ravine that bisects the site.

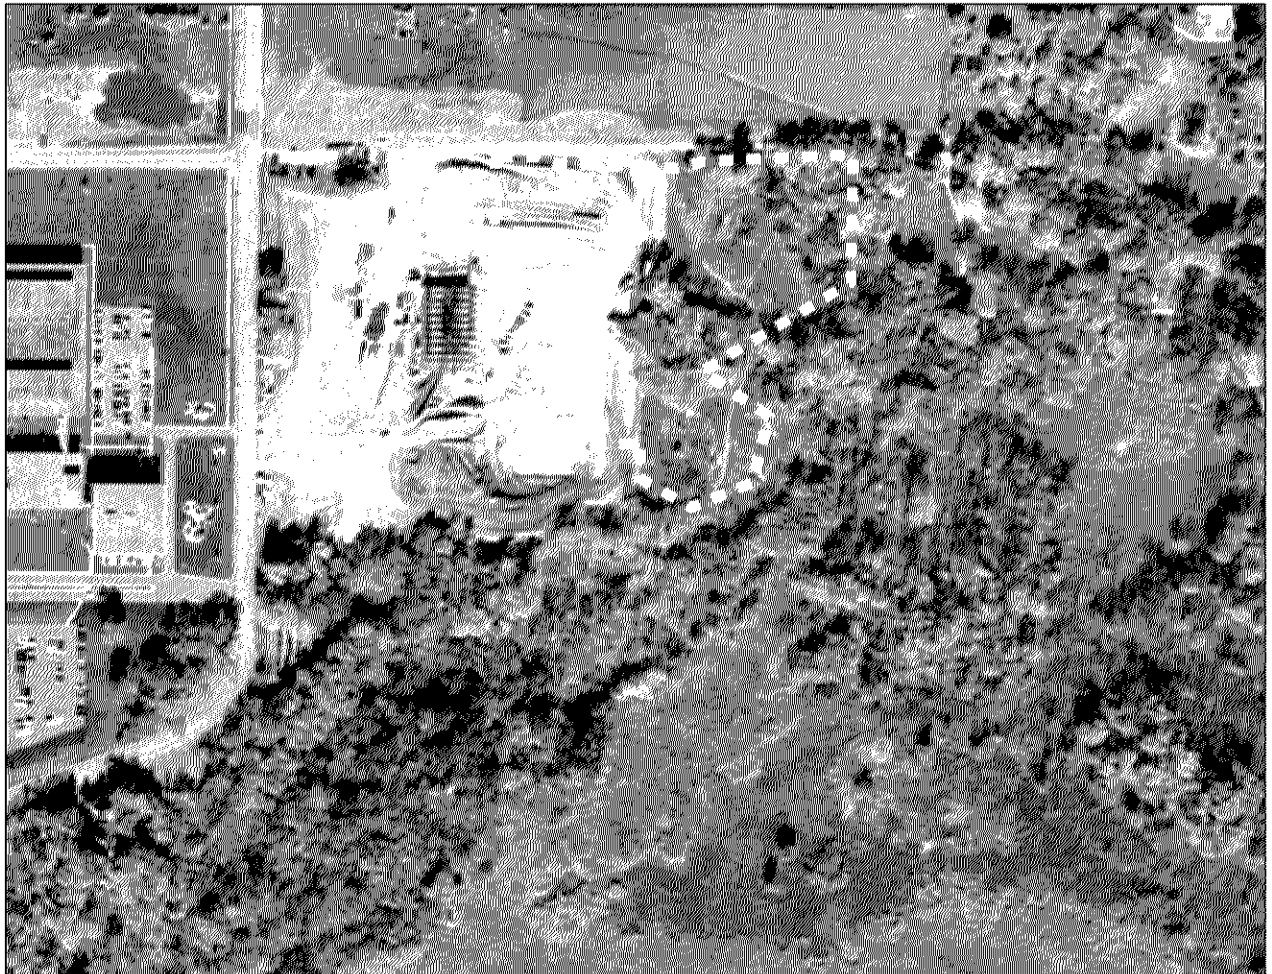
**Photograph 4. Aerial Photograph of the Site in 1972**

Photograph 4 below shows the site which appears to be in construction process for the buildings and parking ramps. Prior to the parking ramp structure, no structures were documented on the property. Hennepin County lists the construction date of the office tower and parking ramp as 1973. The Crown Plaza Hotel was constructed in 1980.

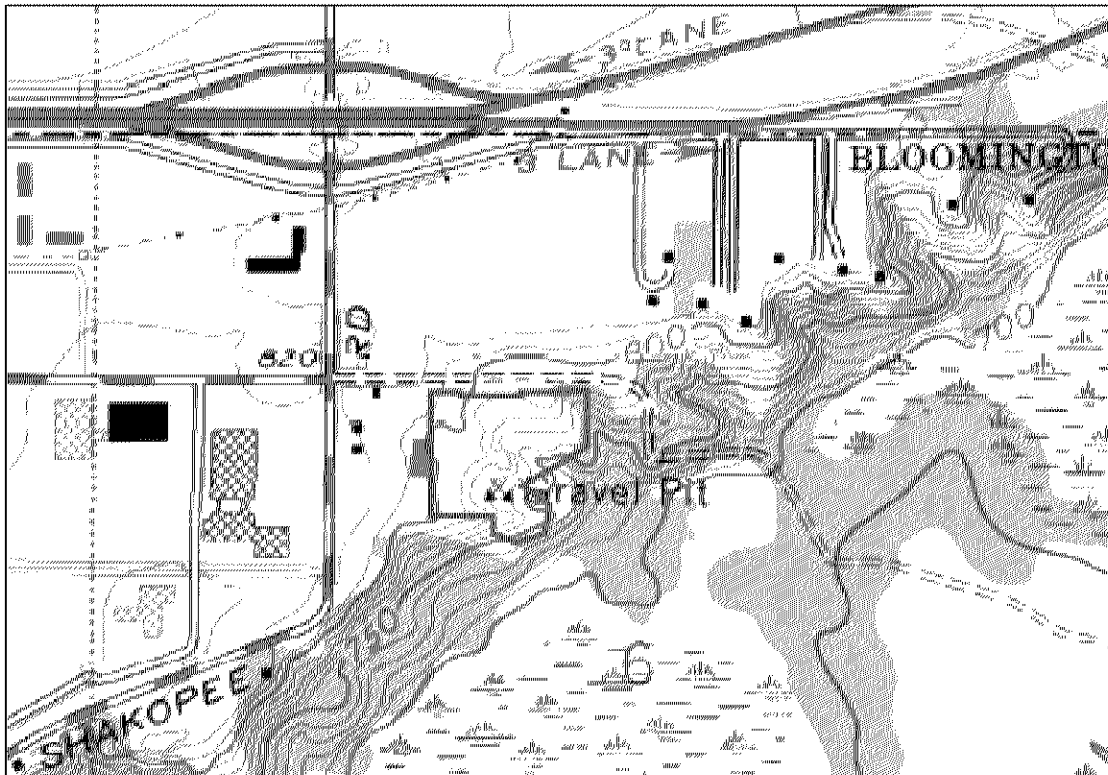
**Figure 3. Topography from 1980 USGS Quadrangle**

Figure 3 is shown after grading and construction has occurred. It still indicates a gravel pit at the site but the ravine is less defined as compared to Figure 2.

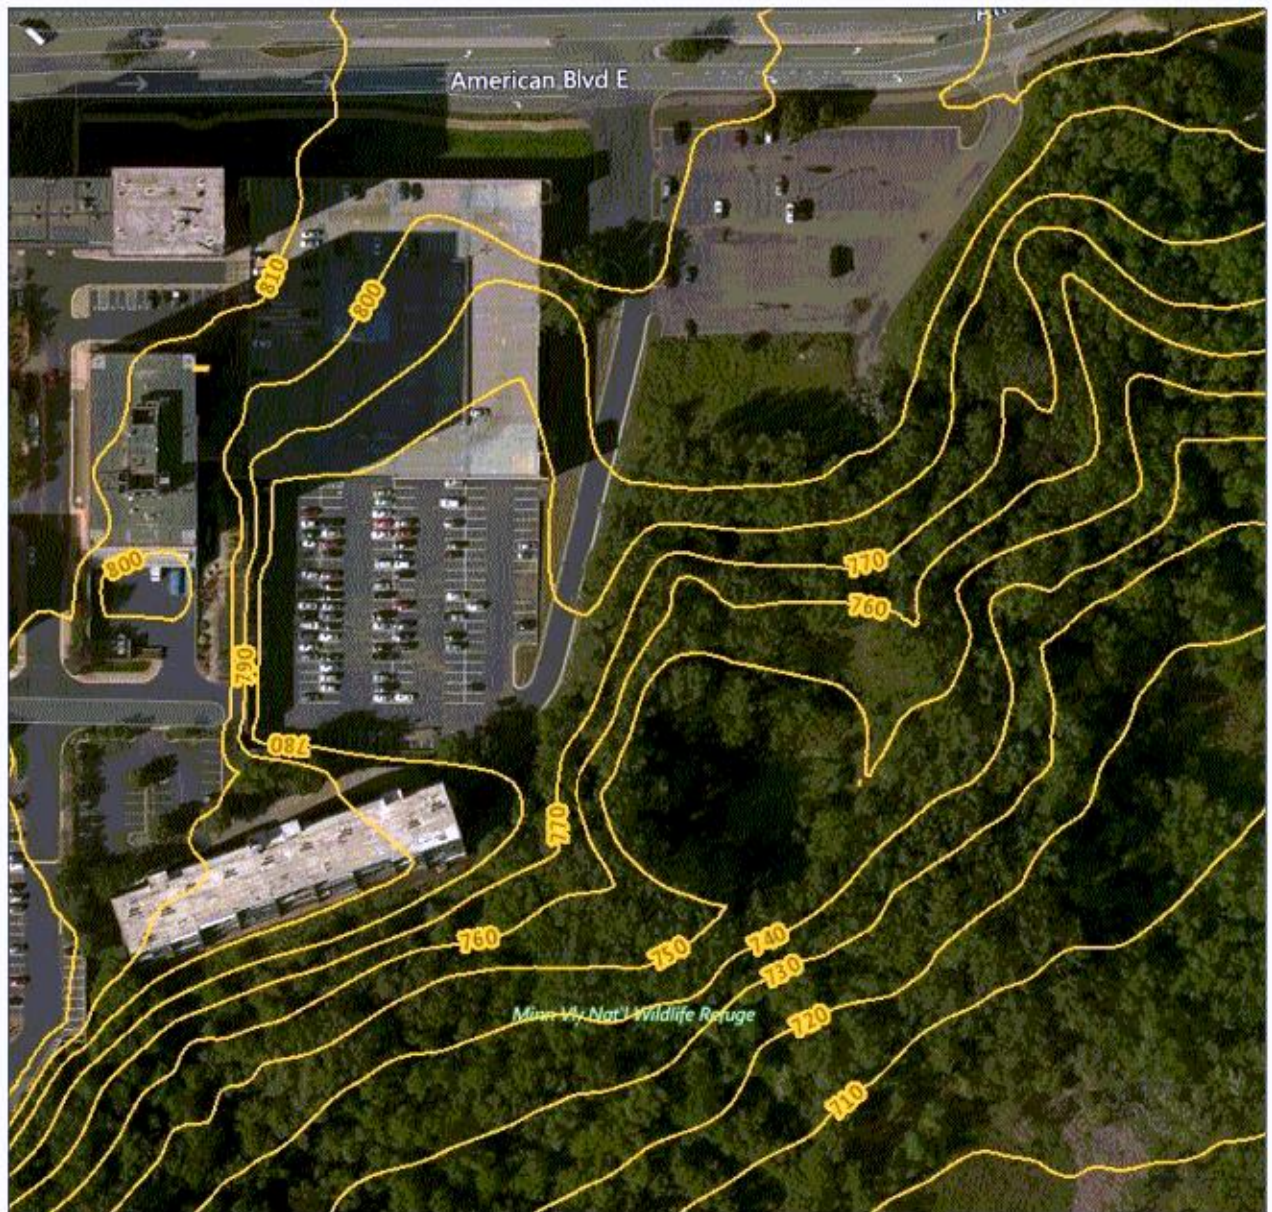
**Photograph 5. Aerial Photograph of the Site in 2018**

Photograph 5 below illustrates the site in more or less the same condition as it is now, along with the existing topography overlaid. Generally speaking, the topography of the site appears to be relatively the same as the post-mining operation topography. As described above, the existing six-story parking garage is shown as well as the two surface parking lots.

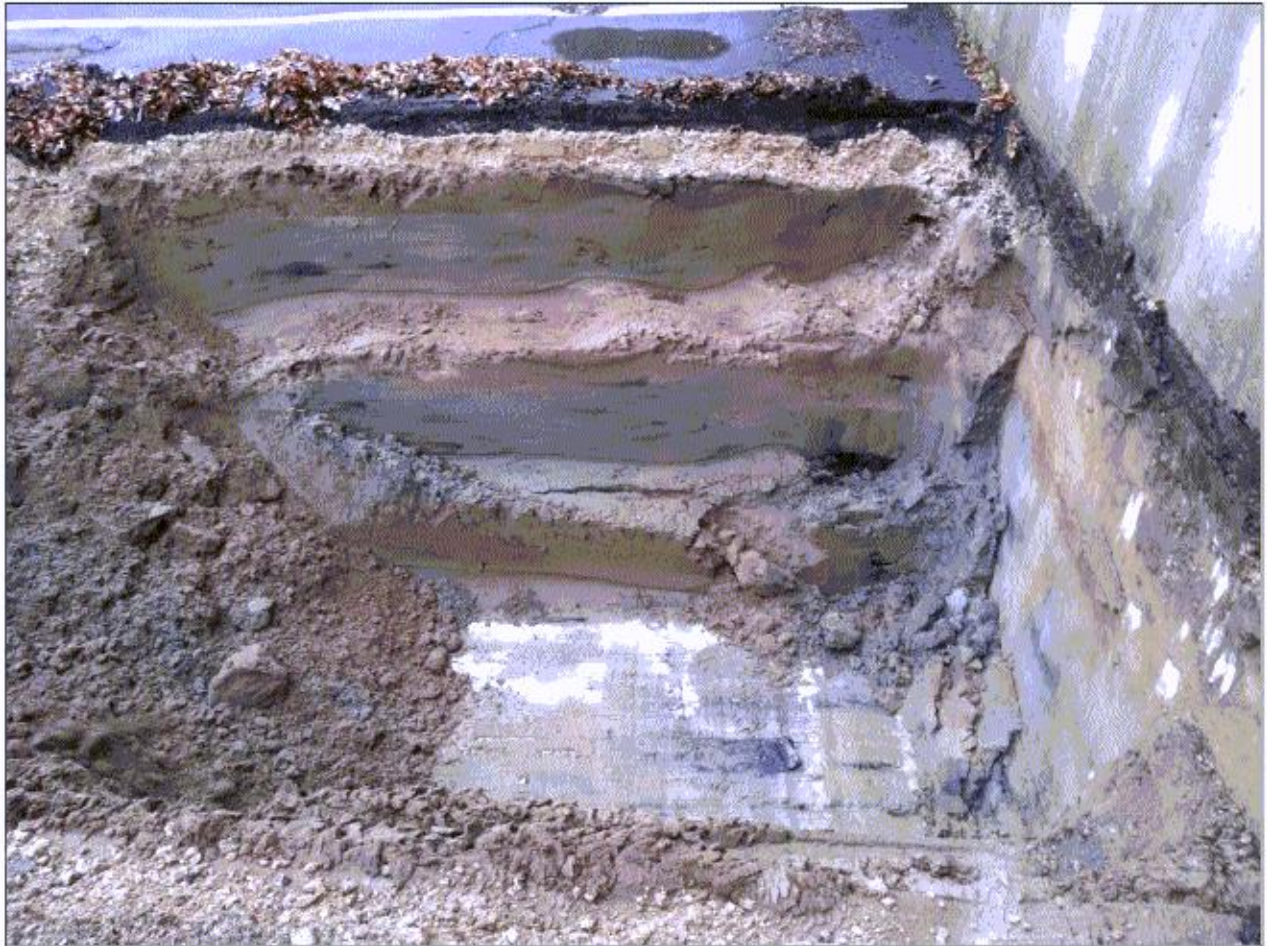
**Photograph 6. TP-1**

- Test pit TP-1 was dug to expose the existing footing and contained 1 foot of pavement over 6 feet of fill down to the top of the footing. The fill consisted of silty sand and poorly graded sand with silt and contained no debris. The footing extended from the wall approximately 15 feet and we had not found the edge yet. The footing was estimated to be over 24 inches thick as we were not able to view the base when scanned with ground penetrating radar.

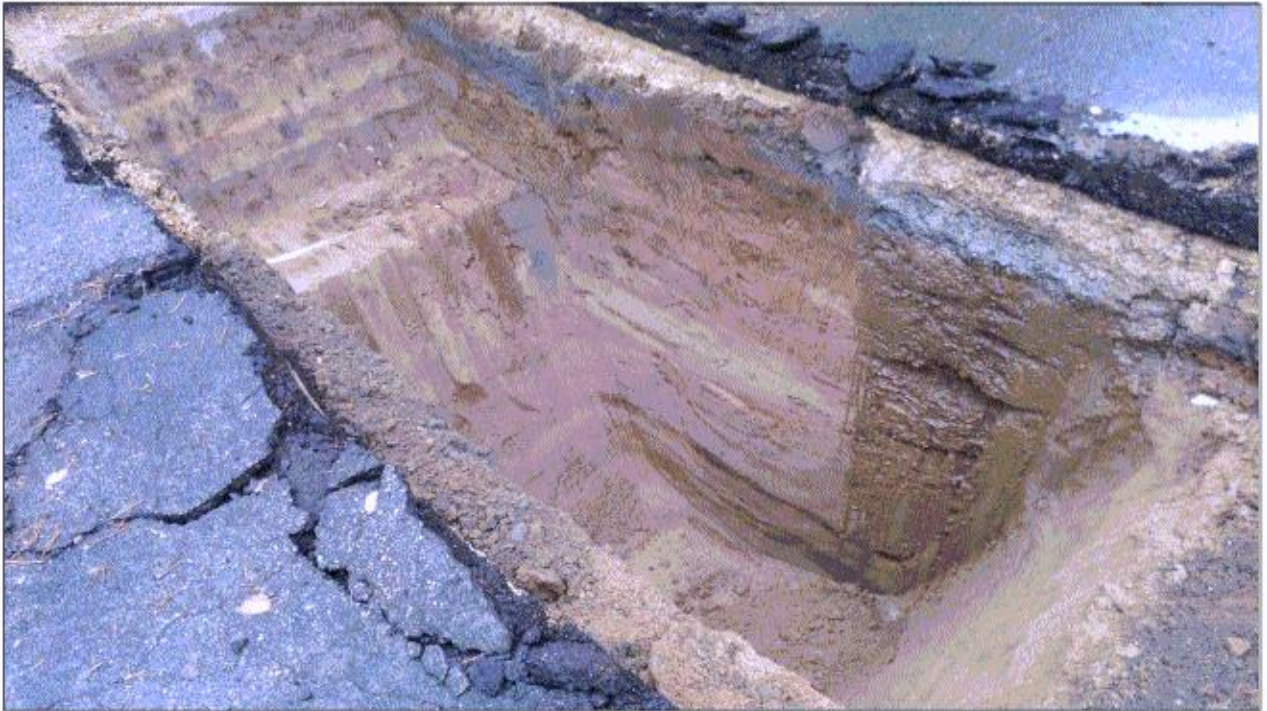
**Photograph 7. TP-2**

- Test pit TP-2 was dug in the south parking lot in the southeast corner. This test pit encountered 1 foot of pavement over 3 1/2 feet of fill consisting of poorly graded sand with silt underlain by native poorly graded sand.

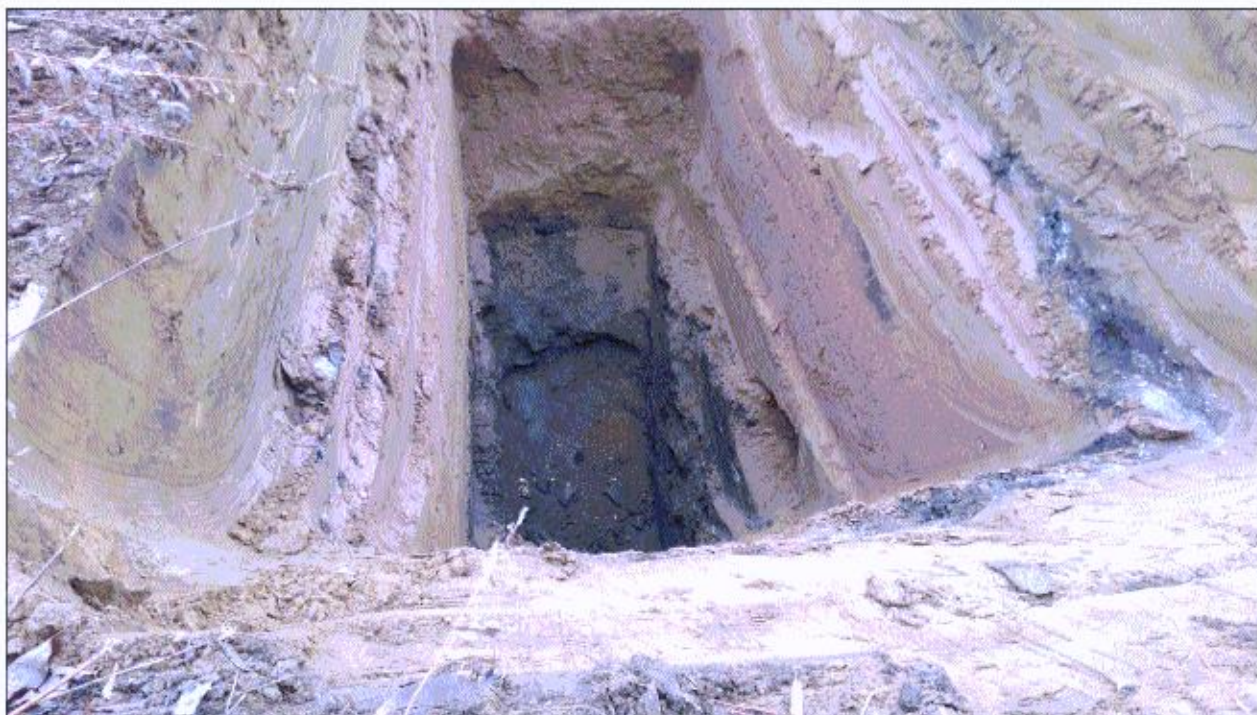
**Photograph 8. TP-3**

- Test pits TP-3 and TP-4 were dug in the east surface parking lot. These two test pits encountered similar soils. The two test pits encountered fill to termination depths of 26 feet. The fill consisted of a silty sand, clayey sand and poorly graded sand with silt with varying amounts of bituminous debris. The bituminous debris was encountered from 16 feet to 26 feet in both test pits along with a bituminous layer at 5 feet in the test pit to the east.

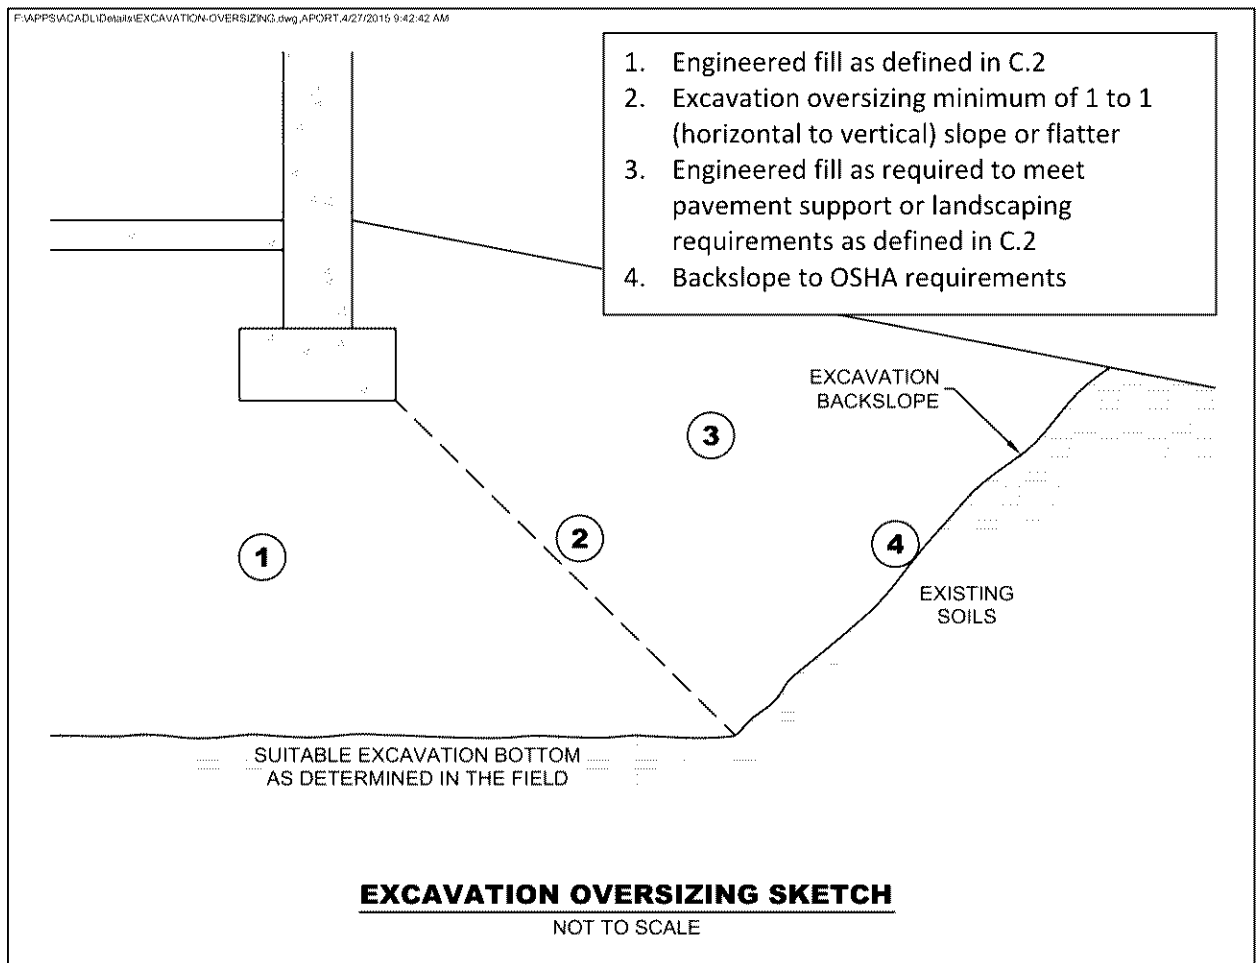
**Figure 5. Generalized Illustration of Oversizing**

When removing unsuitable materials below structures or pavements, we recommend the excavation extend outward and downward at a slope of 1H:1V (horizontal:vertical) or flatter. See Figure 5 for an illustration of excavation oversizing.

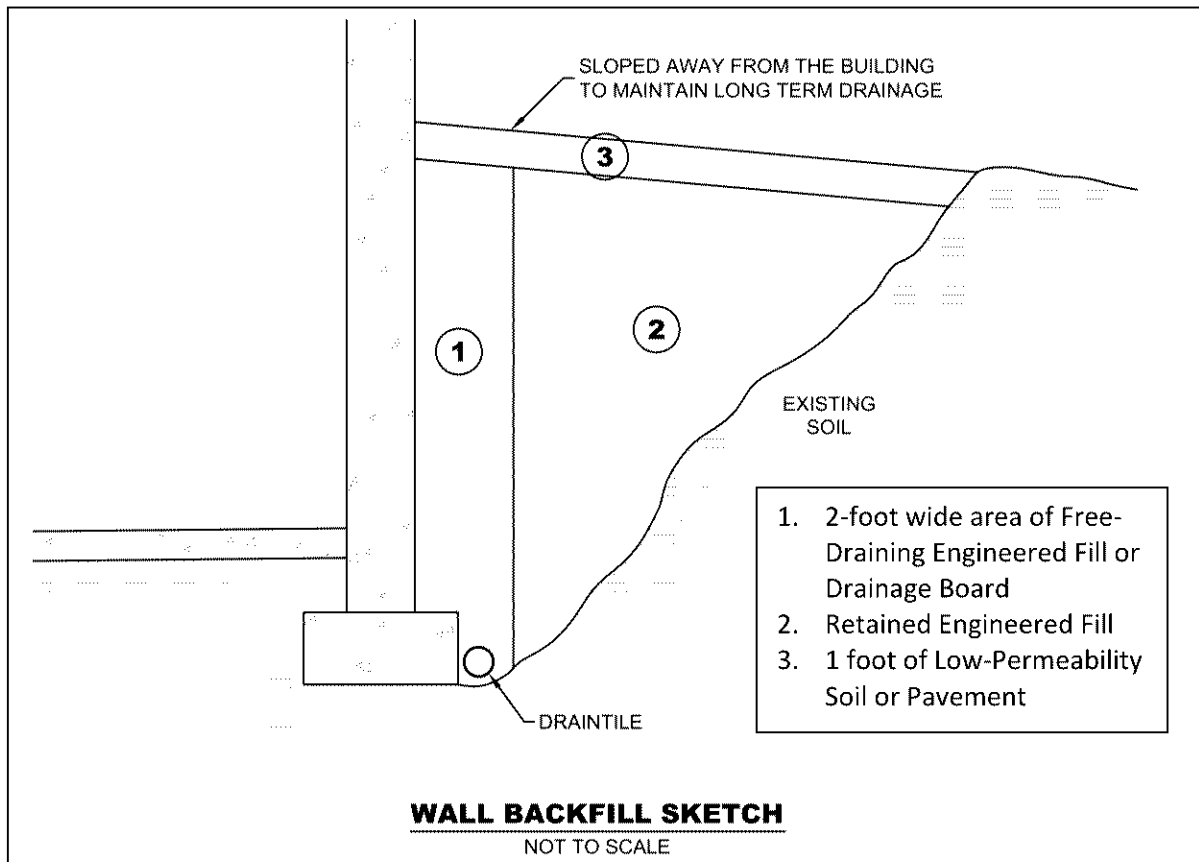
**Figure 6. Generalized Illustration of Wall Engineered Fill**

We recommend installing drain tile to remove water behind the below-grade walls, at the location shown in Figure 6. The below-grade wall drainage system should also incorporate free-draining, engineered fill or a drainage board placed against the wall and connected to the drain tile.

The materials listed in the sketch should meet the definitions in Section C.2. Low-permeability material is capable of directing water away from the wall, like clay, topsoil or pavement. The project documents should indicate if the contractor should brace the walls prior to filling and allowable unbalanced fill heights.

As shown in Figure 6, we recommend Zone 2 consist of retained, engineered fill, and this material will control lateral pressures on the wall. However, we are also providing design parameters for using other engineered fill material. If final design uses non-sand material for engineered fill, project planning should account for the following items:

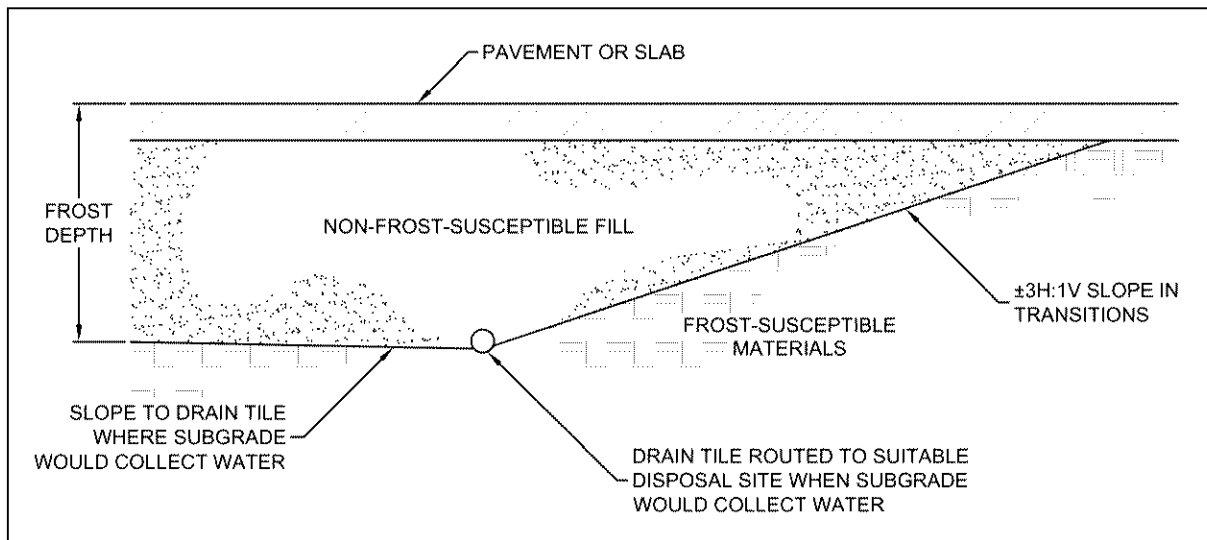
**Figure 8. Frost Protection Geometry Illustration**

Figure 8 shows an illustration summarizing some of the recommendations.

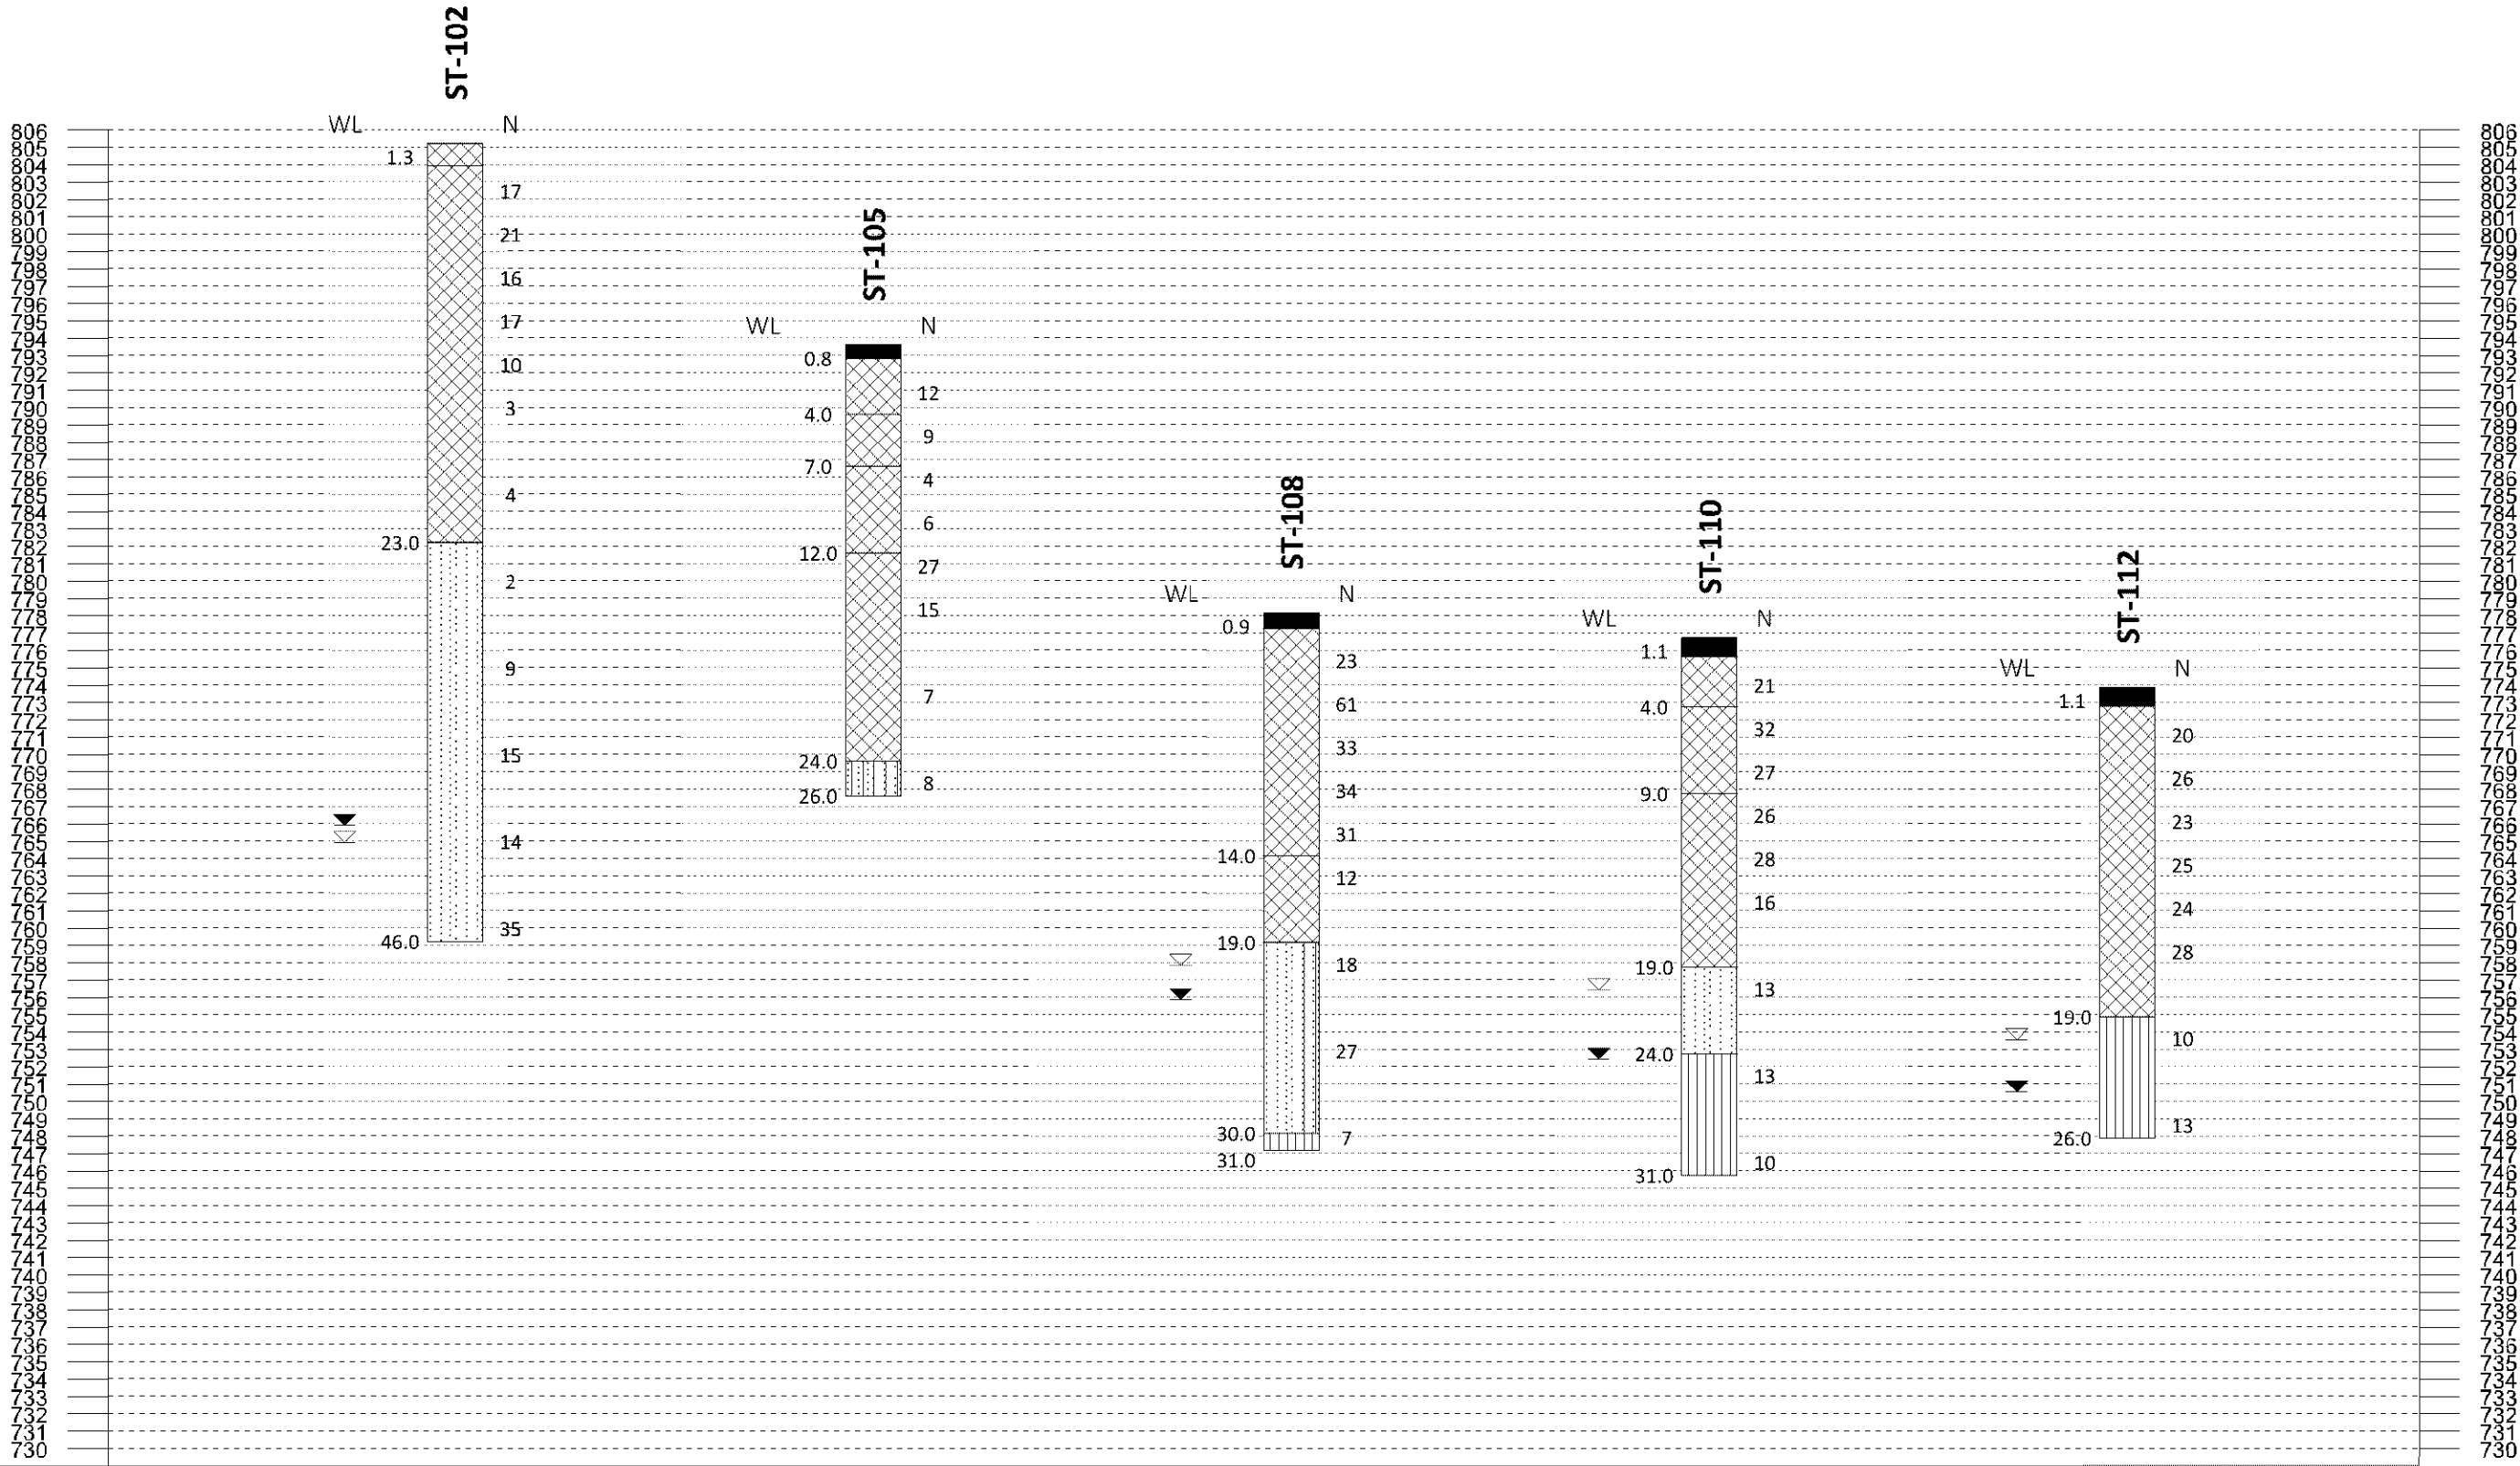
SECTION LINE 1  
Fence Diagram  
Geotechnical & Environmental Evaluation  
Crown Plaza Site  
3601 American Boulevard E  
Bloomington, Minnesota

Project ID: B1909819  
Vert. Scale: 1"= 10'  
Hor. Scale: NTS  
Date: 10-10-2019
