Geotechnical Evaluation Report

Crown Plaza Site
3601 American Blvd E
Bloomington, Minnesota

Re: Geotechnical Evaluation
Crown Plaza Site
3601 American Blvd E
Bloomington, Minnesota

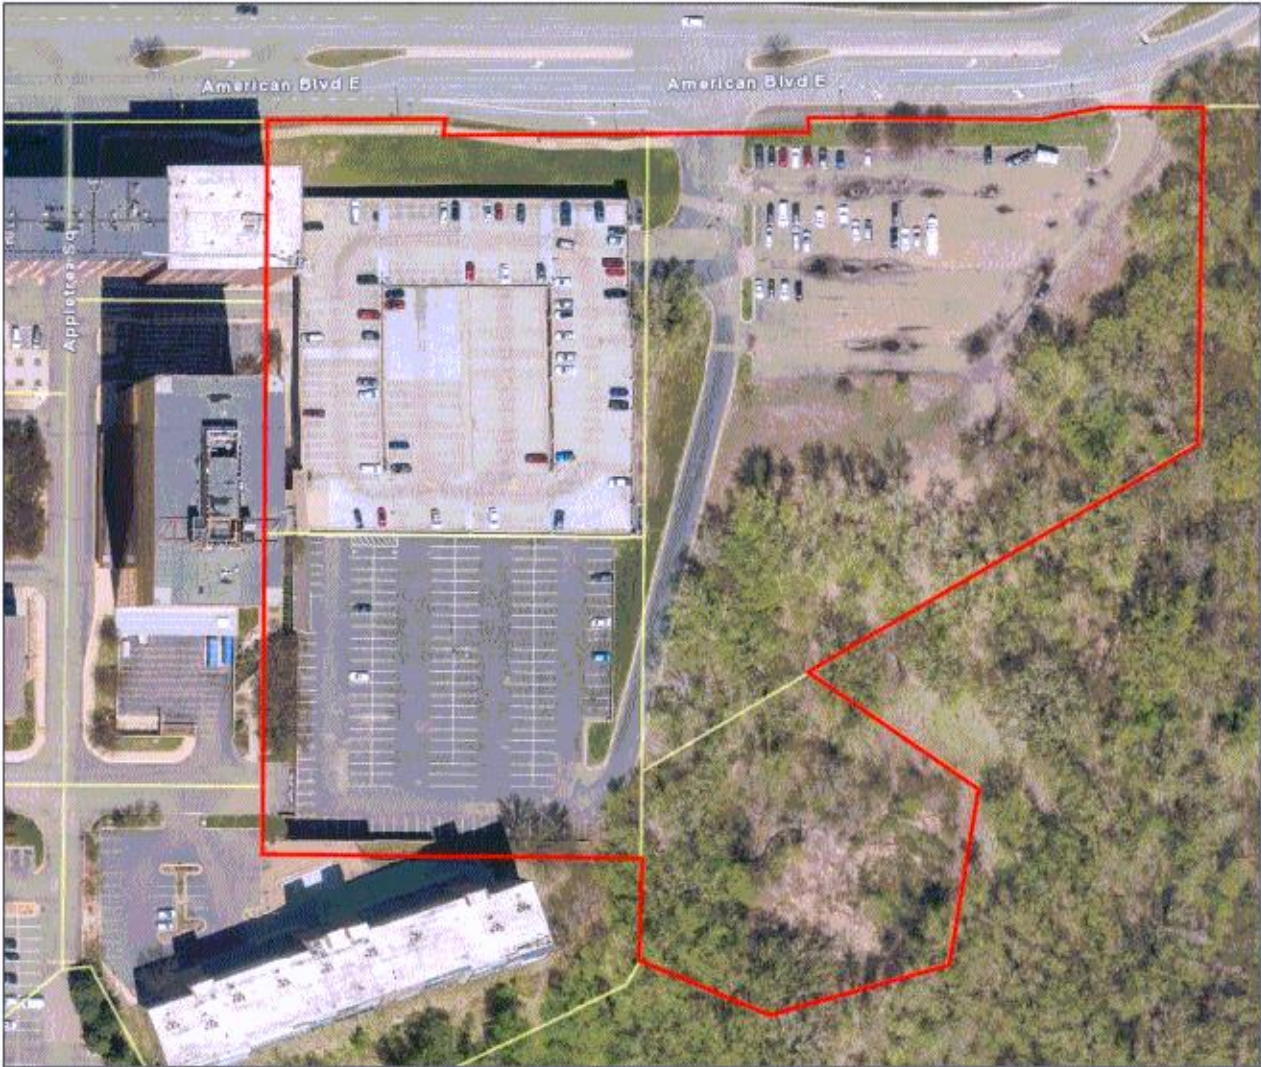
Photograph 1. Site Extents

Currently, the site exists as four separate parcels as shown in Photograph 1 below. The parcels on the west half of the site currently contains a six-story parking garage with a surface parking lot to the south of the ramp. The east parcel exists as a surface parking lot. The site has a notable topography with current grades ranging from 774 to 811 feet Mean Sea Level (MSL). Generally, the site is sloping, from the northwest corner of the site to the southeast corner of the site, with the low area of the site being in the southeast corner around the existing pond.

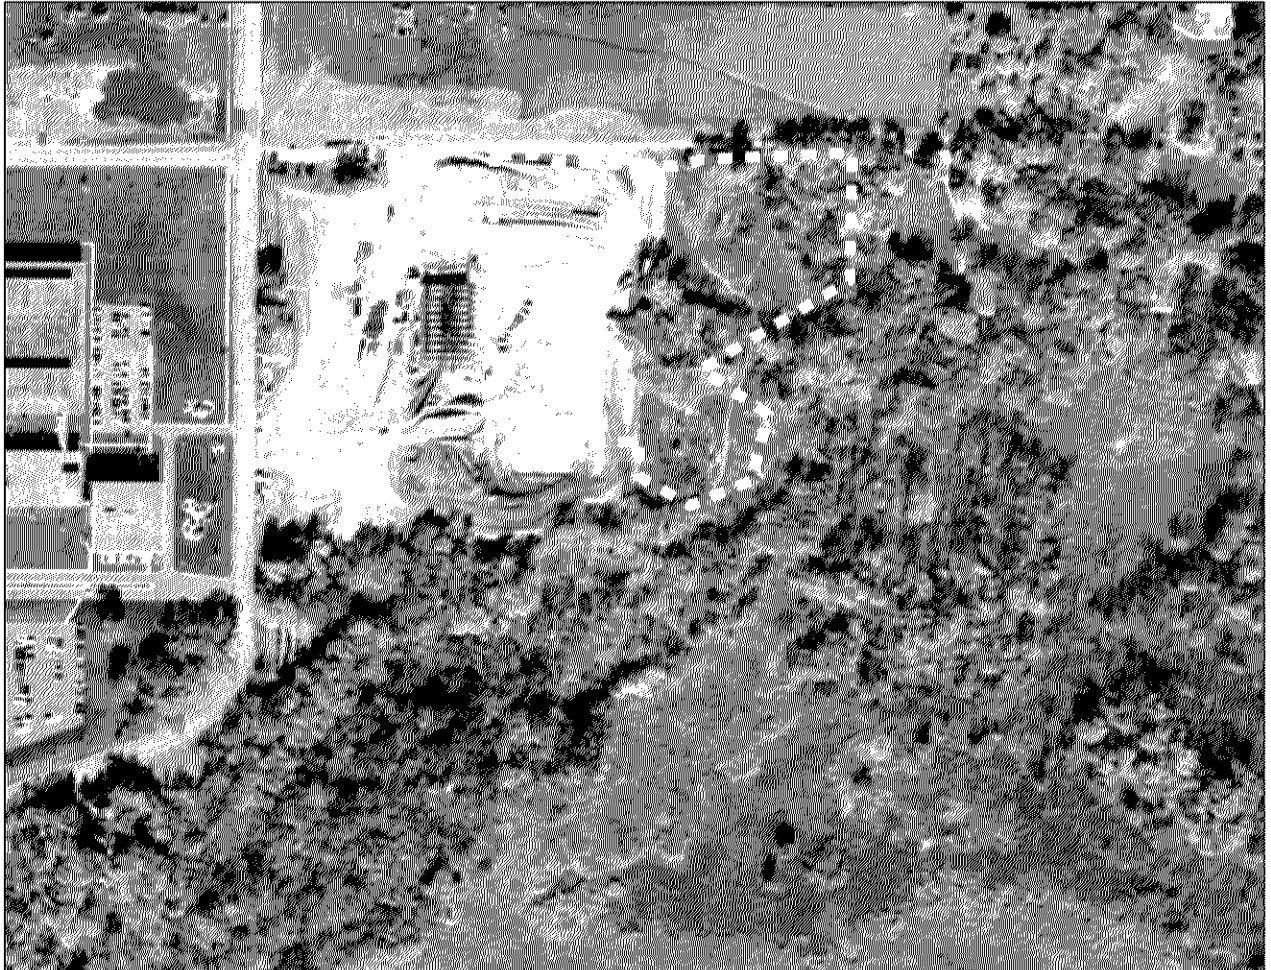
Photograph 4. Aerial Photograph of the Site in 1972

Photograph 4 below shows the site which appears to be in construction process for the buildings and parking ramps. Prior to the parking ramp structure, no structures were documented on the property. Hennepin County lists the construction date of the office tower and parking ramp as 1973. The Crown Plaza Hotel was constructed in 1980.

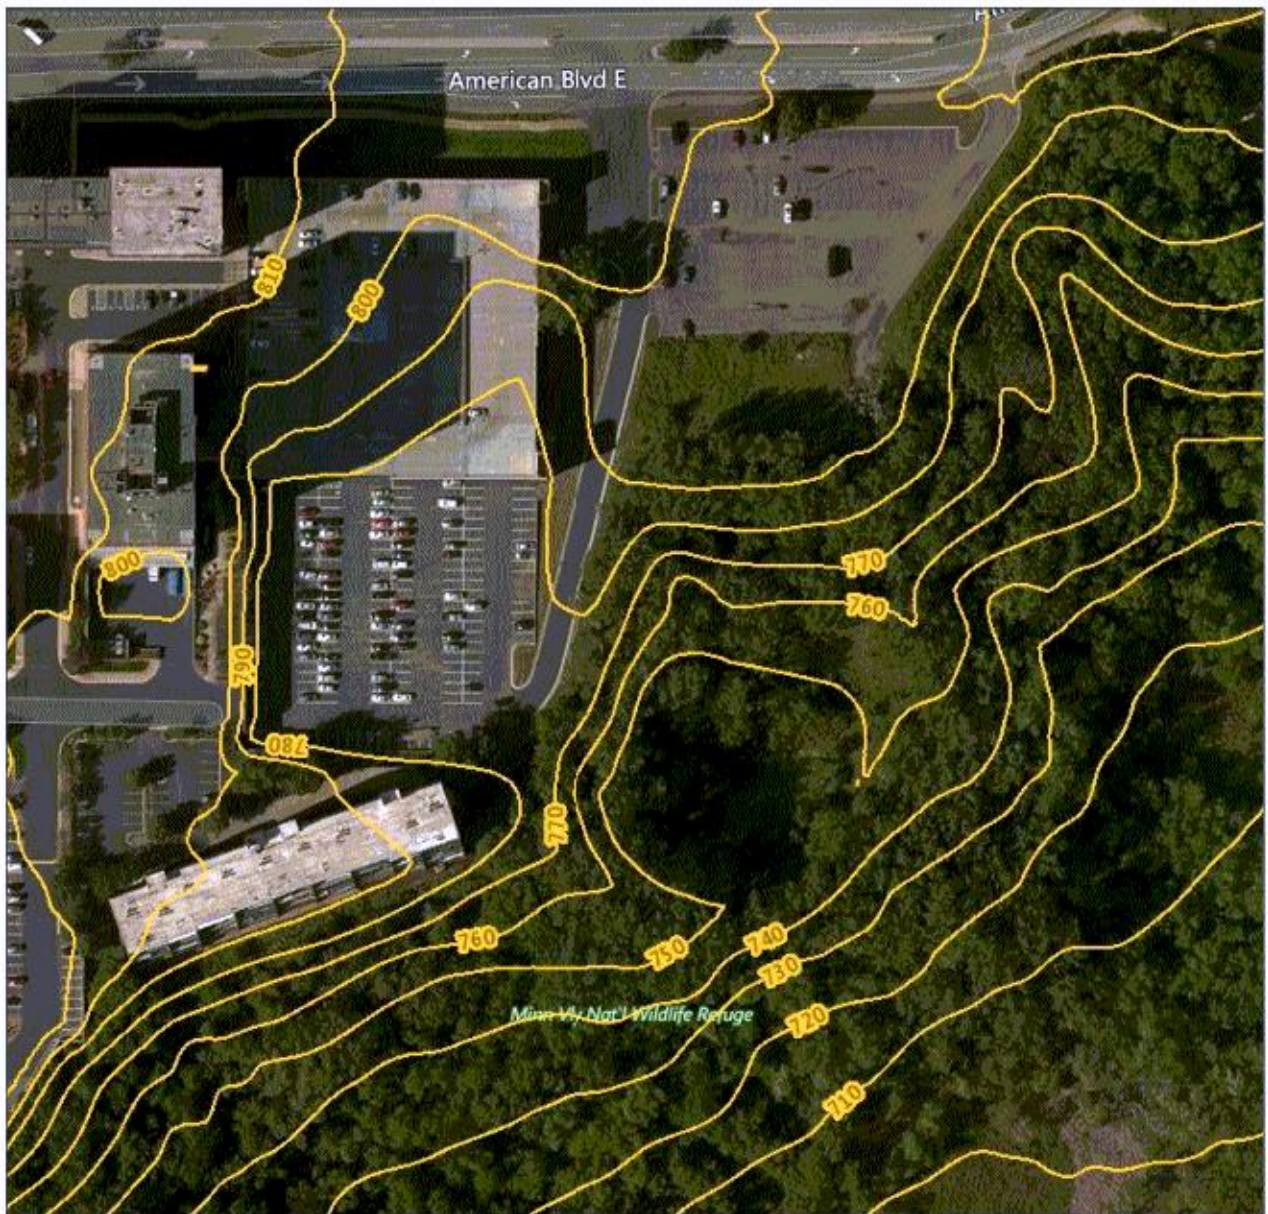
Photograph 5. Aerial Photograph of the Site in 2018

Photograph 5 below illustrates the site in more or less the same condition as it is now, along with the existing topography overlaid. Generally speaking, the topography of the site appears to be relatively the same as the post-mining operation topography. As described above, the existing six-story parking garage is shown as well as the two surface parking lots.

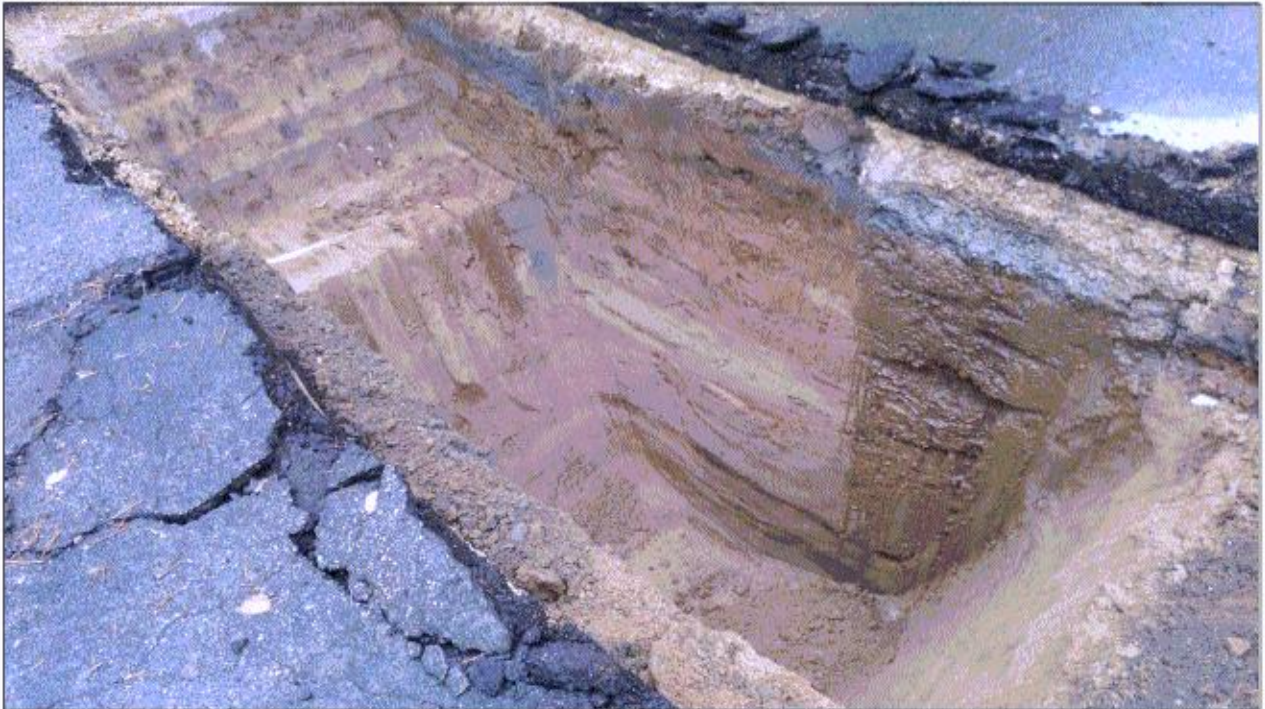
Photograph 7. TP-2

- Test pit TP-2 was dug in the south parking lot in the southeast corner. This test pit encountered 1 foot of pavement over 3 1/2 feet of fill consisting of poorly graded sand with silt underlain by native poorly graded sand.

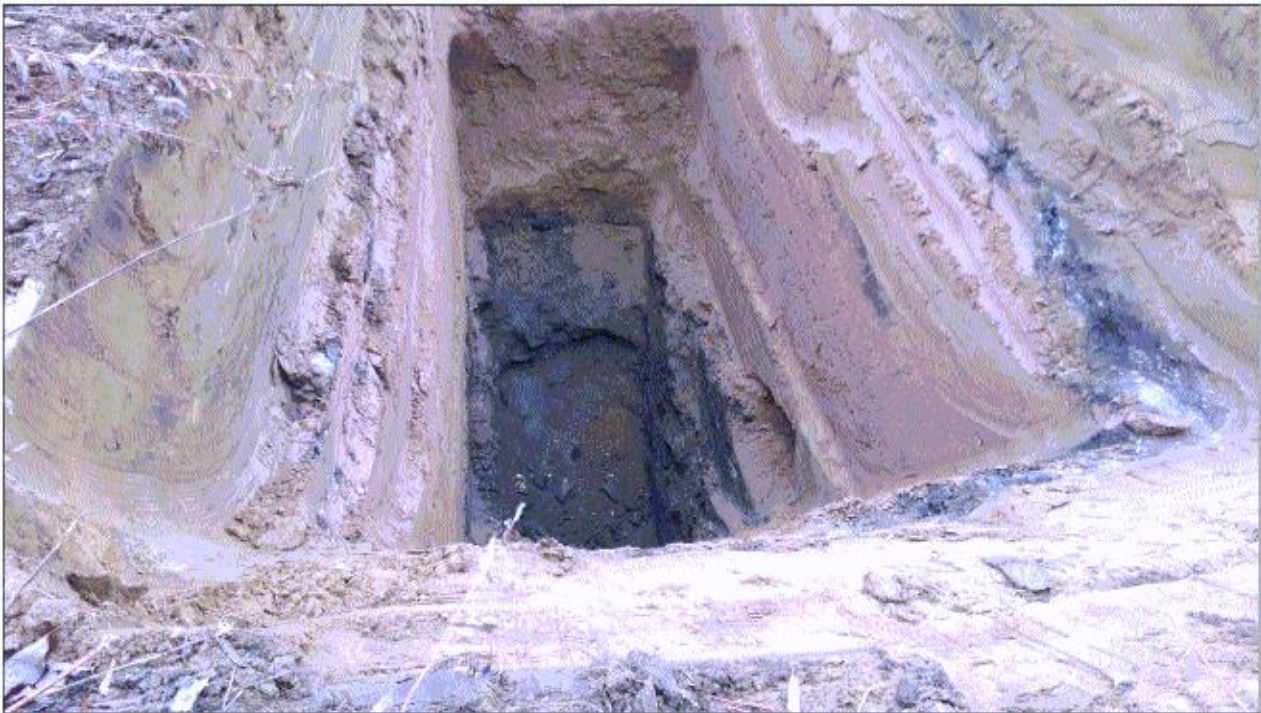
Photograph 8. TP-3

- Test pits TP-3 and TP-4 were dug in the east surface parking lot. These two test pits encountered similar soils. The two test pits encountered fill to termination depths of 26 feet. The fill consisted of a silty sand, clayey sand and poorly graded sand with silt with varying amounts of bituminous debris. The bituminous debris was encountered from 16 feet to 26 feet in both test pits along with a bituminous layer at 5 feet in the test pit to the east.
