February 28, 2022

Subject: Summary Report for  
Carwash Noise Control  
Tommy's Express Car Wash – Bloomington, Minnesota

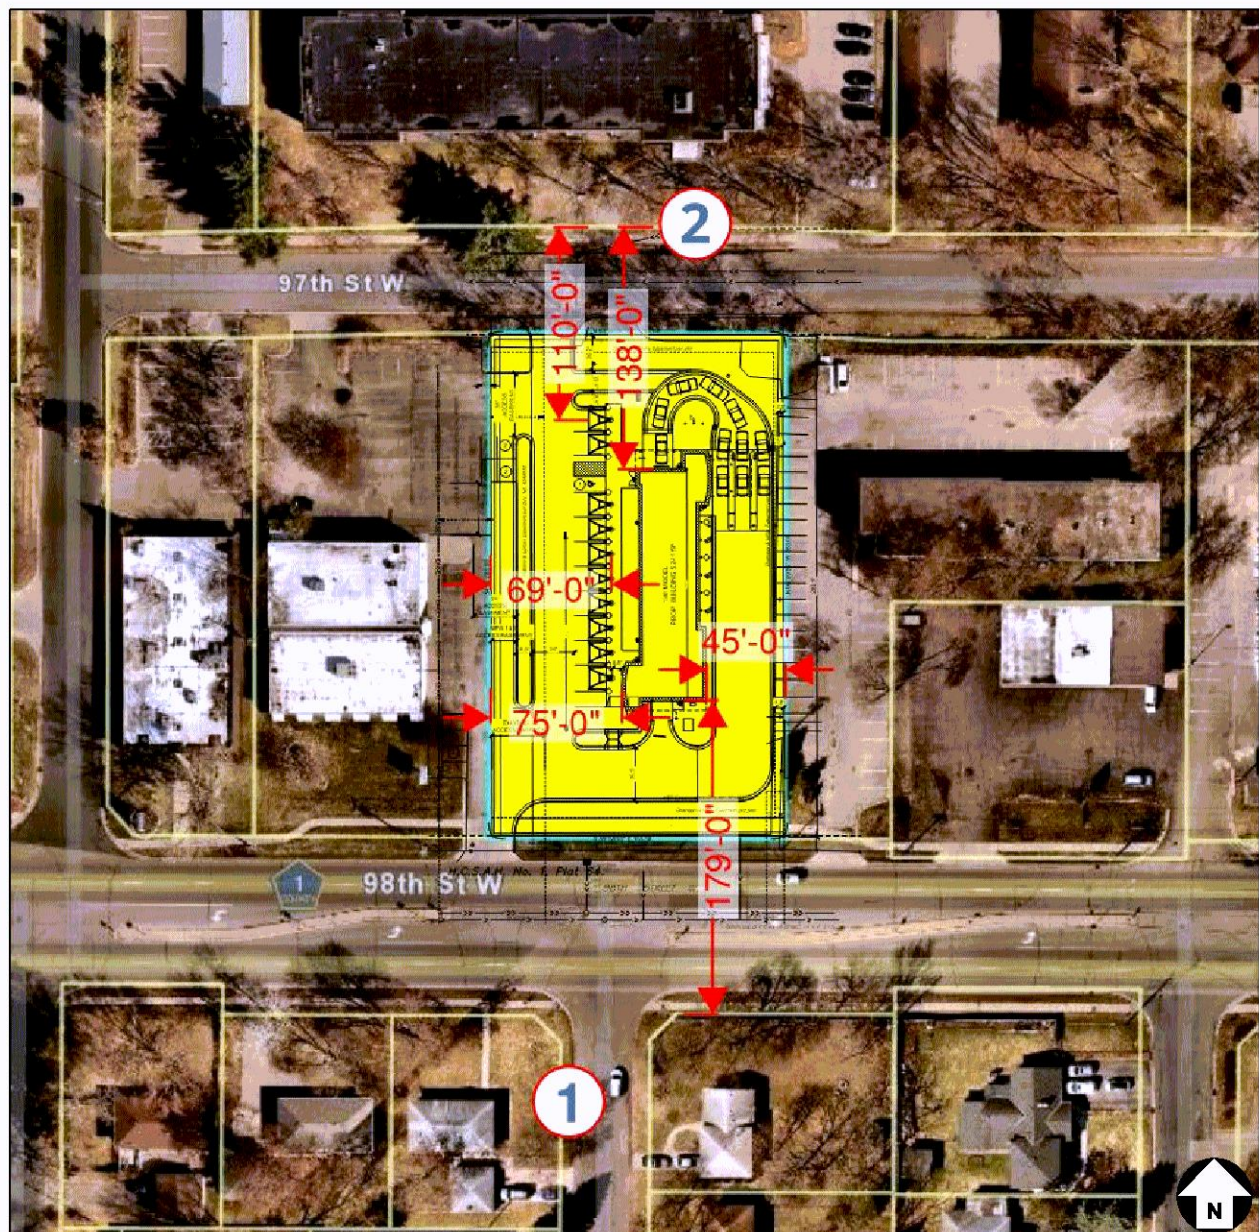
Figure 2 – Car wash site plan overlaid on an aerial image showing the distances to the nearest receiver property lines and the ambient noise measurement locations.

The proposed project site is a 1.08 acre commercial lot that is located on the north side of the West 98<sup>th</sup> Street and Pillsbury Avenue South intersection. As shown in Figure 2, the current architectural site plan has the car wash building located near the middle of the lot with the car wash entrance facing north and the exit facing south. Ten vacuums are shown at the head of parking stalls near the west side of the car wash building. Figure 2 also shows the distances from the building and vacuums to the nearest receiver property lines.

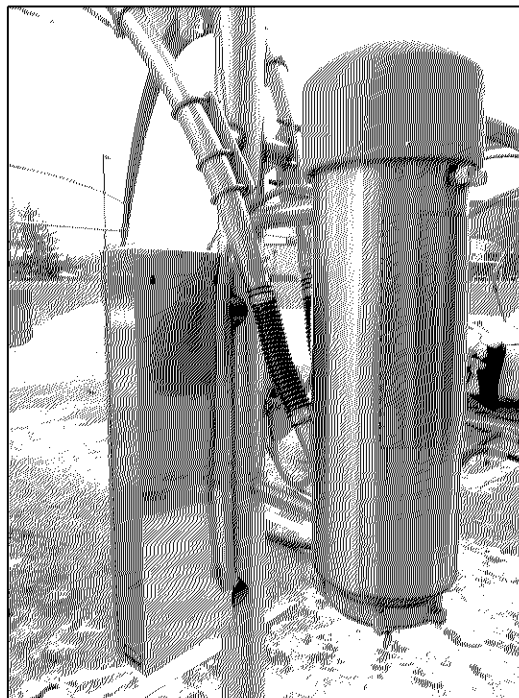
1. There were multiple Tommy Car Wash Systems vacuums at the site (see Figure 3). No mufflers were installed on top of the vacuums. The measured L50 sound pressure level at a distance of 10' from one running vacuum was 72 dBA.

**Figure 3 – Photo of a vacuum at the Tommy's Express Car Wash.**

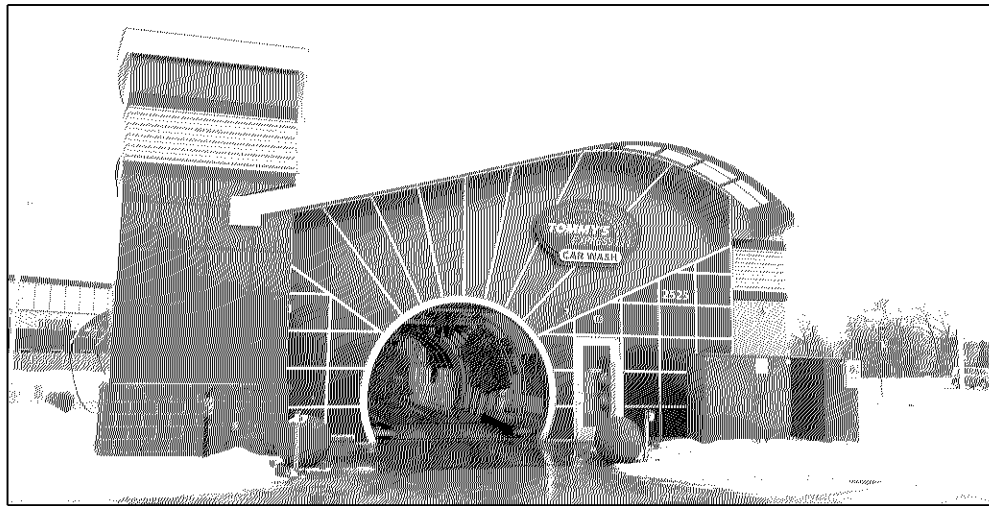
2. The dominate noise source near the car wash exit (see Figure 4) was the drier system, which had eighteen blowers (shown in Figure 5). The measured L50 sound pressure level at a distance of 58' from the exit, with a zero degree offset from the exit centerline, was 83 dBA. When a measurement was made 54' from the exit with a 45 degree offset from the exit centerline, the measured L50 was 79 dBA.

**Figure 4 – Photo of the Tommy's Express Car Wash exit with drier system beyond.**

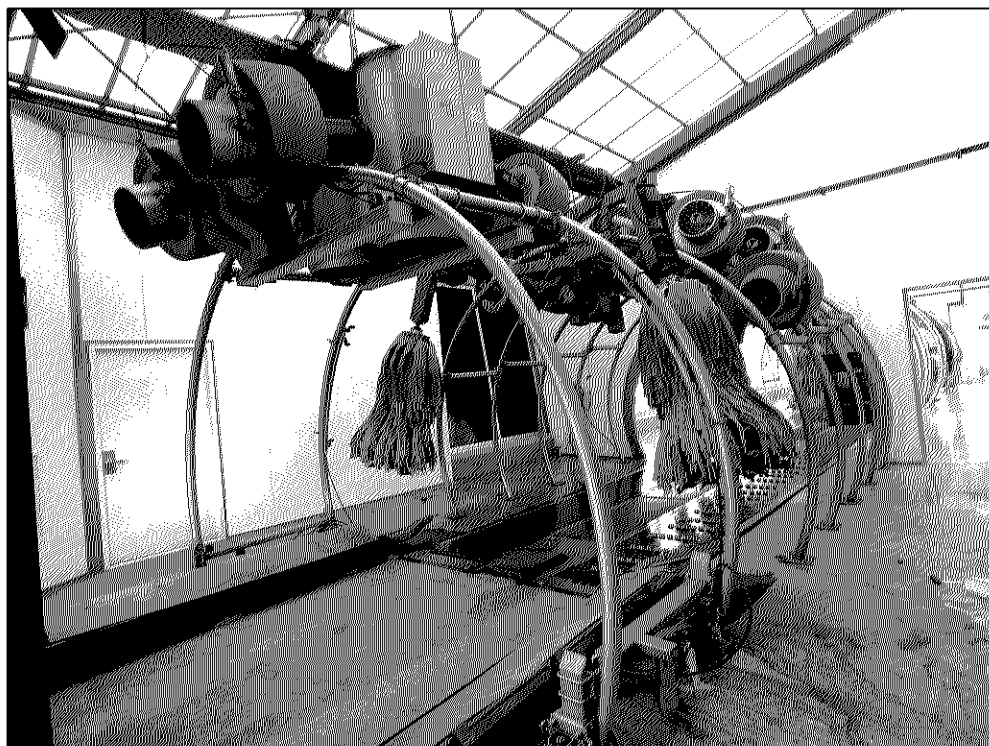
**Figure 5 – Photo of the Tommy's Express Car Wash drier system.**

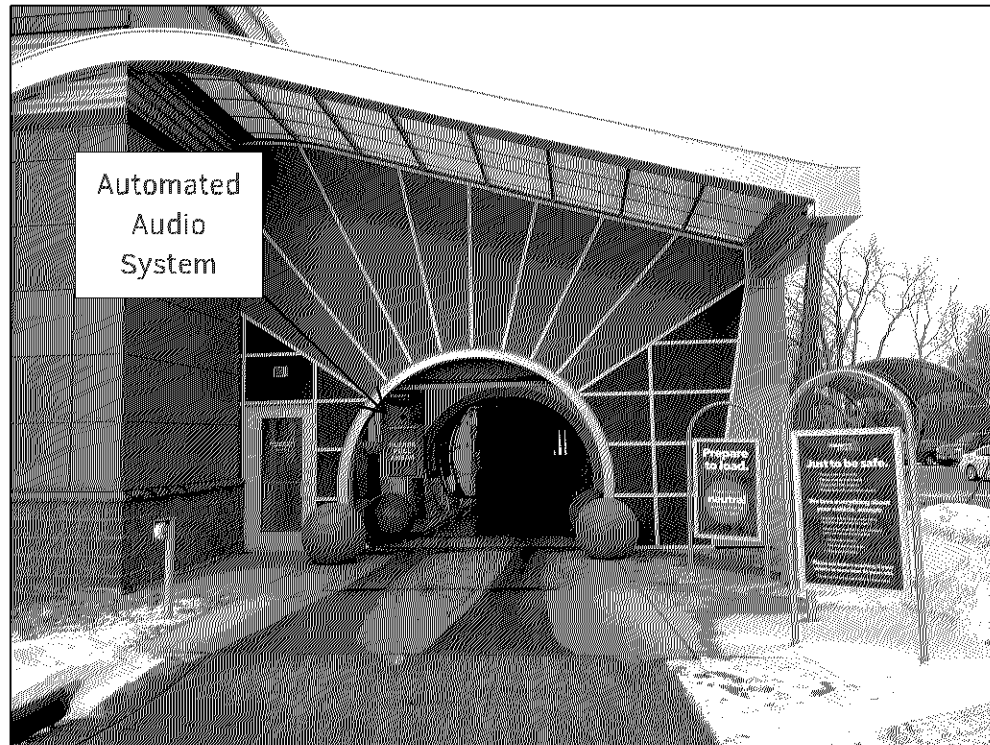
3. The dominate noise sources near the car wash entrance were the automated audio system (see Figure 6) and the drier system at the other end of the car wash. The measured L50 sound pressure level at a distance of 48' from the entrance, with a zero degree offset from the entrance centerline, was 71 dBA.

**Figure 6 – Photo of the Tommy's Car Wash entrance.**

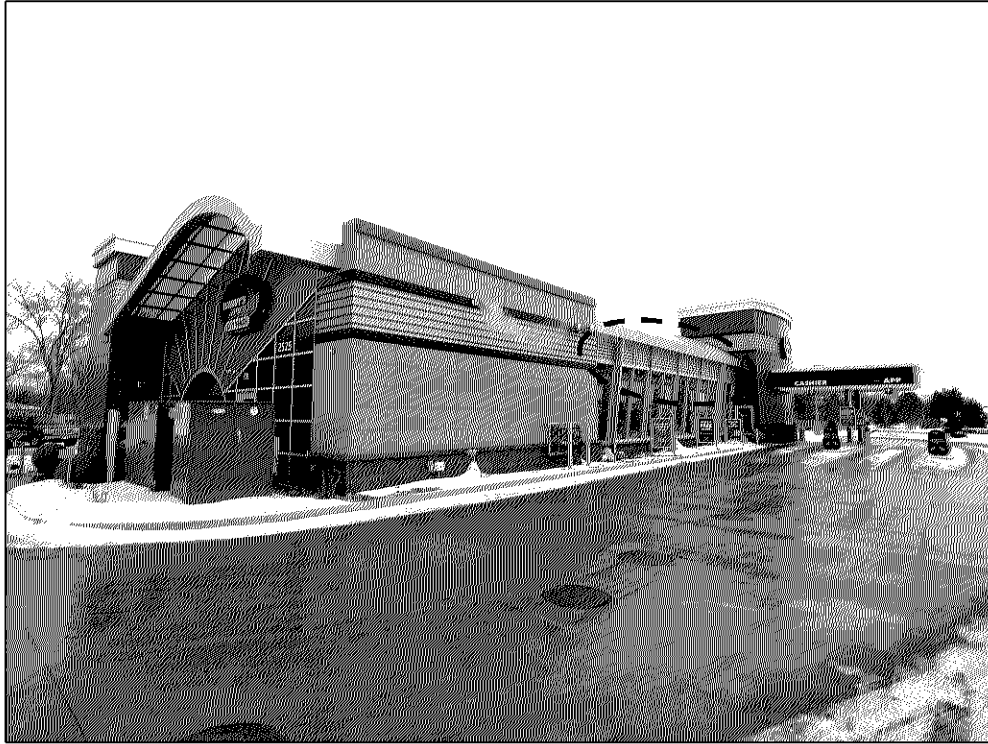
4. The car wash building had louvers with dampers on each side (see Figure 7). The dampers could be opened and closed to control the release of heat and steam from inside the building, which also allows sound to leak out. The dominate noise source radiating from the dampers was the drier system. The measured L50 level at a distance of 8.5' from one open damper (shown in Figure 8) was 75 dBA.

**Figure 7 – Photo of the Tommy's Express Car Wash with sidewall louvers circled.**

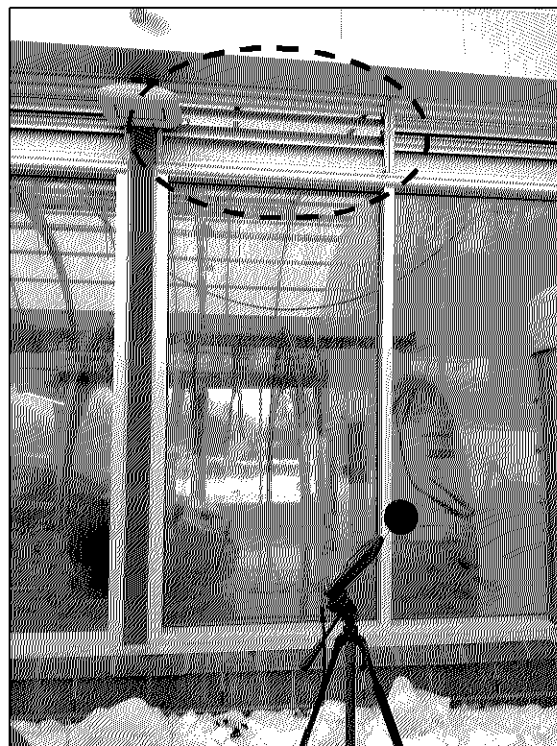
**Figure 8 – Photo of the Tommy's Express Car Wash with an open damper circled.**

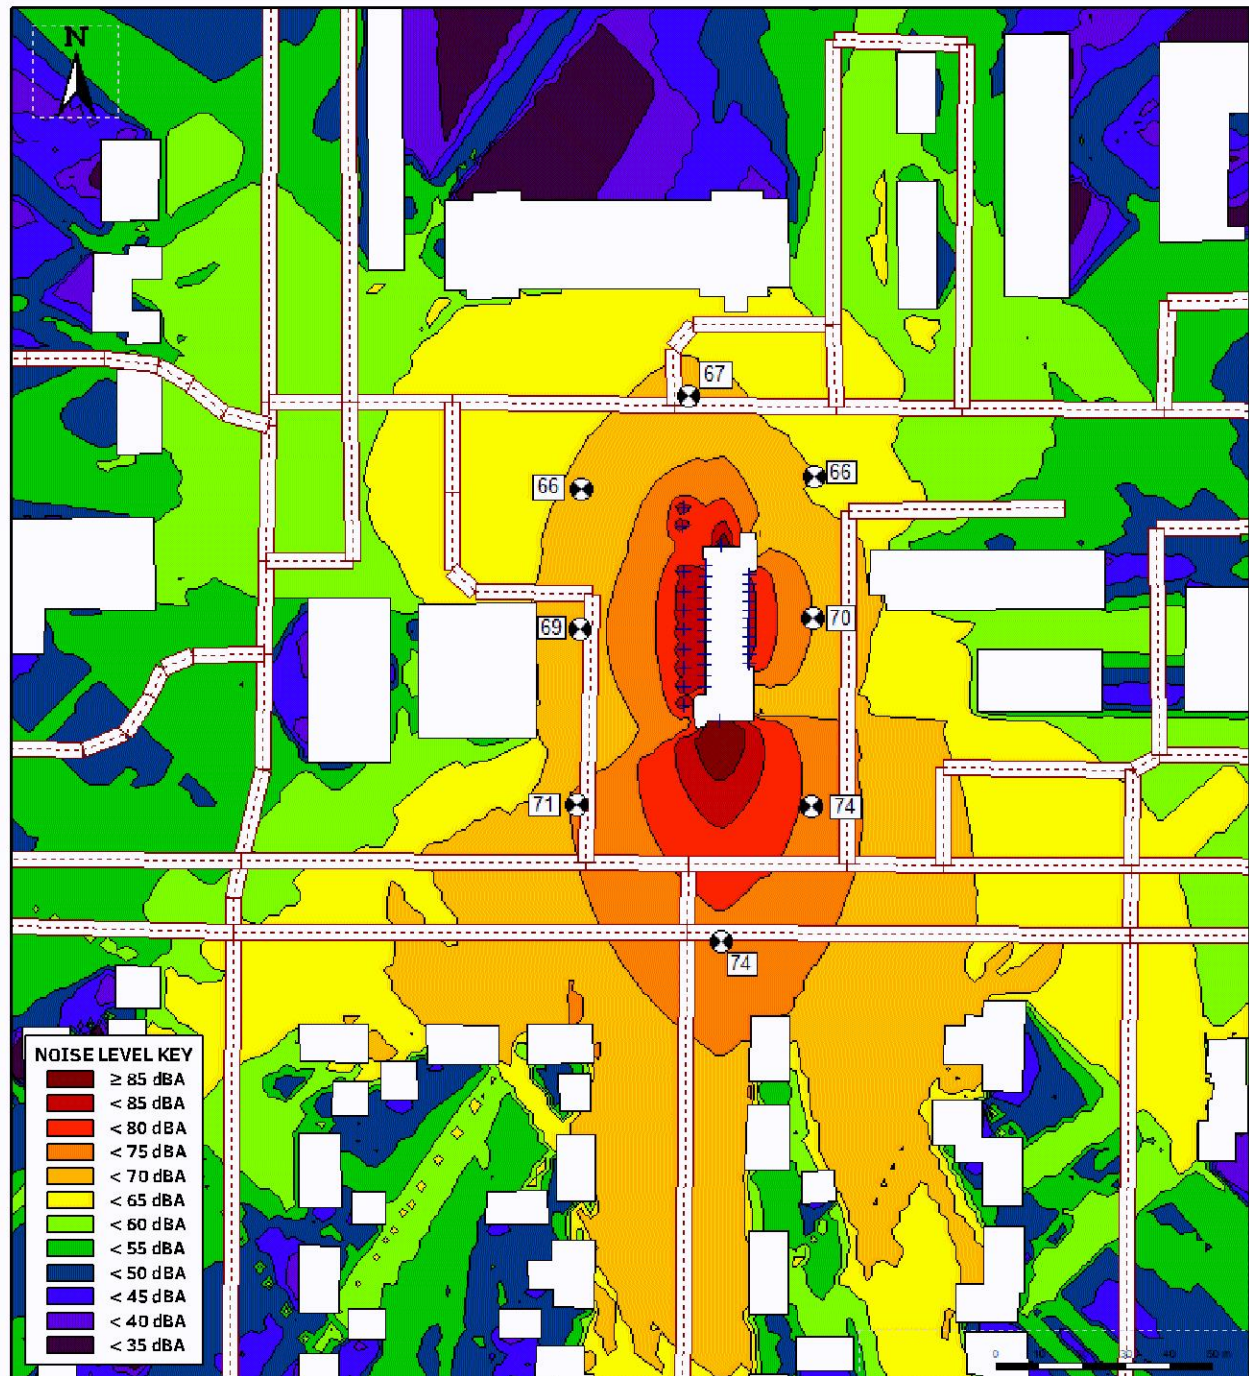
The calculation results for these basis-of-design conditions are summarized in the noise contour plot shown in Figure 9. The noise level results at the nearest residential and commercial receivers exceeded the daytime requirements of 60 dBA. The highest exceedance was the noise level at the nearest residential receiver south of the car wash exit. The calculated level at this position was 74 dBA, which exceeds the requirement by 14 decibels.

**Figure 9 – Noise contour plot showing the basis-of-design Tommy's Express Car Wash equipment noise levels at the proposed Bloomington project site.**

A noise contour plot was prepared to help evaluate the car wash noise levels at the proposed project site. The calculations included the car wash building, all other nearby buildings, and a source for each of the car wash noise producers. Sources were the exit opening, entrance opening, eleven east facing sidewall louvers, twelve west facing sidewall louvers, and ten vacuums near the west side of the car wash building.

The existing car wash measurement results also showed that drier system noise at the exit and entrance was directional. At a 45 degree offset from the centerline, the sound power was about 5 dBA quieter. This “tunnel effect” of the sound dispersion from the exit and entrance was included in the noise calculations.

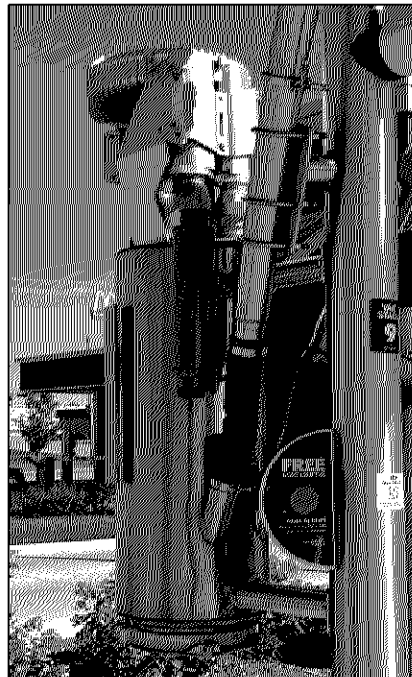
1. Tommy Car Wash Systems has optional mufflers that can be provided with the vacuums. Based on a Tommy Car Wash Systems report (provided in Attachment C), installing a P-VAC-335 muffler (shown in Figure 10) on top of a vacuum reduces noise levels by 9 dBA and does not affect the vacuum suction. We recommend installing P-VAC-335 mufflers on all of the vacuums for the Bloomington project.

**Figure 10 – Photo of a Tommy Car Wash Systems vacuum with a P-VAC-335 muffler.**

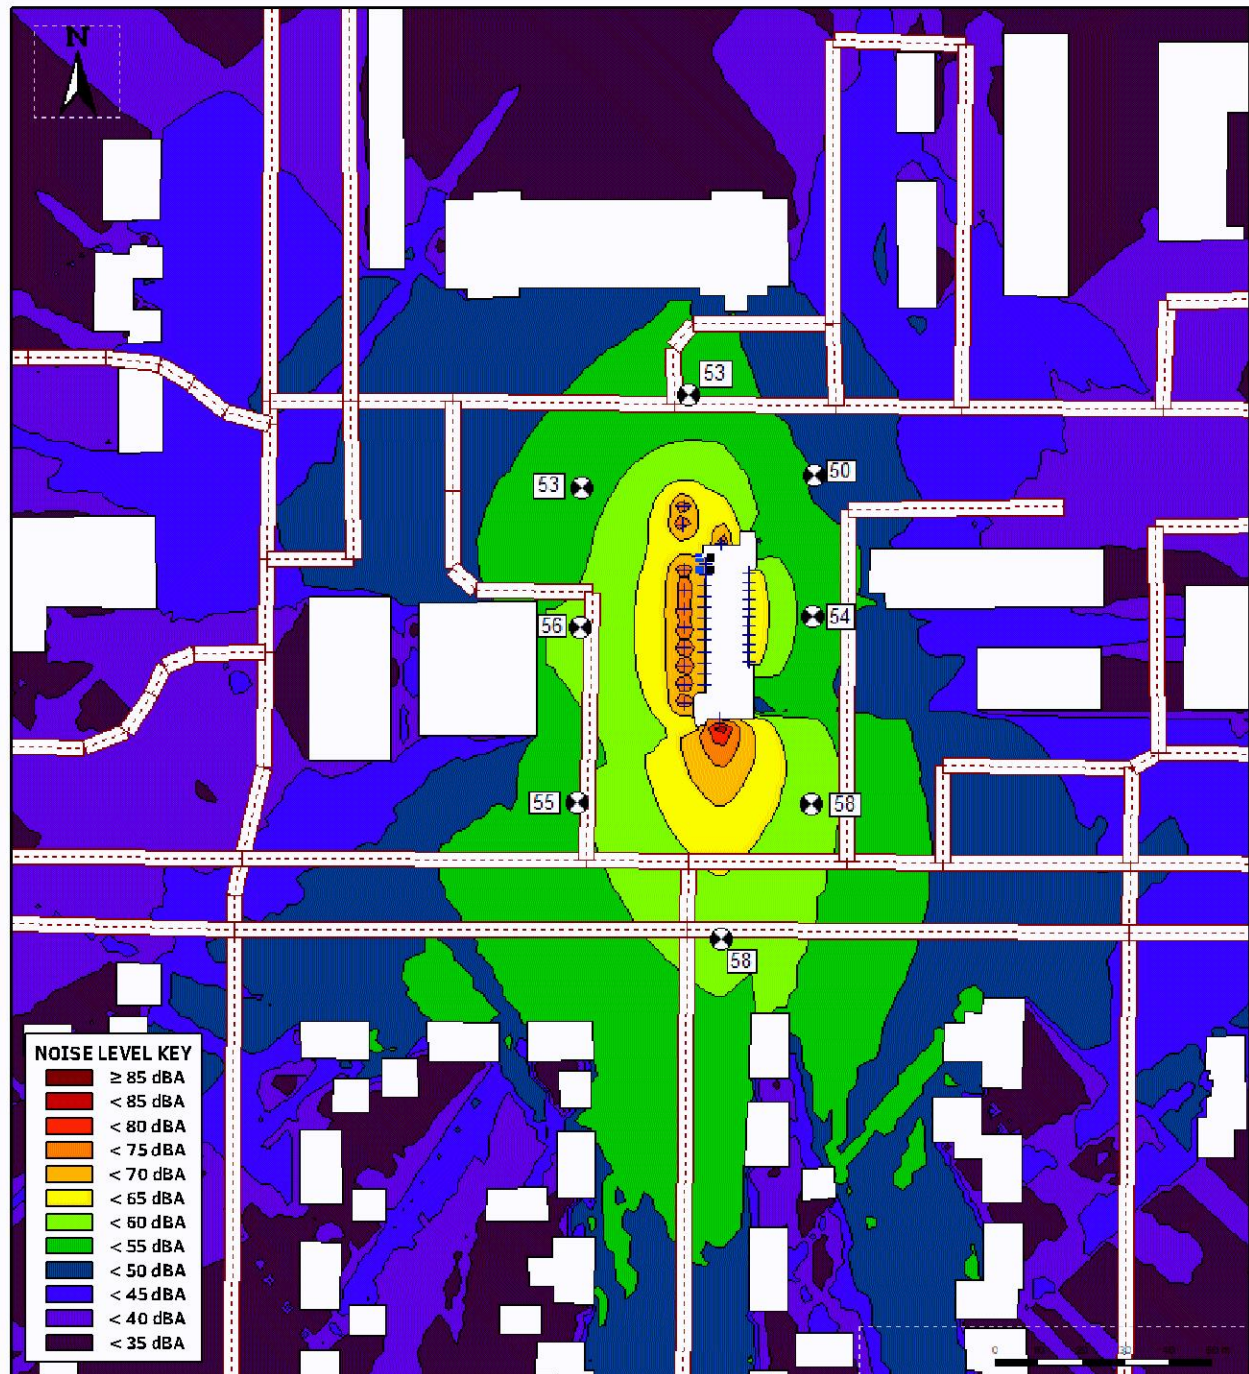
The resultant noise contour plot with the vacuums having P-VAC-335 mufflers (9 dBA of reduction) and the blowers running at 30 Hz (17 dBA of reduction for the exit, entrance, and sidewall louver sources) is provided in Figure 11. With these recommendations, the results show a maximum noise level of 58 dBA at the loudest residential and commercial receiver positions, which meets the 60 dBA and 65 dBA daytime Code limits, respectively. No other modifications to the car wash equipment are necessary.

**Figure 11 – Noise contour plot showing the Tommy's Express Car Wash equipment noise levels at the proposed Bloomington site with the recommended vacuum mufflers included and the blowers running at 30 Hz.**

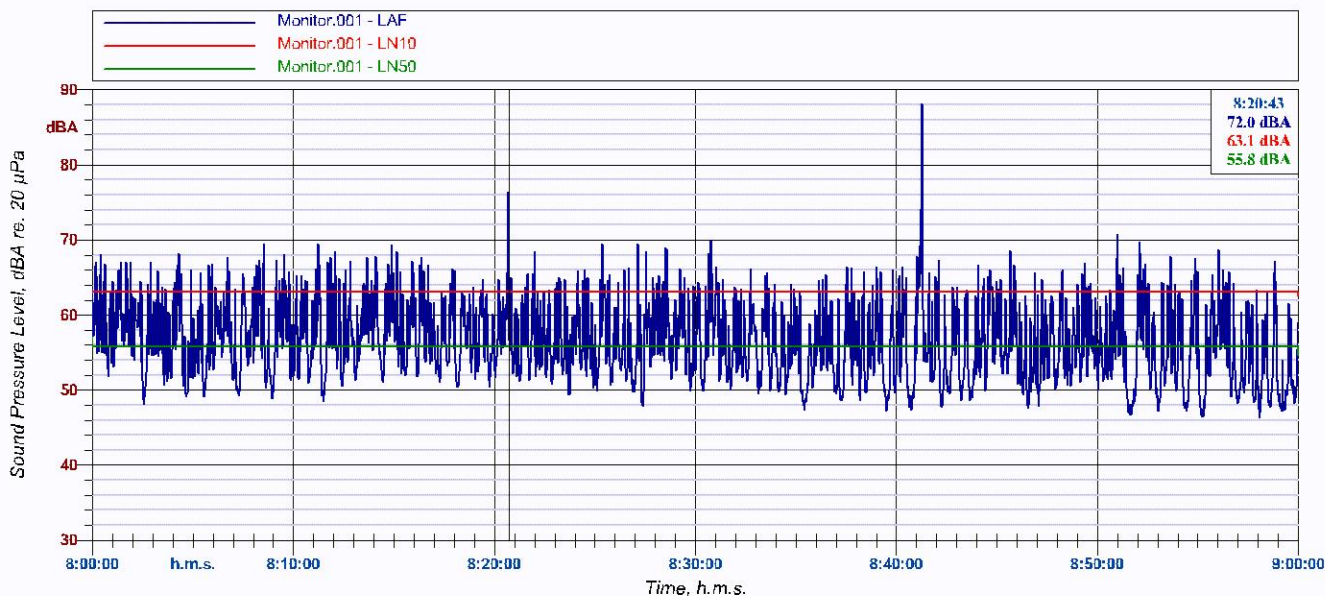
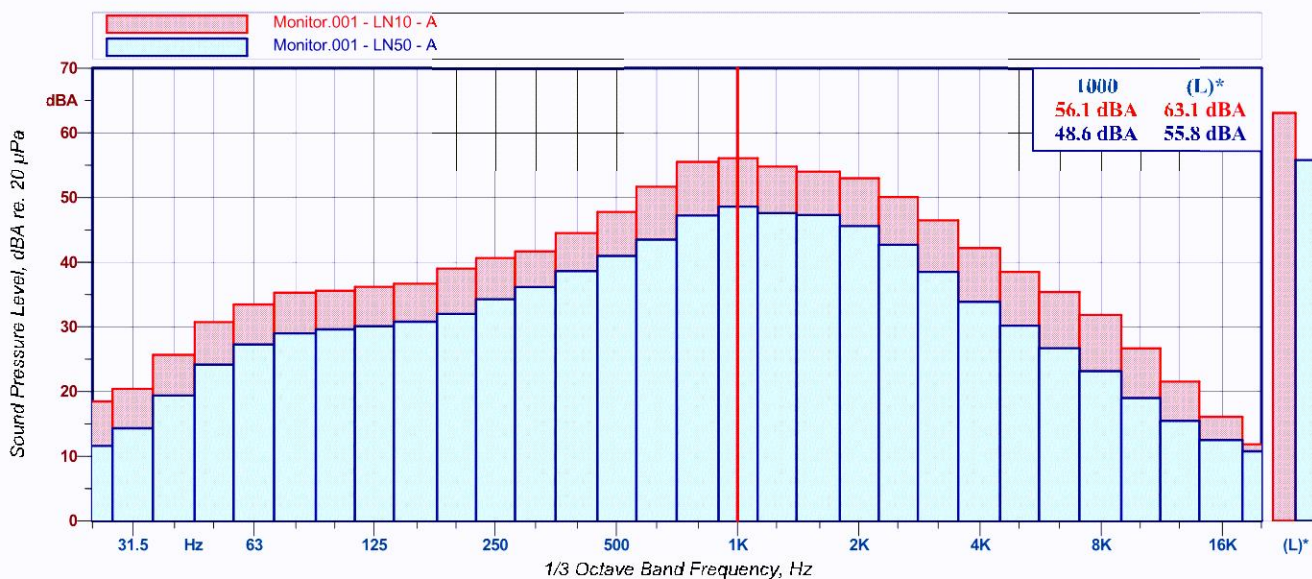
Figure A1

**Measurements:** File N. 1: Ambient Noise from Traffic  
On West 98th Street.  
Wednesday, 8 PM to 9 PM

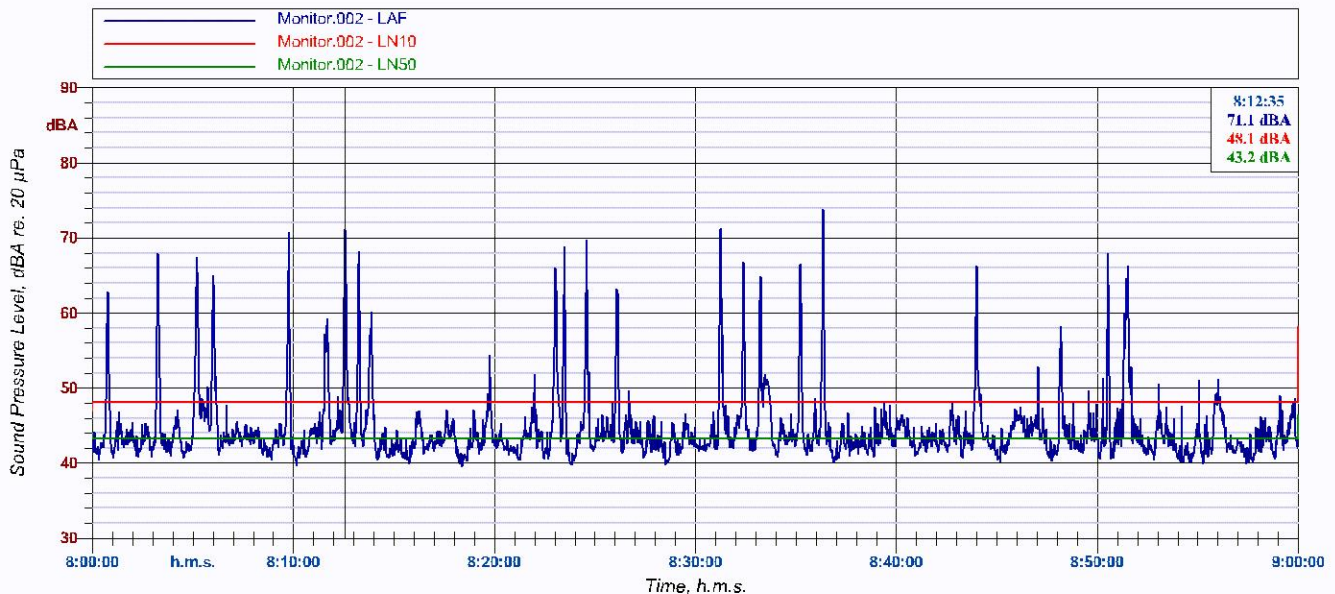
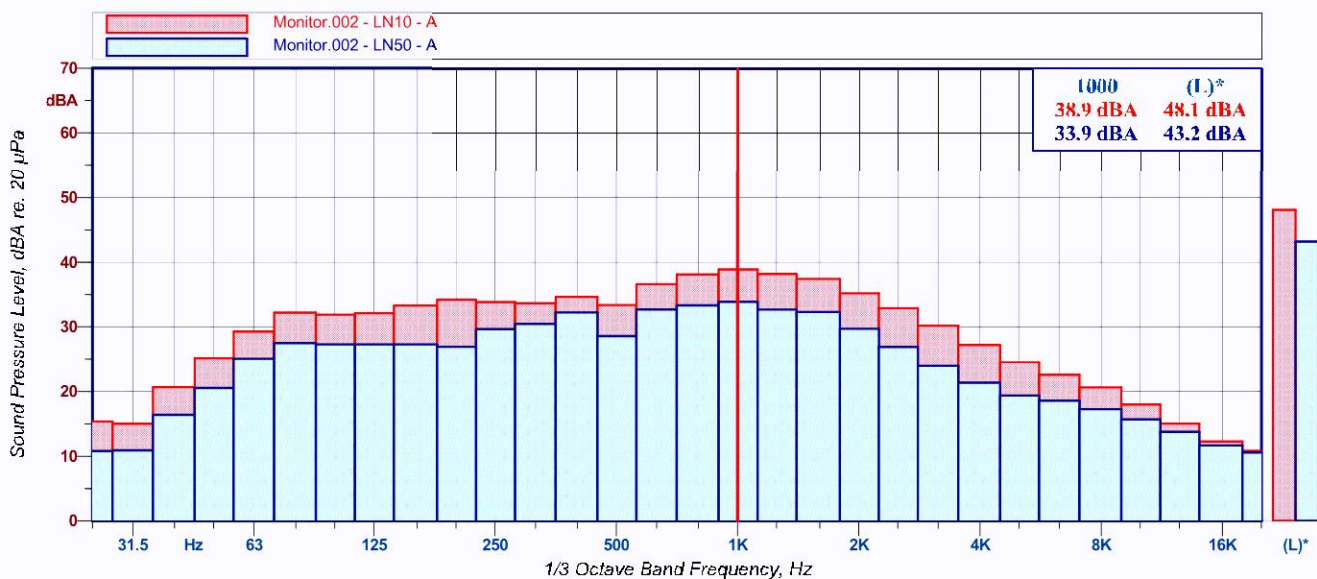
Figure A2

**Measurements:** File N. 2: Ambient Noise from Traffic  
On West 97th/98th Streets.  
Monday, 8 PM to 9 PM

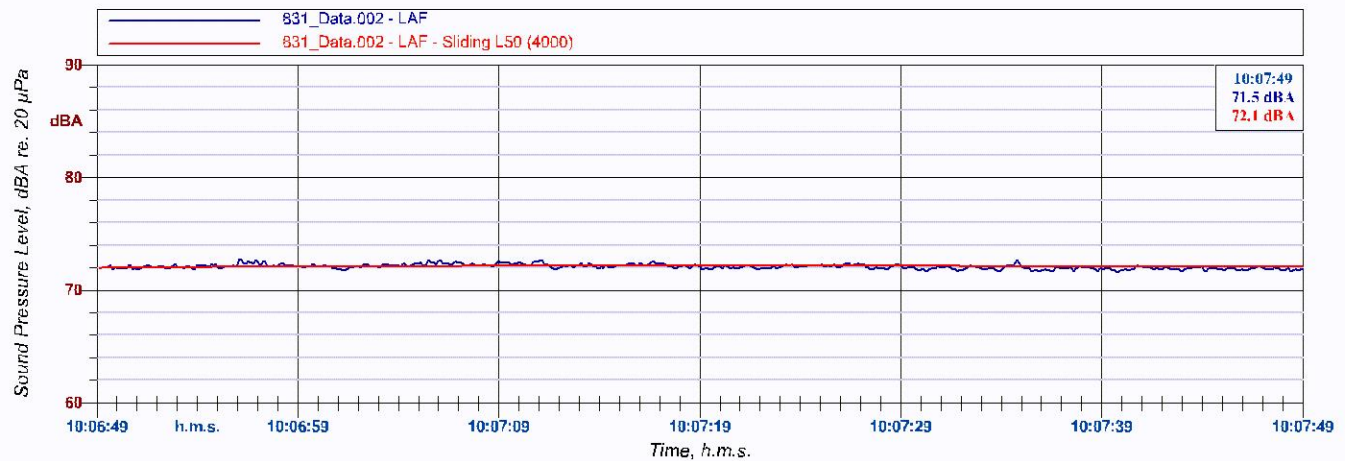
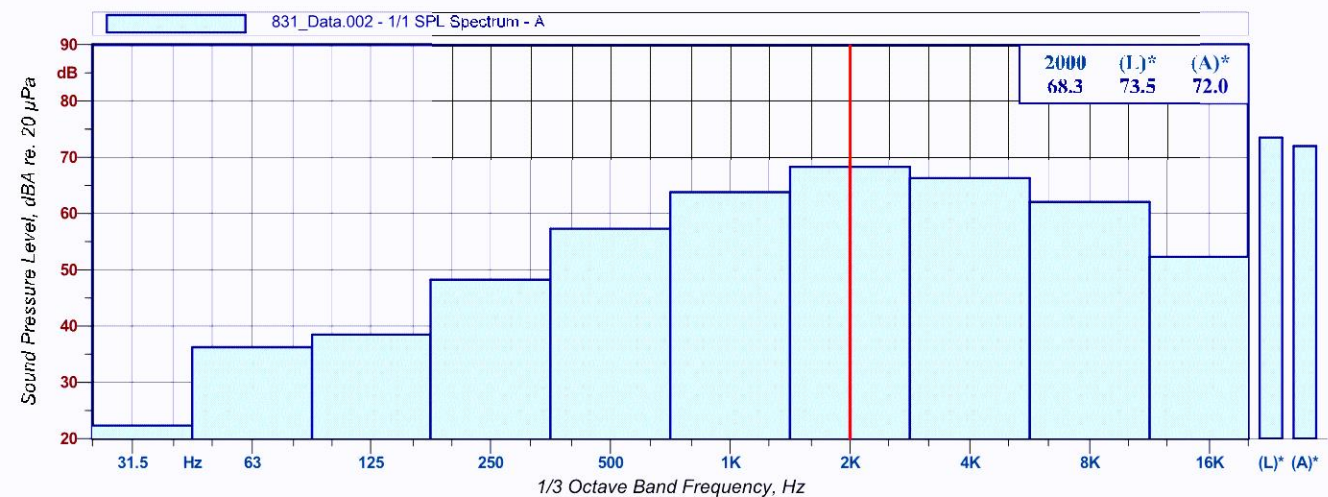
Figure B1

**Measurements:** File N. 2: 10' from a Running Vacuum.

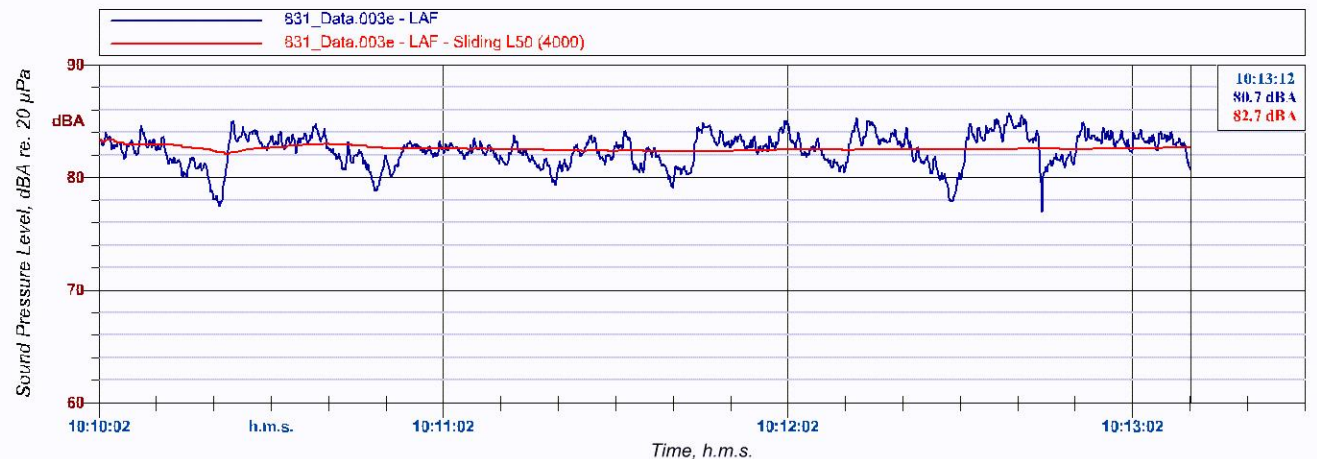
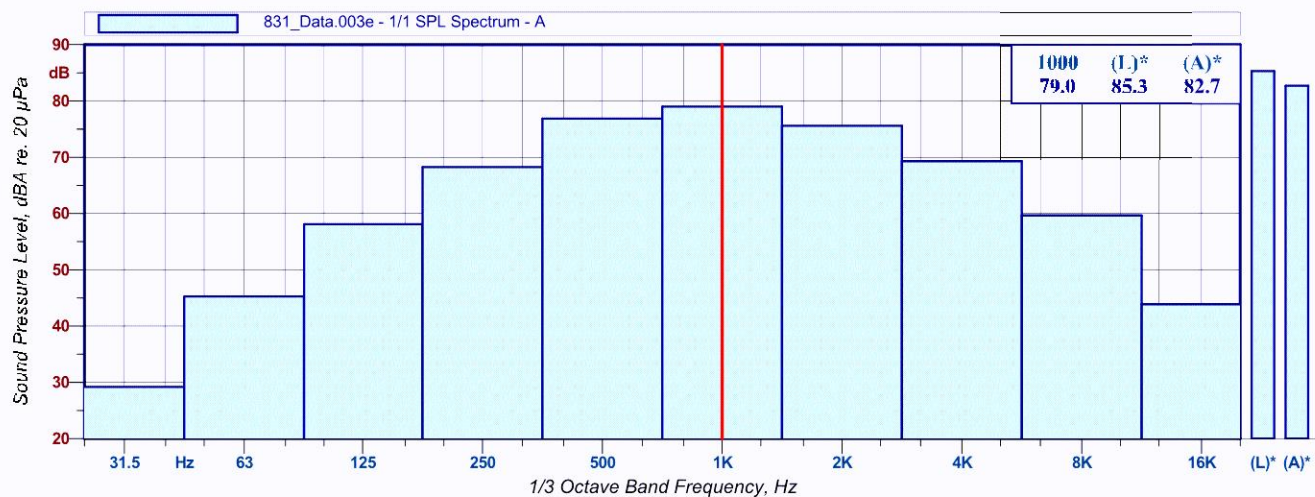
Figure B2

**Measurements:** File N. 3: 57'-6" from the Exit.  
Zero Degree Offset from Centerline.  
Blowers On (Blowers Off Time Extracted).

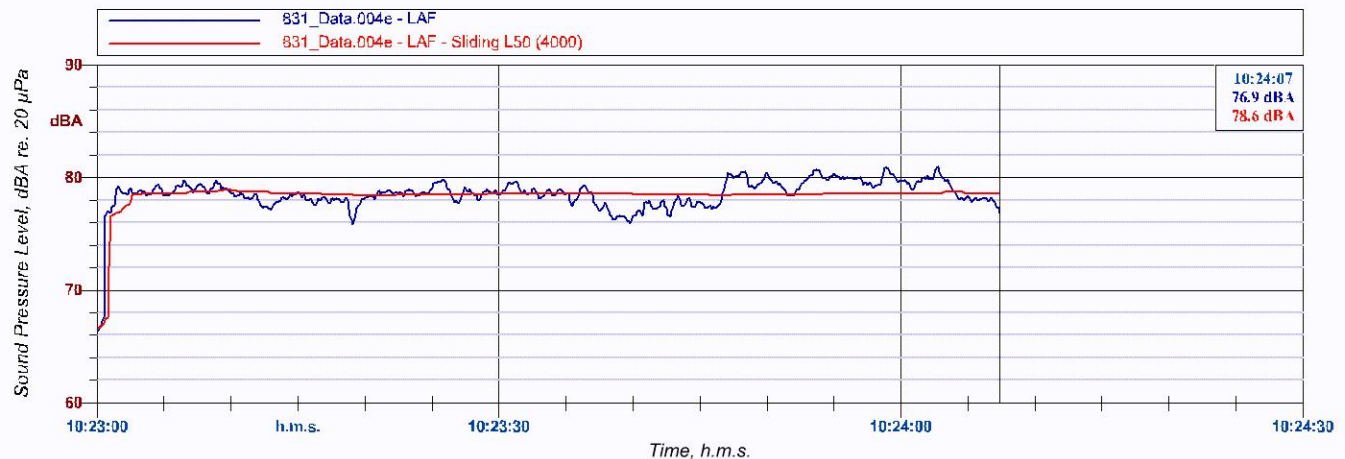
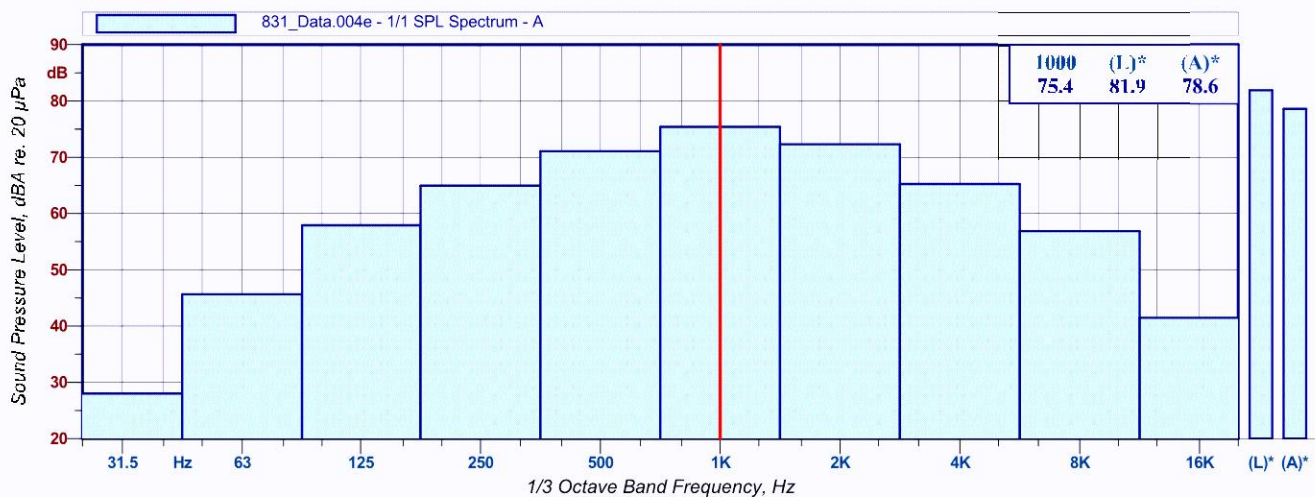
Figure B3

**Measurements:** File N. 4: 54' from the Exit.  
 45 Degree Offset from Centerline.  
 Blowers Drying 3 Cars (Blowers Off Time Extracted).

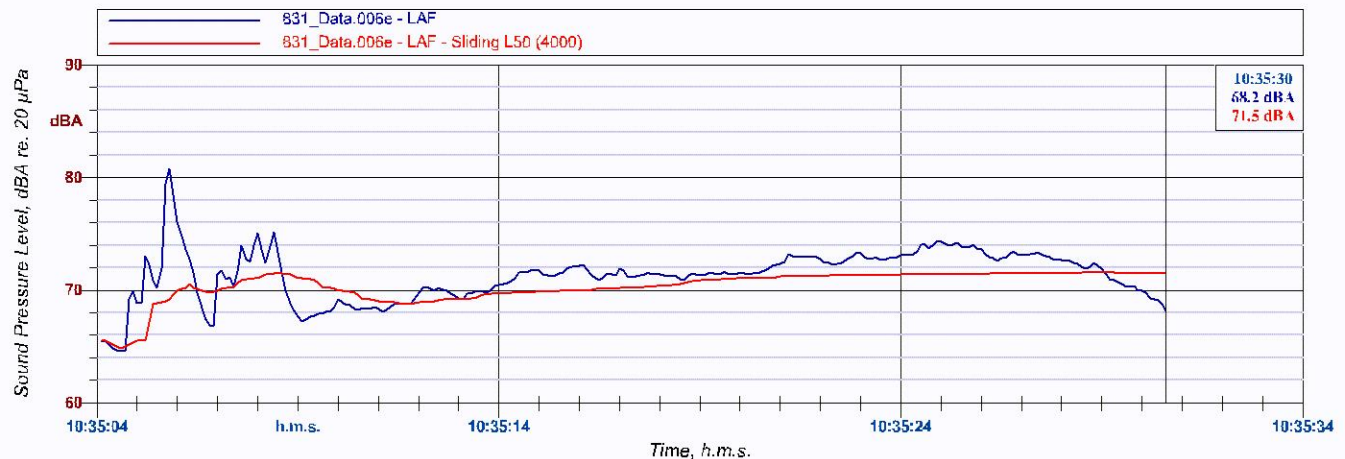
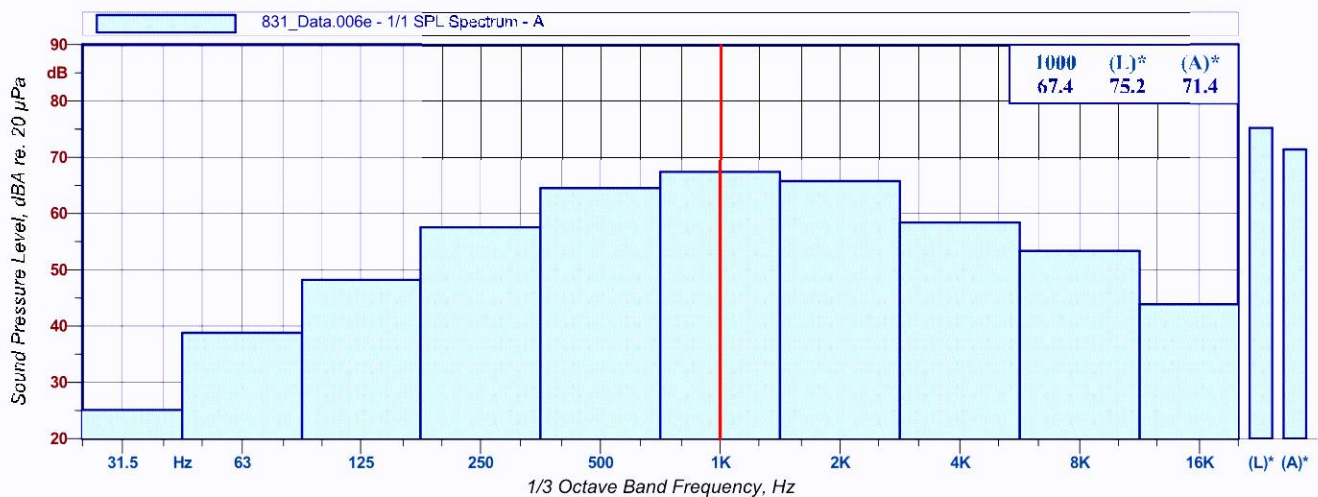
Figure B4

**Measurements:** File N. 6: 48'-4" from the Entrance Door. Doors Open.  
 Zero Degree Offset from Centerline.  
 Only Entry Automated Greeting and Blowers.

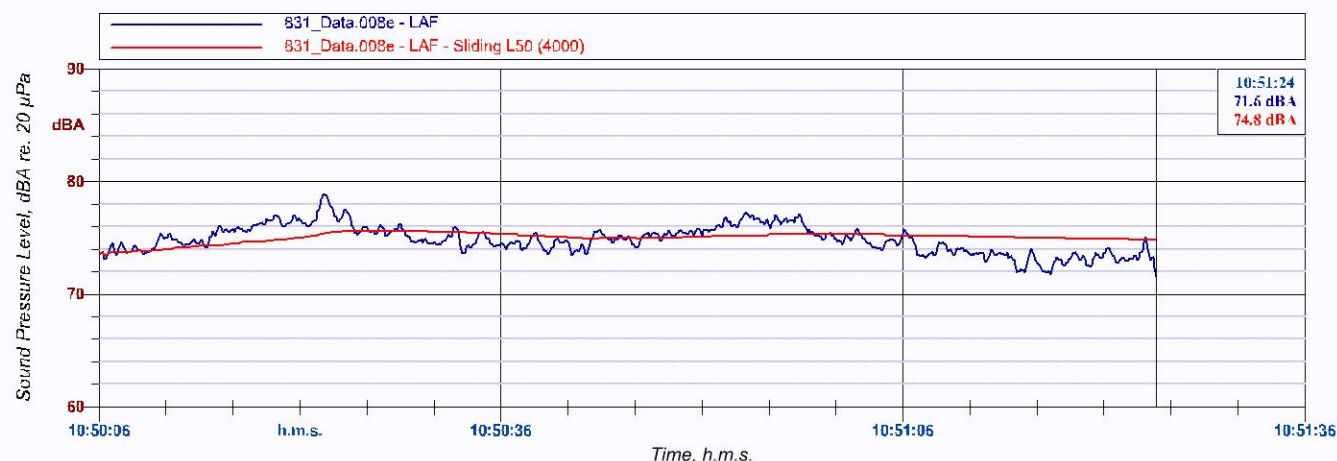
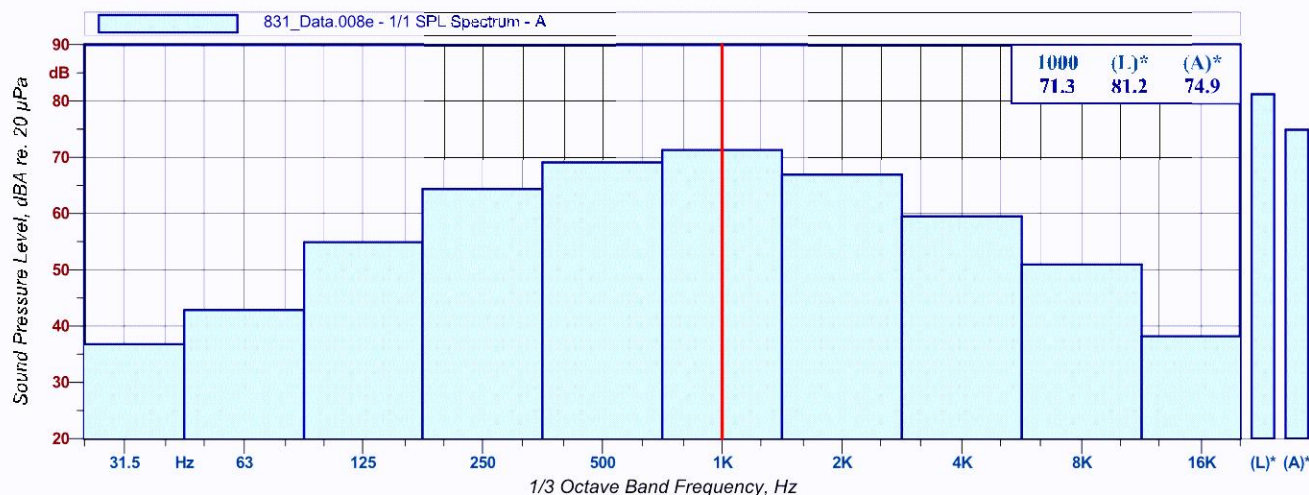
Figure B5

**Measurements:** File N. 8: 8'-6" from 1 Open Sidewall Louver.  
Northeast Side of the Building.  
Blowers On (Blowers Off Time Extracted).

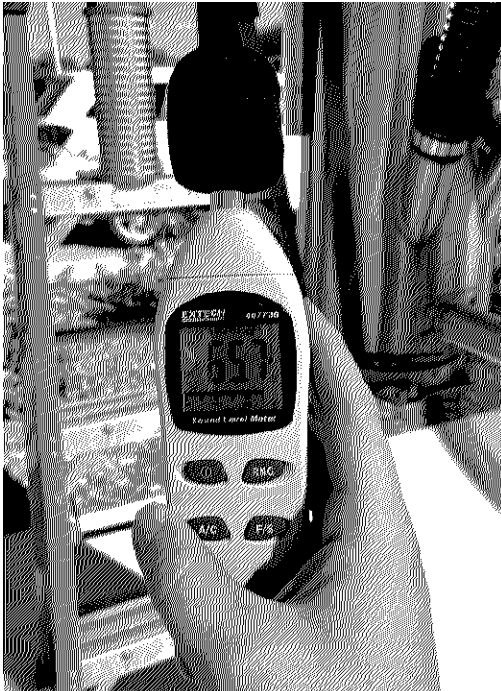
FIGURE 1.1

1. BASELINE RESULTS (No mufflers attached)
  - a. Noise
    - i. Ambient (no vacs running): 65.7 dB (See figure 1.1)
    - ii. Running Vac with no muffler: 88.1 dB (See Figure 1.2)
  - b. Additional Maintenance necessary / clogging: NO
  - c. Suction: 50 kPa/ 0%
  - d. Aesthetics: Great

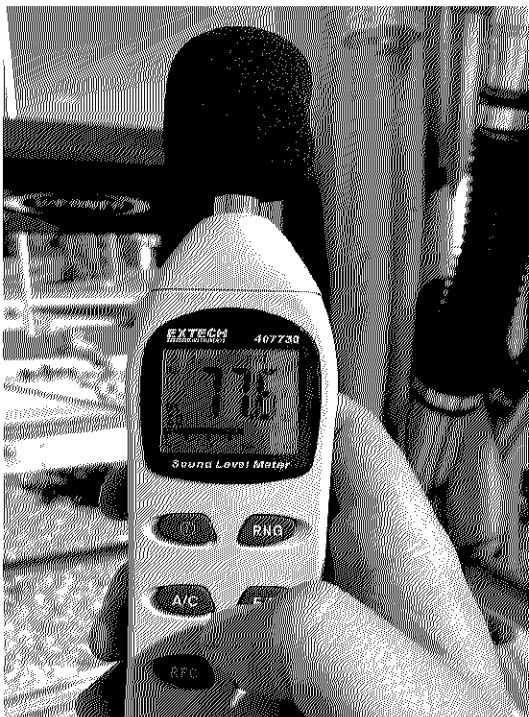
Figure 2.1

- a. Noise reduction (dB):
  - i. Reading: 77.6 dB (See Figure 2.1)
  - ii. Reduction: 10.5 dB
- b. Additional Maintenance necessary / clogging
  - i. Yes: Minor (additional maintenance and clogging)
    - 1. Reverse pulse vacs to help with this
    - 2. Wash Mufflers to help with this
- c. Suction loss (KPa and %)
  - i. Reading: 40kPa (see Figure 2.2)
  - ii. Loss: 10kPa – 20% loss in suction
- d. Aesthetics
  - i. Good (See Figure 2.3)

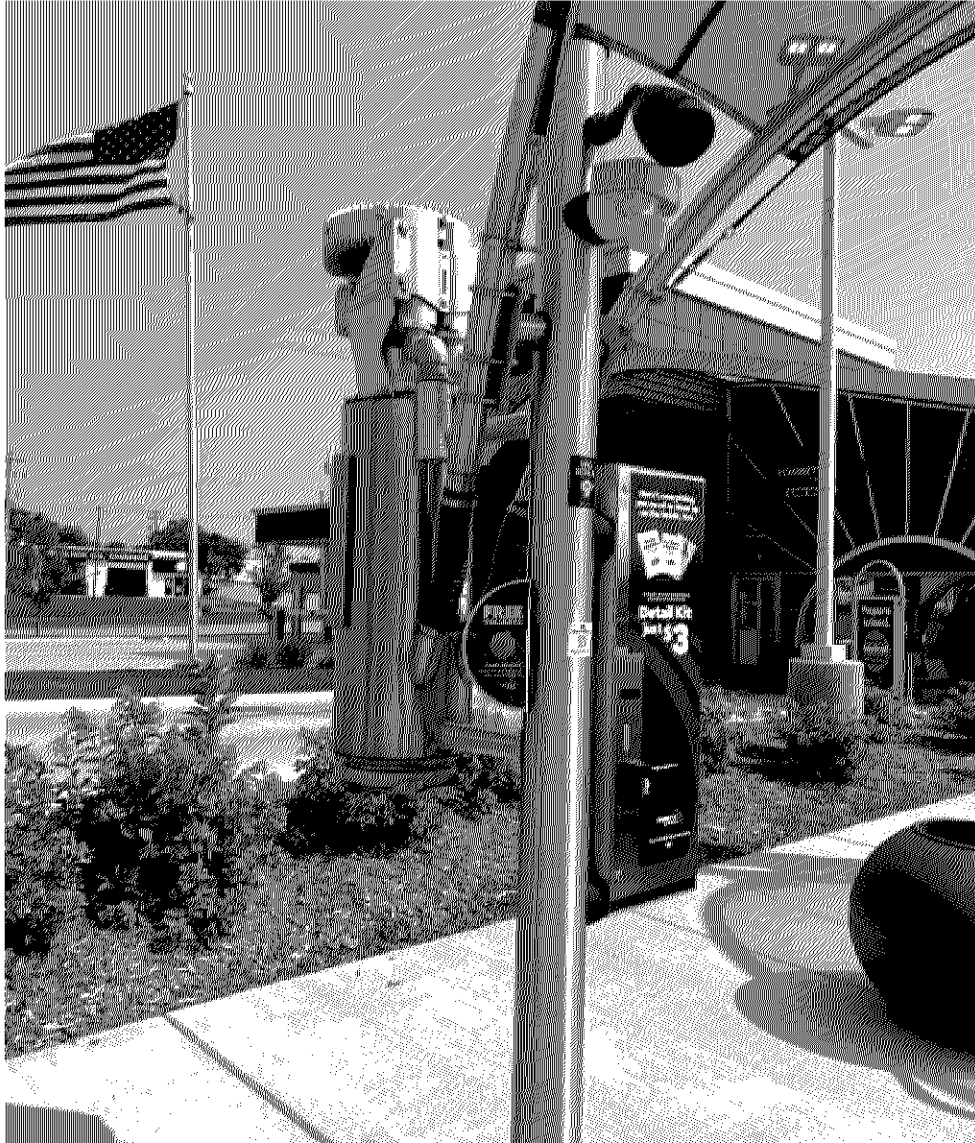
Figure 2.3: P-VAC-334

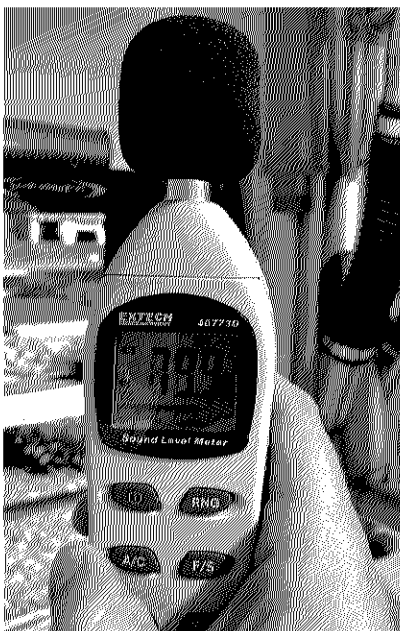
3.1

- a. Noise reduction (dB):
  - i. Reading: 79.1 dB (See Figure 3.1)
  - ii. Reduction: 9 dB
- b. Additional Maintenance necessary / clogging
  - 1. Yes: Minimal (additional maintenance, no clogging)
    - a. Eventually replace filter of muffler.
- c. Suction loss (KPa and %)
  - i. Reading: 50kPa (see Figure 3.2)
  - ii. Loss: 0kPa – 0% loss in suction
- d. Aesthetics
  - i. Fair (See Figure 3.3)
