February 28, 2022

Subject: Summary Report for  
Carwash Noise Control  
Tommy's Express Car Wash – Bloomington, Minnesota

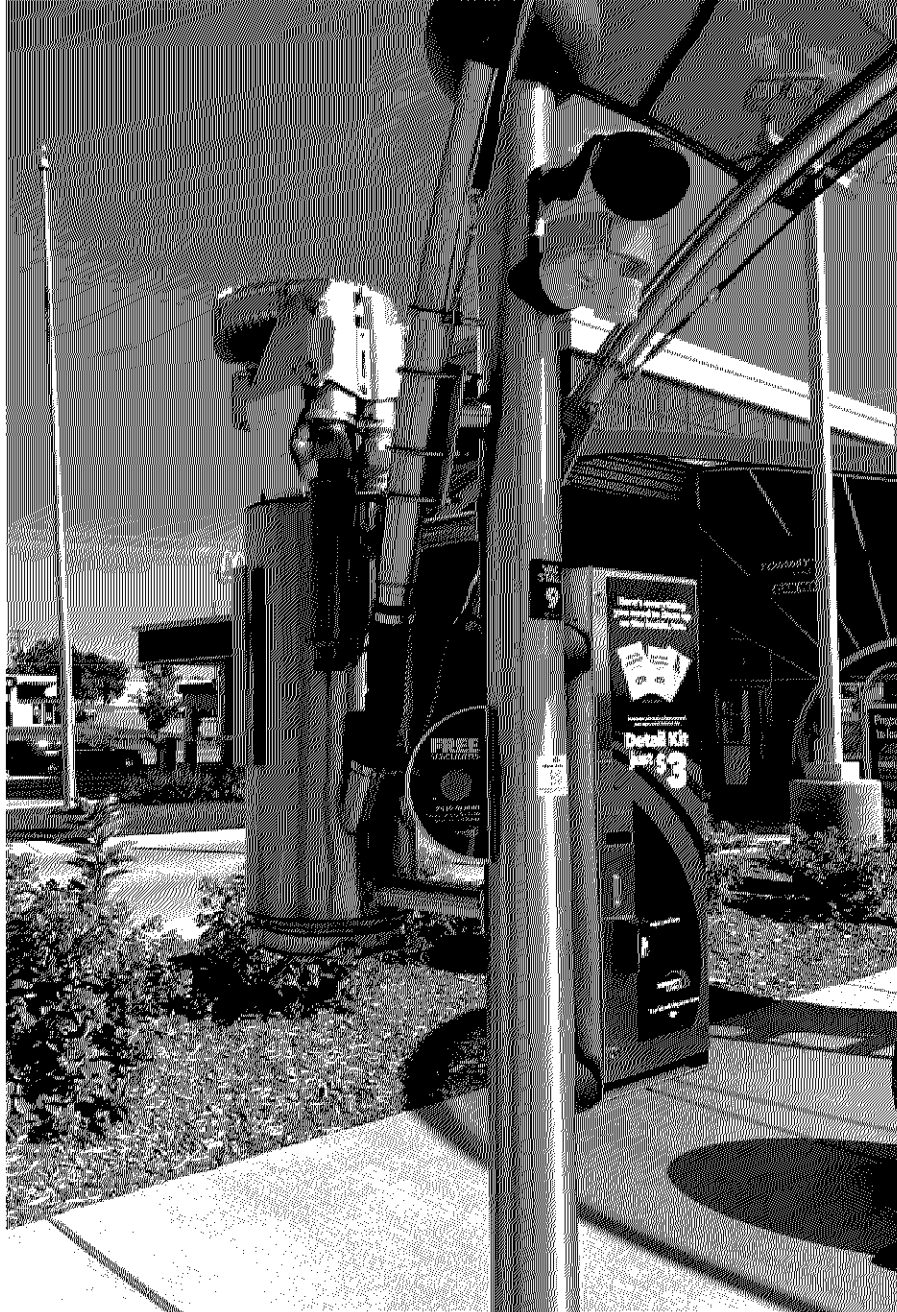
- a. Noise reduction (dB):
  - i. Reading: 79.1 dB (See Figure 3.1)
  - ii. Reduction: 9 dB
- b. Additional Maintenance necessary / clogging
  - 1. Yes: Minimal (additional maintenance, no clogging)
    - a. Eventually replace filter of muffler.
- c. Suction loss (KPa and %)
  - i. Reading: 50kPa (see Figure 3.2)
  - ii. Loss: 0kPa – 0% loss in suction
- d. Aesthetics
  - i. Fair (See Figure 3.3)

FIGURE 3.3 (P-VAC-335)

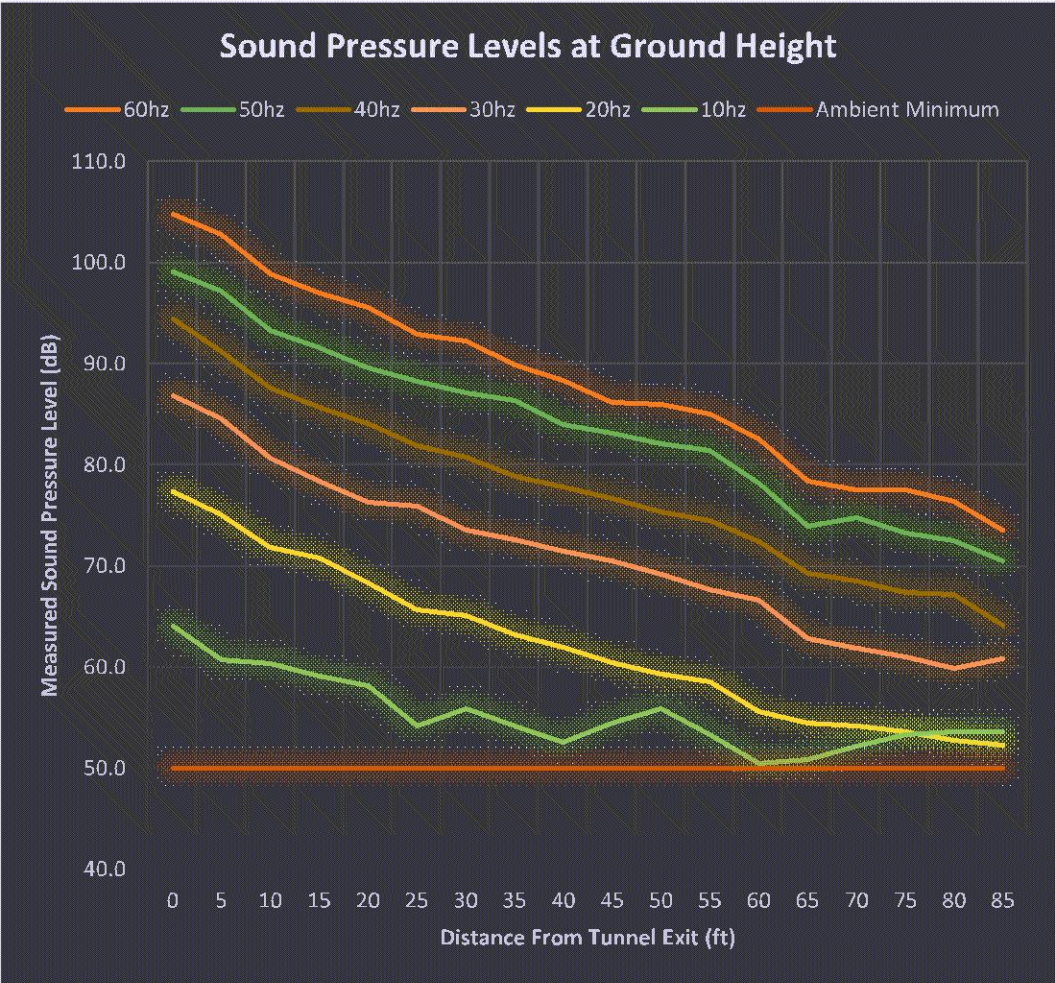
Recorded data for each position at ground level is shown below in Table 2. This data is displayed in Figure 1. Recorded data for each position at 5ft height is shown below in Table 3. This data is displayed in Figure 2.

Figure 1: Measured Sound Pressure Levels at Ground Height

By varying the frequency of the blower motor, it was possible to achieve sound pressure levels which did not exceed the ambient conditions at the maximum recorded distance. It was not possible to record the true sound level at these positions due to ambient sound conditions.

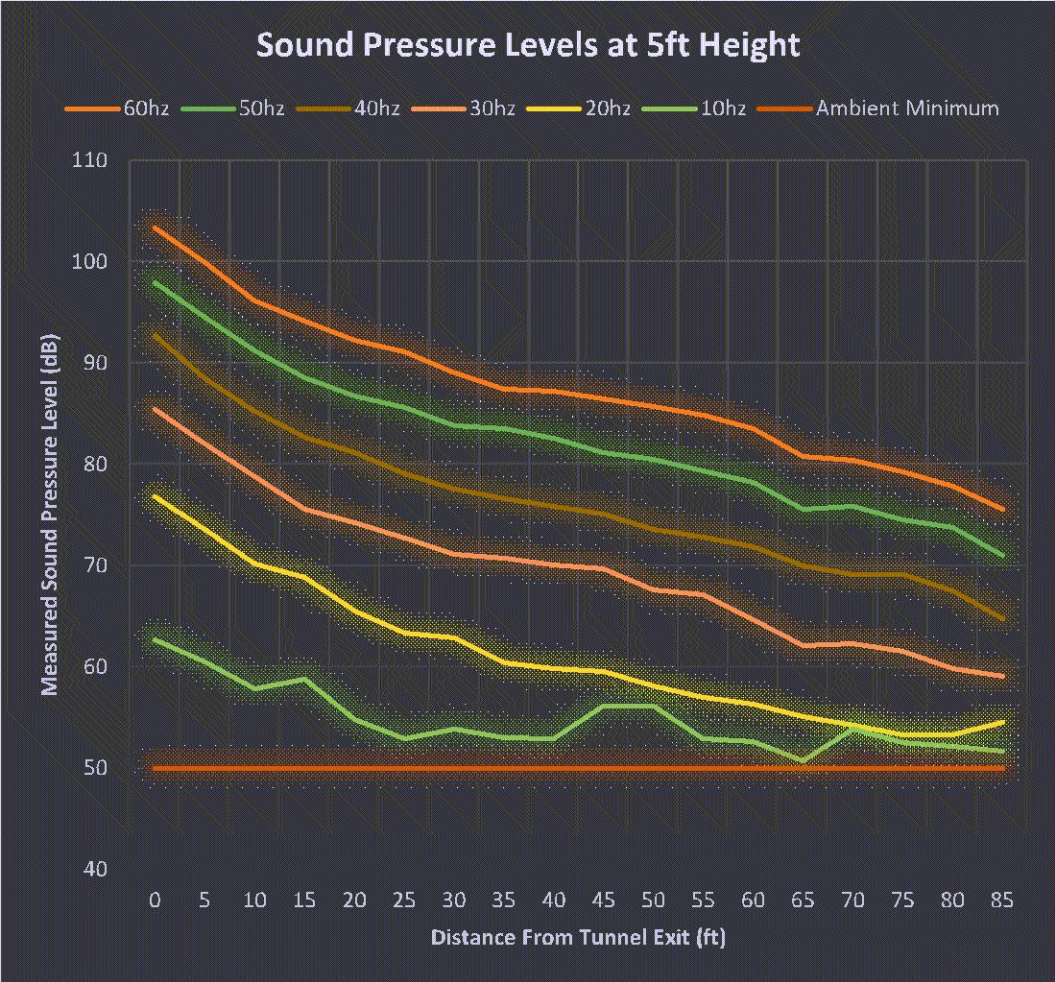
**Figure 2: Measured Sound Pressure Levels at 5ft Height**
