| CHANGE ORDER | | | | | |

## TCWS Muffler Report

## Sound Level Testing – Hudsonville 5/18/21

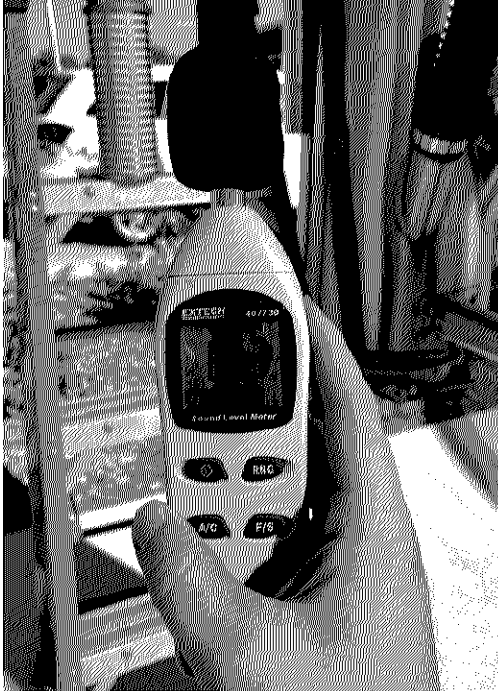
FIGURE 1.1

1. BASELINE RESULTS (No mufflers attached)
  - a. Noise
    - i. Ambient (no vacs running): 65.7 dB (See figure 1.1)
    - ii. Running Vac with no muffler: 88.1 dB (See Figure 1.2)
  - b. Additional Maintenance necessary / clogging: NO
  - c. Suction: 50 kPa/ 0%
  - d. Aesthetics: Great

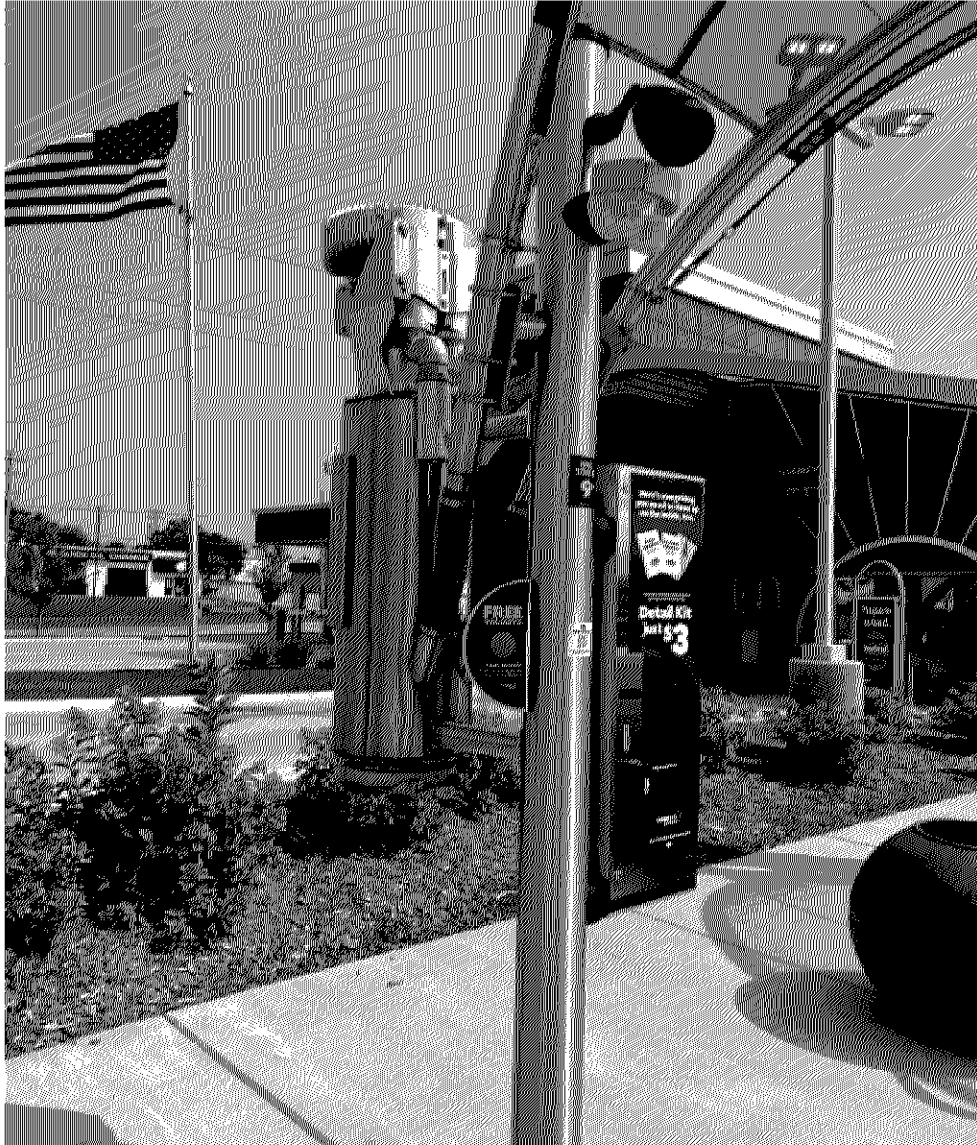
- a. Noise reduction (dB):
  - i. Reading: 77.6 dB (See Figure 2.1)
  - ii. Reduction: 10.5 dB
- b. Additional Maintenance necessary / clogging
  - i. Yes: Minor (additional maintenance and clogging)
    - 1. Reverse pulse vacs to help with this
    - 2. Wash Mufflers to help with this
- c. Suction loss (KPa and %)
  - i. Reading: 40kPa (see Figure 2.2)
  - ii. Loss: 10kPa – 20% loss in suction
- d. Aesthetics
  - i. Good (See Figure 2.3)

Figure 2.3: P-VAC-334

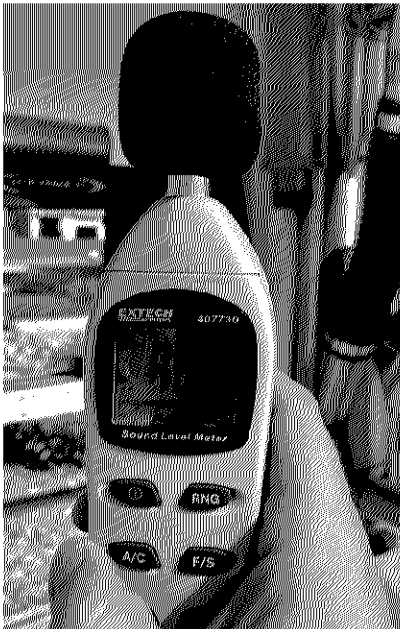
3.1

- a. Noise reduction (dB):
  - i. Reading: 79.1 dB (See Figure 3.1)
  - ii. Reduction: 9 dB
- b. Additional Maintenance necessary / clogging
  - 1. Yes: Minimal (additional maintenance, no clogging)
    - a. Eventually replace filter of muffler.
- c. Suction loss (KPa and %)
  - i. Reading: 50kPa (see Figure 3.2)
  - ii. Loss: 0kPa – 0% loss in suction
- d. Aesthetics
  - i. Fair (See Figure 3.3)

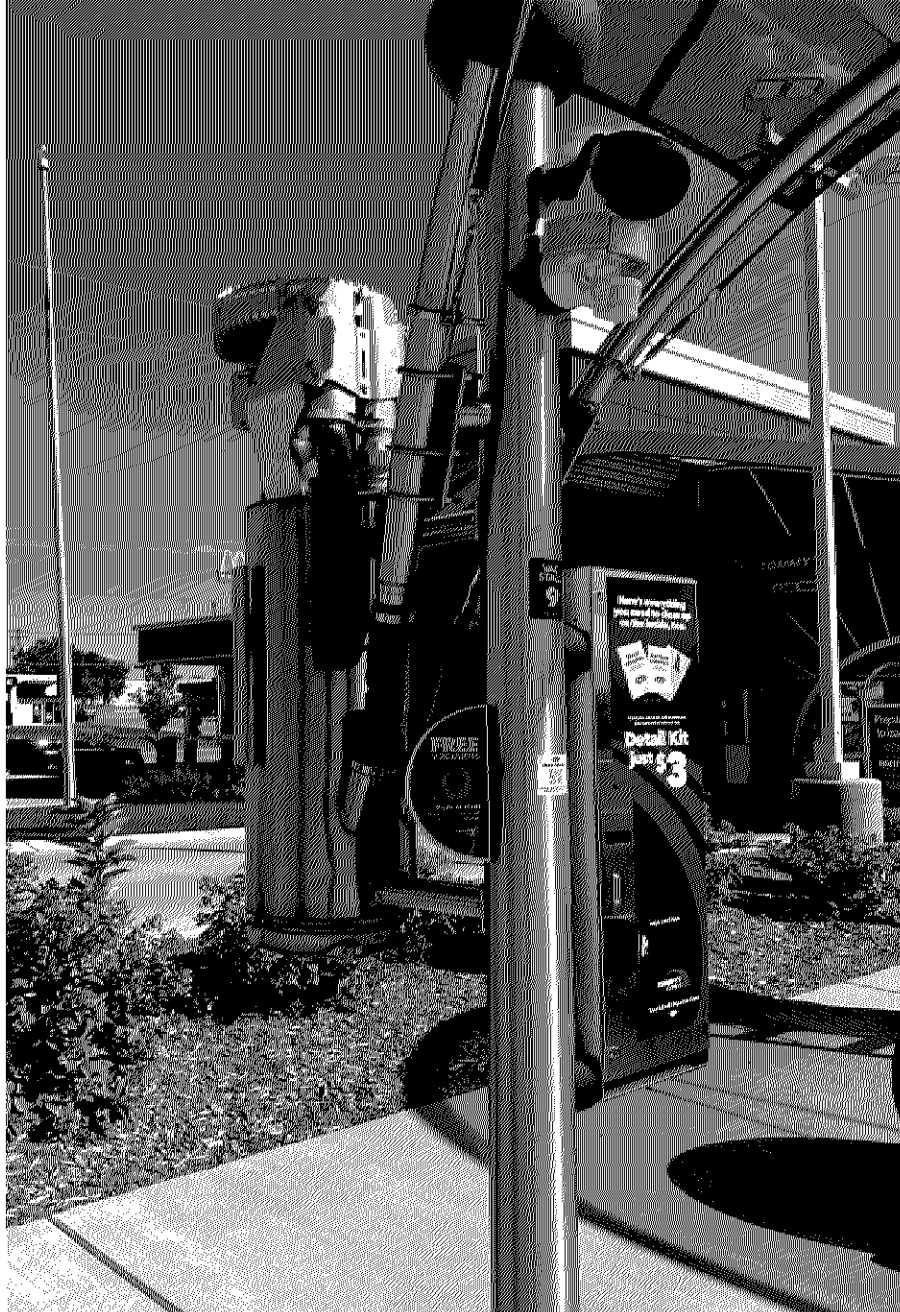
FIGURE 3.3 (P-VAC-335)
